Pit, Below-Grade Tank, or
Proposed Alternative Method Permit or Closure Plan Application

ConocoPhillips Company
San Juan Basin
Below Grade Tank Closure Report

Lease Name: Lindrith B Unit 41

API No.: 30-039-23840

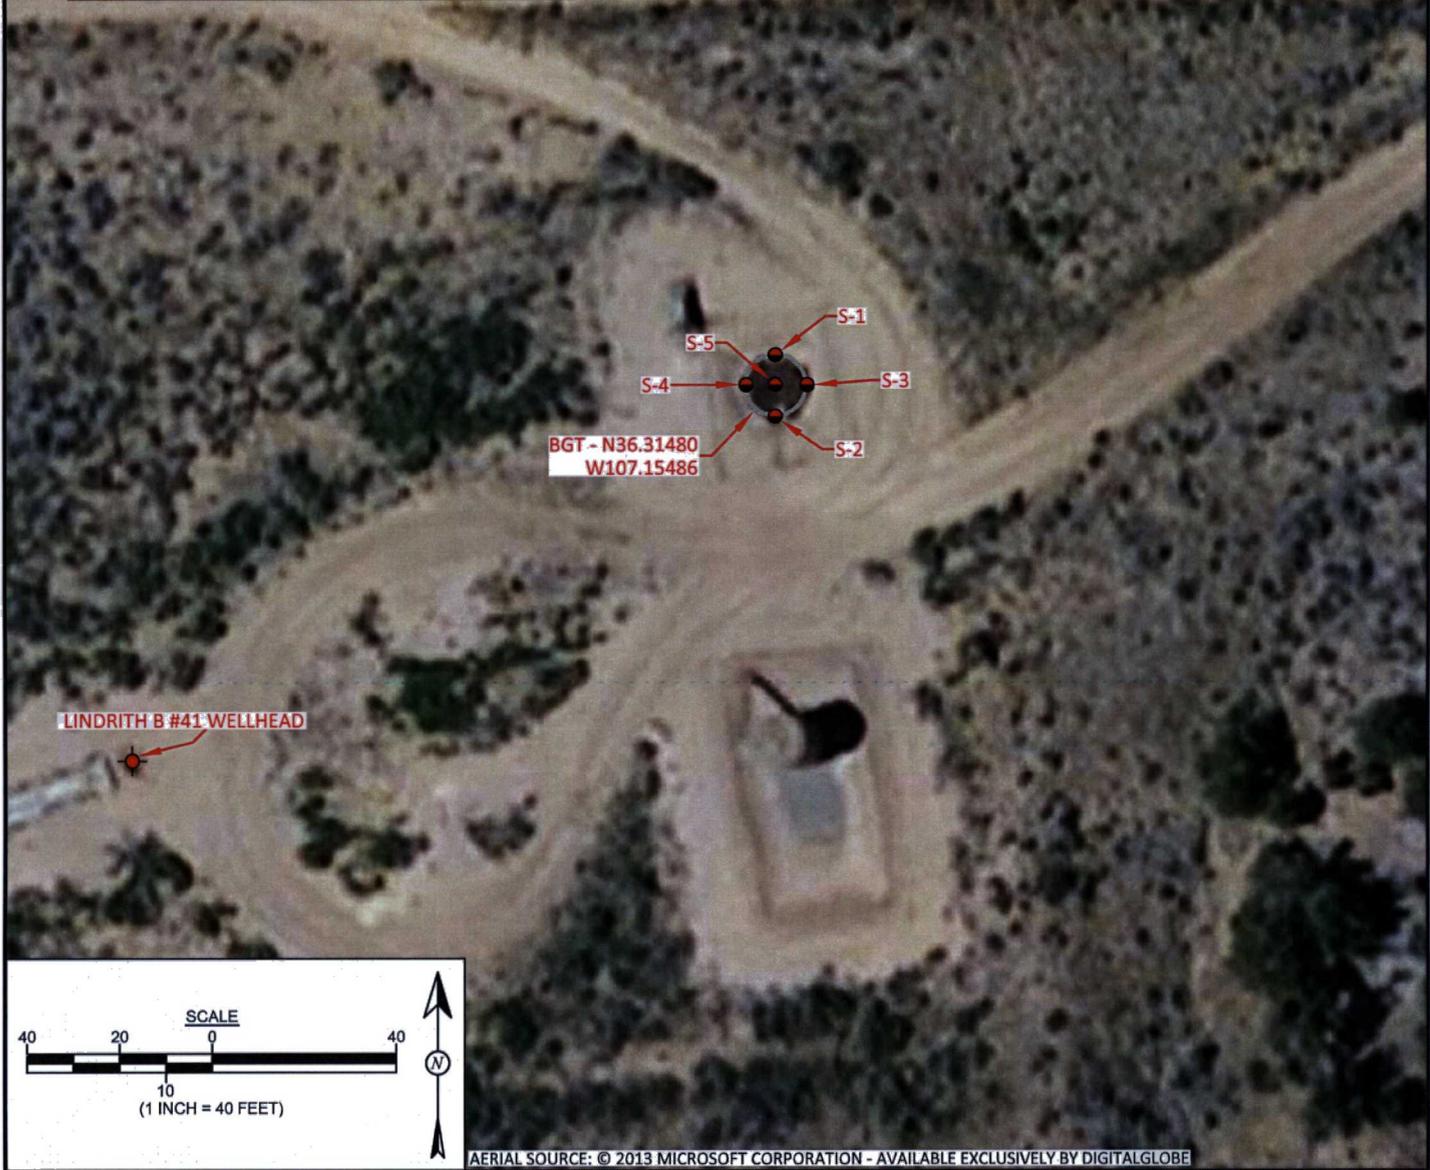
Laboratory Analytical Results						
Sample ID	Date	Benzene (mg/kg)	Total BTEX (mg/kg)	TPH - GRO (mg/kg)	TPH - DRO (mg/kg)	Chlorides (mg/kg)
NMOCD ACTION LEVEL		0.2	50	100		250
SC-1	10/23/13	<0.050	<0.25	<5.0	19	<30

SAMPLE WAS ANALYZED PER EPA METHOD 8021B, 8015D AND 300.0.
