Pit, Below-Grade Tank, or
Proposed Alternative Method Permit or Closure Plan Application

1.	Operator: <u>ConocoPhillips Company</u> OGRID #: <u>217817</u> Address: <u>PO BOX 4289, Farmington, NM 87499</u> Facility or well name: <u>HARDIE 4E - NORTH</u> API Number: <u>30-045-24938</u> OCD Permit Number: _____ U/L or Qtr/Qtr <u>E</u> Section <u>24</u> Township <u>29N</u> Range <u>8W</u> County: <u>San Juan</u> Center of Proposed Design: Latitude <u>36.71331 °N</u> Longitude <u>-107.63456 °W</u> NAD: <input type="checkbox"/> 1927 <input checked="" type="checkbox"/> 1983 Surface Owner: <input checked="" type="checkbox"/> Federal <input type="checkbox"/> State <input type="checkbox"/> Private <input type="checkbox"/> Tribal Trust or Indian Allotment

FIGURE 2
AERIAL SITE MAP
OCTOBER 2013
ConocoPhillips
HARDIE #4E
SW¼ NW¼, SECTION 24, T29N, R8W
SAN JUAN COUNTY, NEW MEXICO
N36.71331, W107.63448

**FINAL EXCAVATION SAMPLE
LOCATIONS AND RESULTS
OCTOBER 2013**
ConocoPhillips
HARDIE #4E
SW¼, NW¼, SECTION 24, T29N, R8W
SAN JUAN COUNTY, NEW MEXICO
N36.71331, W107.63448

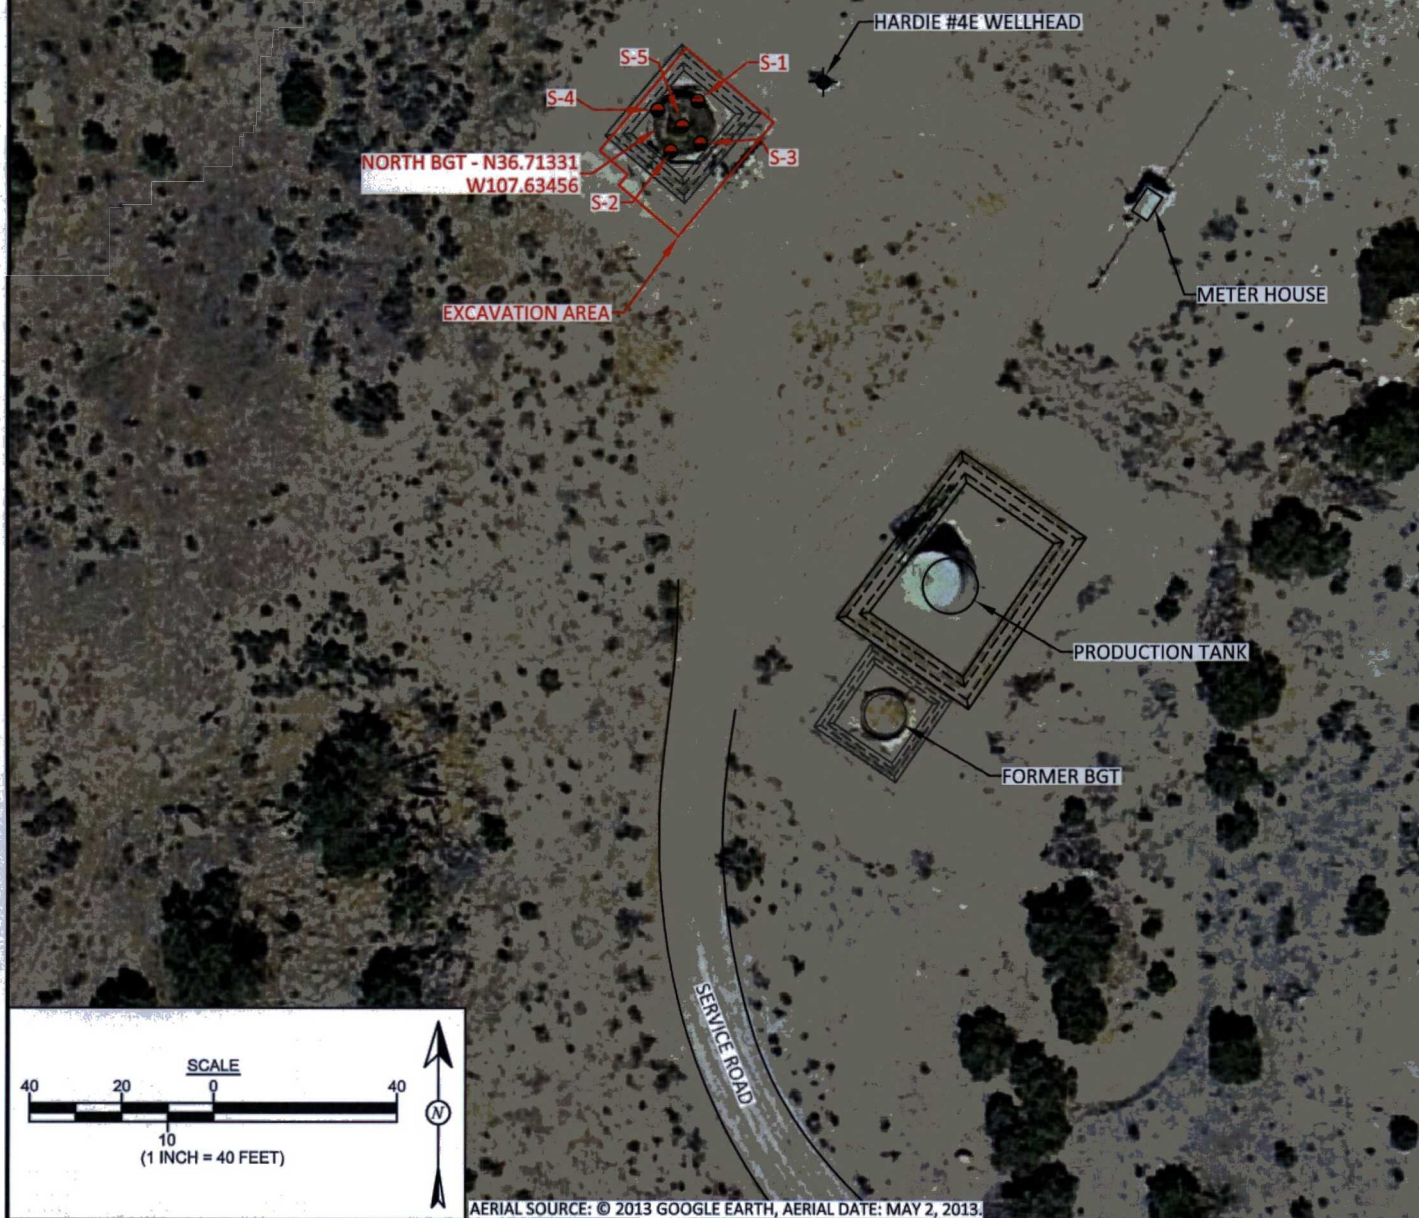
AES was initially contacted by Doyle Clark of CoP on October 21, 2013, and on October 22, 2013, Deborah Watson and David Reese of AES conducted BGT closure sampling. AES personnel collected six soil samples from below the BGT liner. Four samples (S-1 through S-4) were collected from the perimeter of the BGT footprint, one sample (S-5) was collected from the center of the BGT footprint, and one sample (BGT SC-1) was composited from the four perimeter samples and one center sample. Based on visual observations and field screening results, AES recommended excavation of the release area. Sample locations are shown on Figure 2.

SECONDARY CONTAINMENT BERM

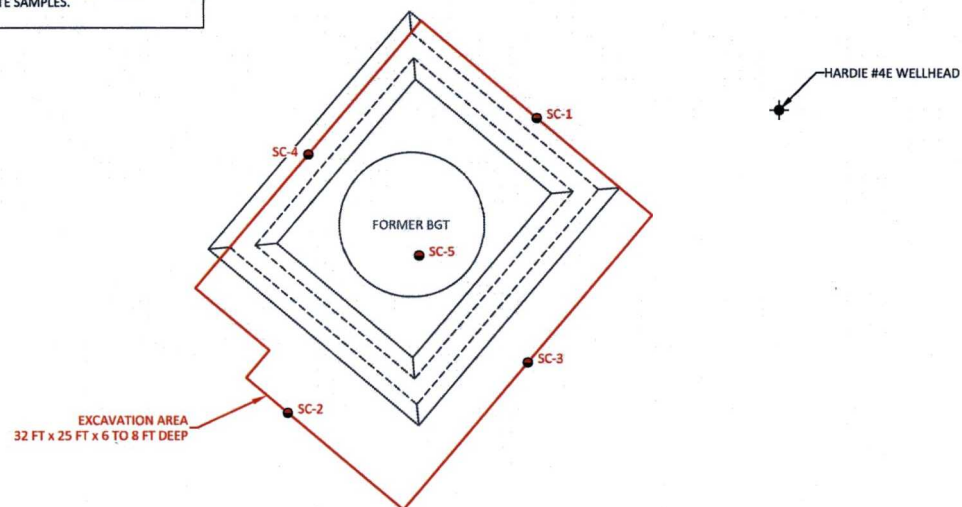
FIGURE 3

Field Screening Results				
Sample ID	Date	Depth (ft)	OVM-PID (ppm)	TPH (mg/kg)
NMOCD ACTION LEVEL			100	100
SC-1	10/23/13	1 to 6	1.8	55.4
SC-2	10/23/13	1 to 8	23.3	76.8
SC-3	10/23/13	1 to 8	1.0	67.4
SC-4	10/23/13	1 to 6	1.0	63.4
SC-5	10/23/13	6 to 8	61.1	66.0

ALL SAMPLES WERE COMPOSITE SAMPLES.
NA - NOT ANALYZED
