BP AMERICA PRODUCTION COMPANY

BELOW-GRADE TANK CLOSURE PLAN

Storey A LS # 1A - Tank ID: A API #: 3004522401 Unit Letter C, Section 35, T32N, R11W

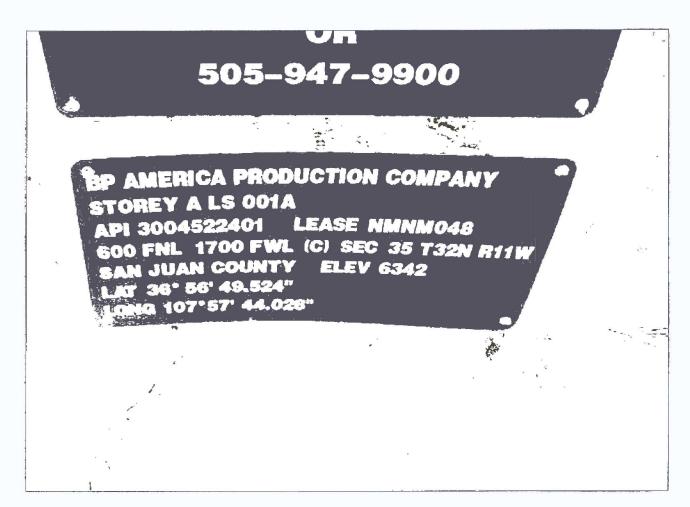
Closure report on C-144 form is included & contains a photo of the reclamation completion.
