Release Notification and Corrective Action

Name of Company BP America Production Company	Contact Steve Moskal
Address 200 Energy Court, Farmington, NM 87401	Telephone No. (505) 326-9497
Facility Name FLORANCE 002A	Facility Type Natural Gas Well
Surface Owner Federal	Mineral Owner Federal
API No. 3004522150

CLIENT: BP	BLAGG ENGINEERING, INC. P.O. BOX 87, BLOOMFIELD, NM 87413 (505) 632-1199	API #: 3004522150 TANK ID (if applicable): A
FIELD REPORT: (circle one): <u>BGT CONFIRMATION</u> / RELEASE INVESTIGATION / OTHER:		PAGE #: 1 of 1
SITE INFORMATION: SITE NAME: FLORANCE # 2A QUAD/UNIT: O SEC: 20 TWP: 30N RNG: 9W PM: NM CNTY: SJ ST: NM 1/4 - 1/4 FOOTAGE: 790'S / 1,475'E SW/SE LEASE TYPE: <u>FEDERAL</u> STATE / FEE / INDIAN LEASE #: SF077833 PROD. FORMATION: MV CONTRACTOR: BP - J. GONZALES		DATE STARTED: 12/12/16 DATE FINISHED: ENVIRONMENTAL SPECIALIST(S): NJV
REFERENCE POINT: WELL HEAD (W.H.) GPS COORD.: 36.79205 X 107.79985 GL ELEV.: 5,985' 1) 95 BGT (SW/DB) - A GPS COORD.: 36.79204 X 107.80006 DISTANCE/BEARING FROM W.H.: 67', DUE WEST 2) GPS COORD.: DISTANCE/BEARING FROM W.H.: 3) GPS COORD.: DISTANCE/BEARING FROM W.H.: 4) GPS COORD.: DISTANCE/BEARING FROM W.H.:		
SAMPLING DATA: C

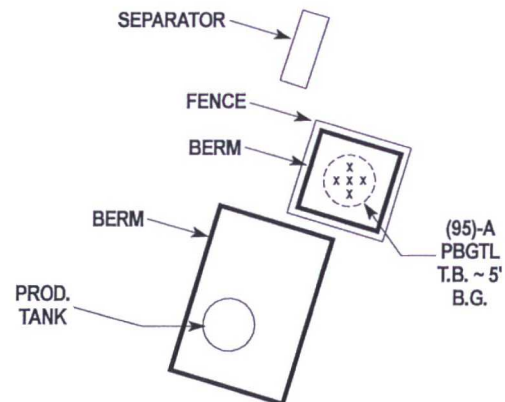
SITE SKETCH BGT Located : off <u>on</u> site PLOT PLAN circle: <u>attached</u> <div style="display: flex; align-items: center;">

<div style="margin-left: 20px;"> <p>SEPARATOR</p> <p>FENCE</p> <p>BERM</p> <p>BERM</p> <p>PROD. TANK</p> <p>W.H.</p> <p>(95)-A BGT. T.B. ~ 5' B.G.</p> </div> </div> <p style="text-align: right; margin-top: 20px;">X - S.P.D.</p>		
<div style="display: flex;"> <div style="flex: 1;"> <p>NOTES: BGT = BELOW-GRADE TANK; E.D. = EXCAVATION DEPRESSION; B.G. = BELOW GRADE; B = BELOW; T.H. = TEST HOLE; ~ = APPROX.; W.H. = WELL HEAD; T.B. = TANK BOTTOM; PBGT = PREVIOUS BELOW-GRADE TANK LOCATION; SPD = SAMPLE POINT DESIGNATION; R.W. = RETAINING WALL; NA = NOT APPLICABLE OR NOT AVAILABLE; SW - SINGLE WALL; DW - DOUBLE WALL; SB - SINGLE BOTTOM; DB - DOUBLE BOTTOM.</p> </div> <div style="flex: 1; border: 1px solid black; padding: 5px;"> <p>MISCELL. NOTES</p> <p>WO:</p> <p>REF. #: P - 658</p> <p>VID: VHIXONEVB2</p> <p>PJ#:</p> <p>Permit date(s): 06/14/10</p> <p>OCD Appr. date(s): 09/12/16</p> <p>Tank ID: A OVM = Organic Vapor Meter ppm = parts per million</p> <p>BGT Sidewalls Visible: Y / <u>N</u></p> <p>BGT Sidewalls Visible: Y / N</p> <p>BGT Sidewalls Visible: Y / N</p> <p>Magnetic declination: 10° E</p> </div> </div>

NOTES: GOOGLE EARTH IMAGERY DATE: 3/16/2016. ONSITE: 12/12/16
