Pit, Below-Grade Tank, or  
Proposed Alternative Method Permit or Closure Plan Application

Facility or well name: CORNELL SRC #4

**Burlington Resources Oil & Gas Company, LP**  
**San Juan Basin**  
**Below Grade Tank Closure Report**

**Lease Name: Cornell SRC 4**  
**API No.: 30-045-08528**

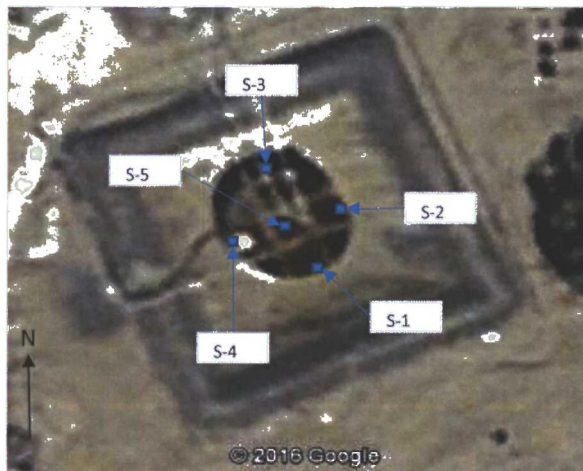
Observations: No staining or excess moisture was observed below the tank.

BGT-1 is a 5-point composite of S-1 through S-5, collected 0.5 ft below BGT.

Sample BGT-1 was laboratory analyzed for TPH (8015), BTEX (8021) and chlorides (300.0).
