**Release Notification and Corrective Action**

**RE: Excavation Clearance Report  
AXI-H9 Lateral Pipeline Release  
SW¼ SW¼, Section 32, T24N, R5W  
Rio Arriba County, New Mexico**

**TOPOGRAPHIC SITE LOCATION MAP**  
DJ RESOURCES  
AXI H-9 PIPELINE  
SW¼ SW¼, SECTION 32, T24N, R5W  
RIO ARRIBA COUNTY, NEW MEXICO  
N36.26487, W107.38830

### AERIAL SITE MAP JUNE 2017

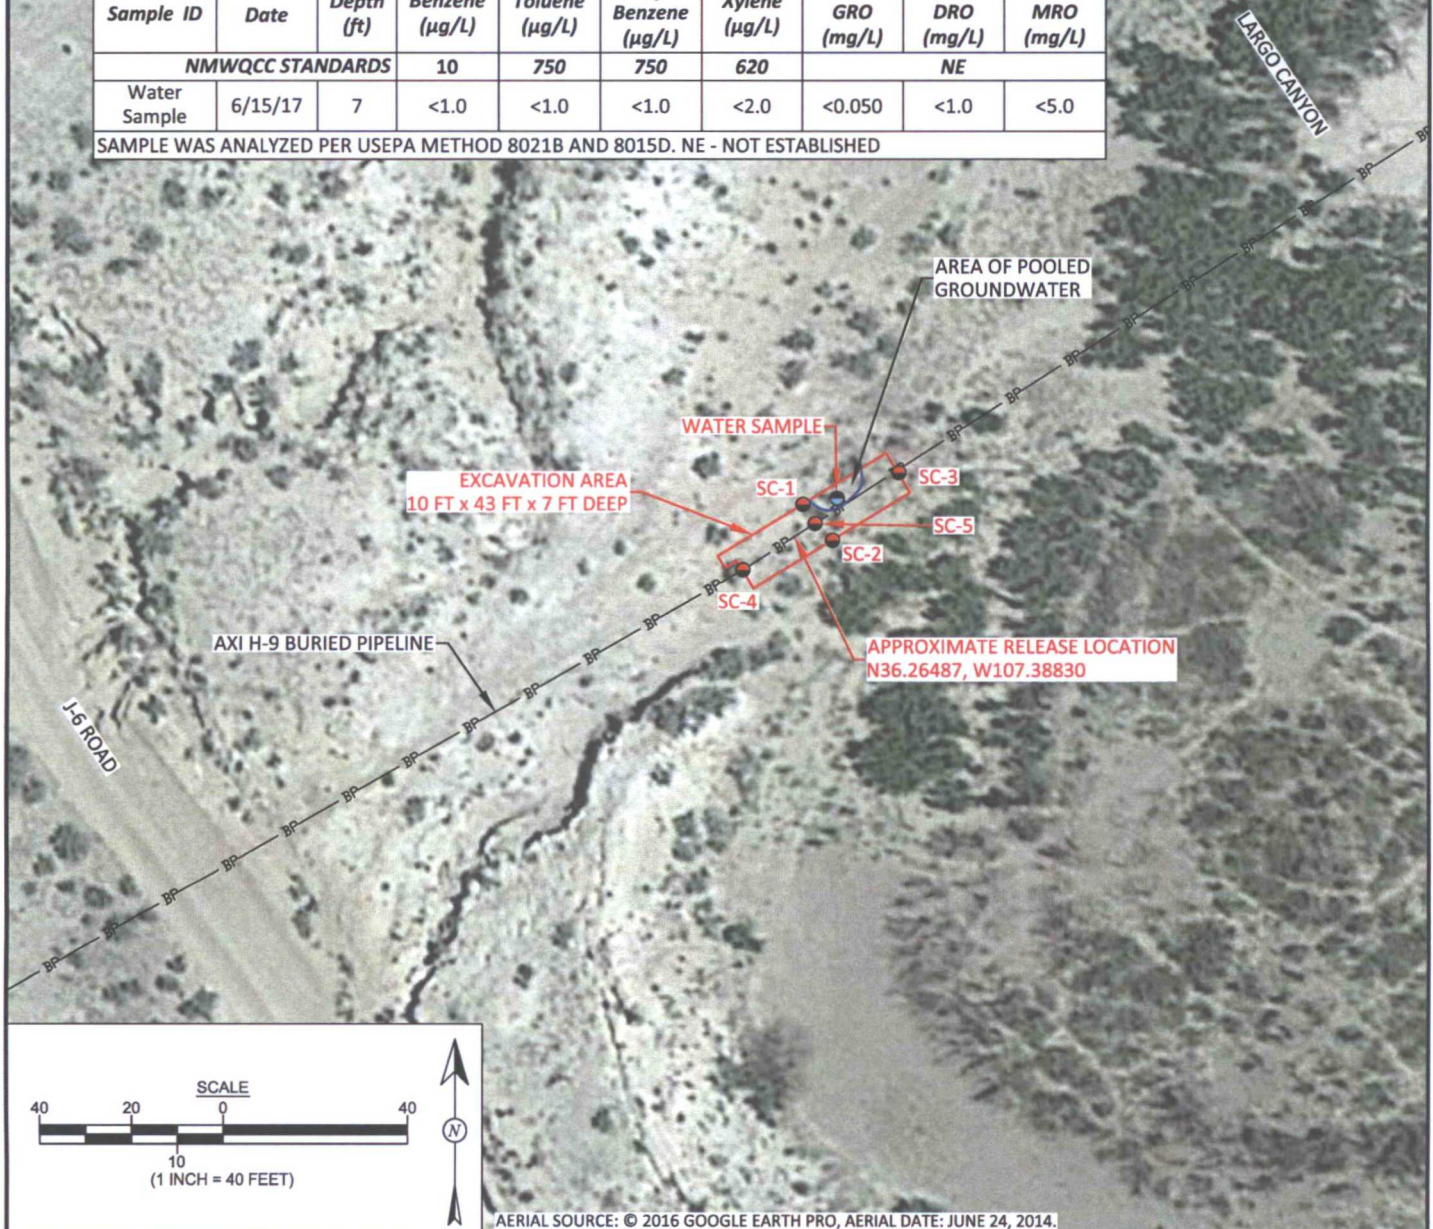
## FIGURE 2

On June 13, 2017, DJ Resources contractors completed an excavation along the pipeline, and AES personnel collected a total of five confirmation soil samples for laboratory analysis from the walls and base of the excavation. The final excavation measured approximately 10 feet by 43 feet by 7 feet deep. Sample locations and final excavation extents are presented on Figure 2.

Laboratory analytical results are summarized in Tables 1 and 2 and on Figure 2. The laboratory analytical reports are attached.

DJ RESOURCES  
AXI H-9 PIPELINE  
SW¼ SW¼, SECTION 32, T24N, R5W  
RIO ARriba COUNTY, NEW MEXICO  
N36.26487, W107.38830

Based on the final laboratory analytical results of the excavation of petroleum contaminated soils at the AXI-H9 Lateral Pipeline release location, benzene and total BTEX were below the applicable JANOGA action levels for the final base and sidewalls. However, TPH exceeded the JANOGA action level for the base (270 mg/kg GRO and DRO), but approval was obtained to apply a potassium permanganate solution and then backfill the excavation. No further work is recommended.
