Pit, Below-Grade Tank, or
Proposed Alternative Method Permit or Closure Plan Application

1.
Operator: ConocoPhillips Company OGRID #: 217817
Address: PO BOX 4289, Farmington, NM 87499
Facility or well name: LUCERNE D 1 - NORTH TANK
API Number: 30-045-07278 OCD Permit Number: _____
U/L or Qtr/Qtr P Section 21 Township 28N Range 11W County: San Juan
Center of Proposed Design: Latitude 36.64282 °N Longitude -108.00308 °W NAD: ☐ 1927 ☒ 1983
Surface Owner: ☒ Federal ☐ State ☐ Private ☐ Tribal Trust or Indian Allotment

Figure 1
Topographic Site Map
Lucerne D #1 North BGT

Rule Engineering Field Work Summary Sheet

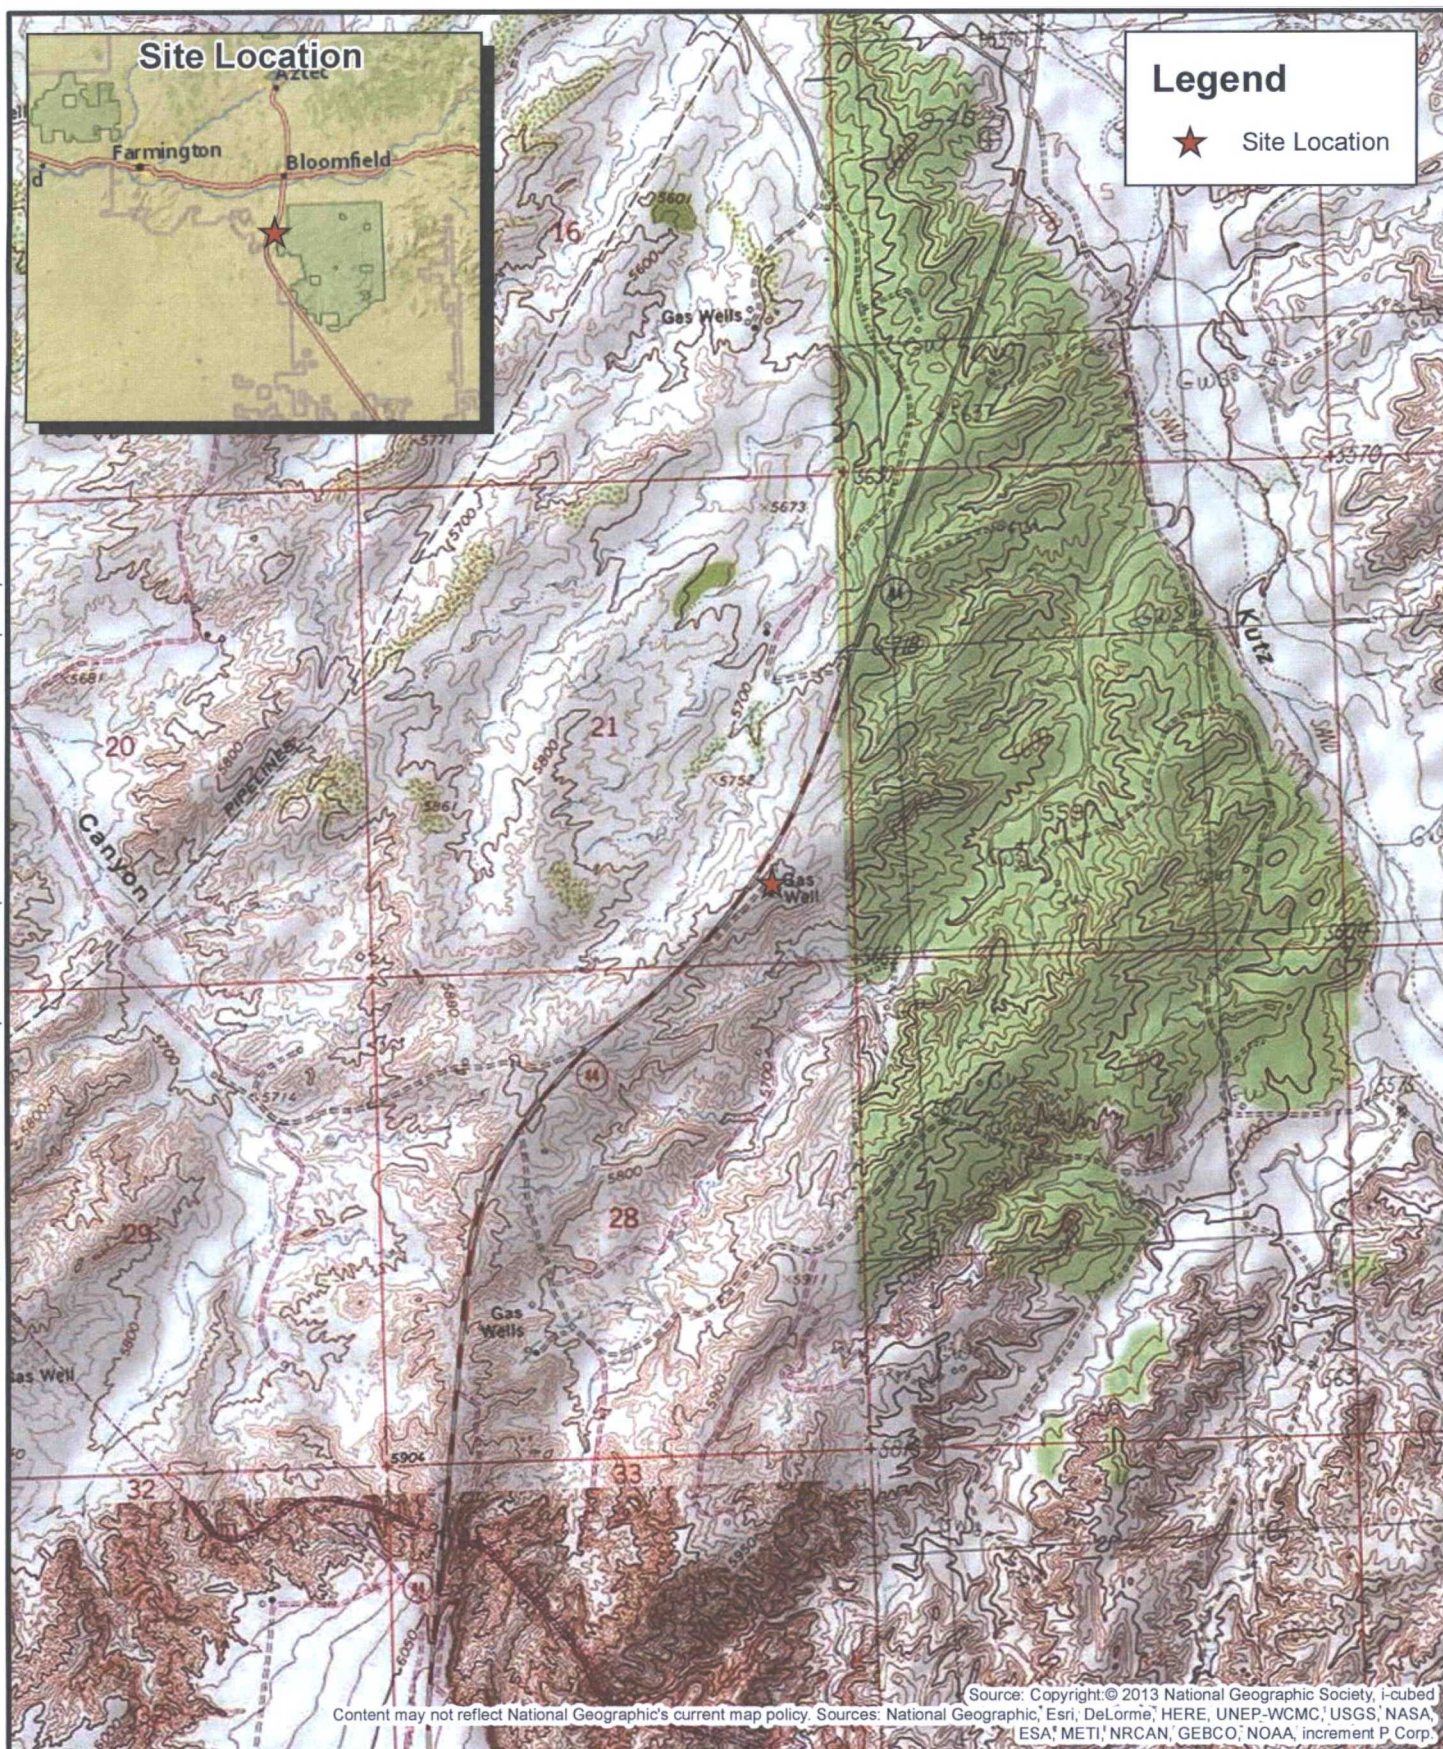
P-S21-T28N-R11W
N36.64266, W108.00321
San Juan County, NM
API: 30-045-07278

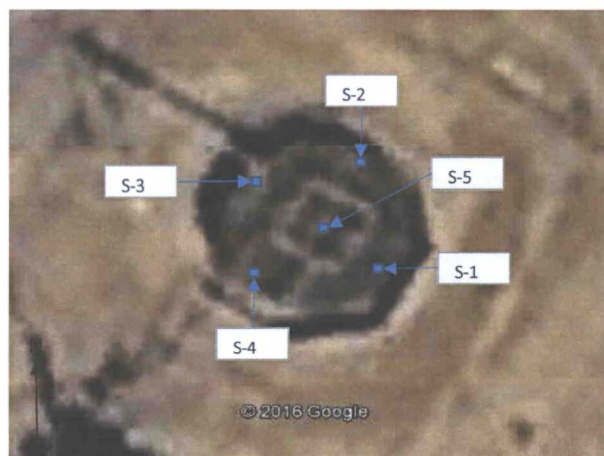
BGTN-1 and BGTN-2 are 5-point composites of S-1 through S-5, collected 0.5 ft and 3 ft below BGT, respectively. Samples BGTN-1 and BGTN-2 were laboratory analyzed for TPH (8015/418.1), BTEX (8021) and chlorides (300.0).

Observations: No excess moisture, but some discoloration, was observed below the tank.
