Pit, Below-Grade Tank, or
Proposed Alternative Method Permit or Closure Plan Application

**ConocoPhillips Company
San Juan Basin
Below Grade Tank Closure Report**

Lease Name: SAN JUAN 29-6 UNIT 86M

API No.: 30-039-26443

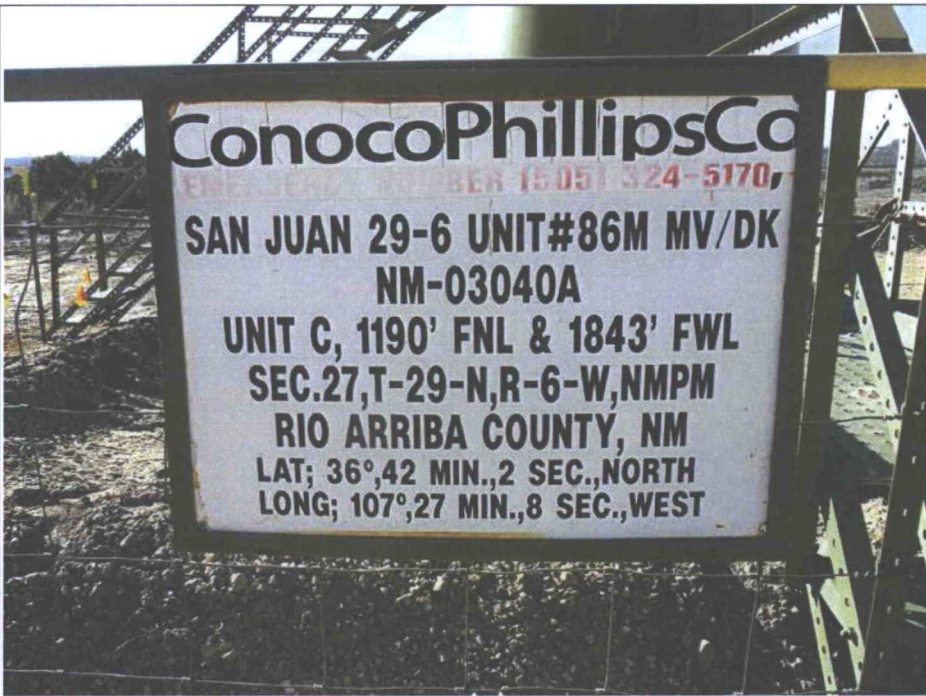
Photo #1

Client: ConocoPhillips	
Project Name: San Juan 29-6 Unit 86M Rio Arriba County, NM	
Date Photo Taken: March 21, 2017	
BGT GPS and Location: 36.70048, -107.45265	
NE¼ NW¼, Section 27, T29N, R6W	
Taken by: Dave Johnson, AES	Subject: BGT sampling, March 2017 Description: Facing S, sign on facility fence by production tank.

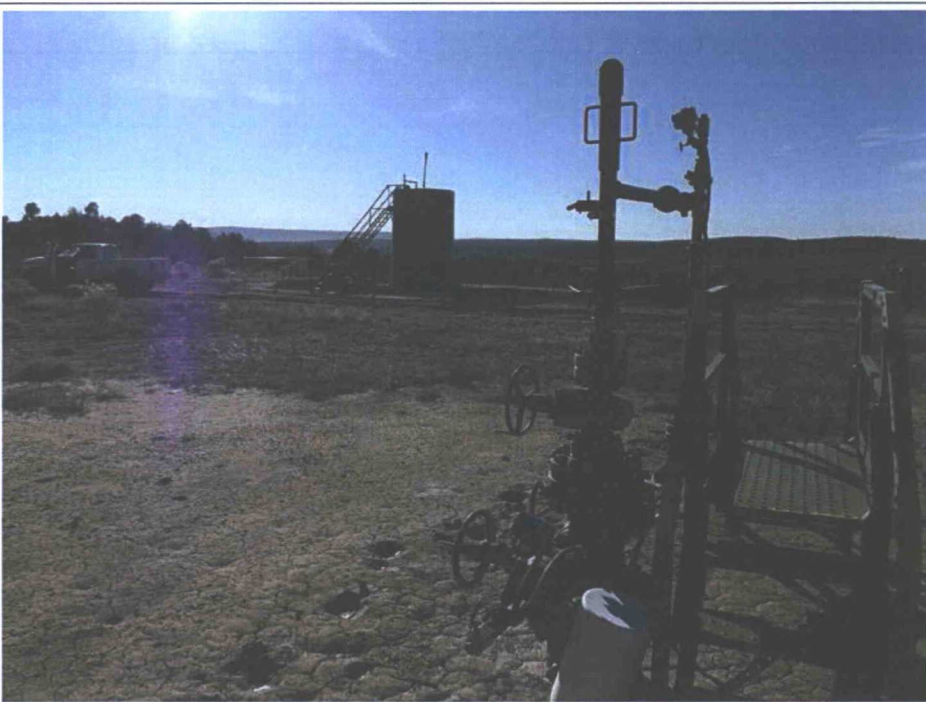
Photo #2

Client: ConocoPhillips	
Project Name: San Juan 29-6 Unit 86M Rio Arriba County, NM	
Date Photo Taken: March 21, 2017	
BGT GPS and Location: 36.70048, -107.45265	
NE¼ NW¼, Section 27, T29N, R6W	
Taken by: Dave Johnson, AES	Subject: BGT sampling, March 2017 Description: Facing SE, in direction sample location.
