Release Notification and Corrective Action

SPILL ASSESSMENT AND CLOSURE ACTIVITIES FOR THE SULLIVAN GAS COM E#1 WELL SITE, SAN JUAN COUNTY, NEW MEXICO

SPILL ASSESSMENT AND CLOSURE REPORT

**BP AMERICA PRODUCTION COMPANY
SULLIVAN GAS COM E#1 WELL SITE
SECTION 22, TOWNSHIP 32 NORTH, RANGE 10 WEST
SAN JUAN COUNTY, NEW MEXICO**

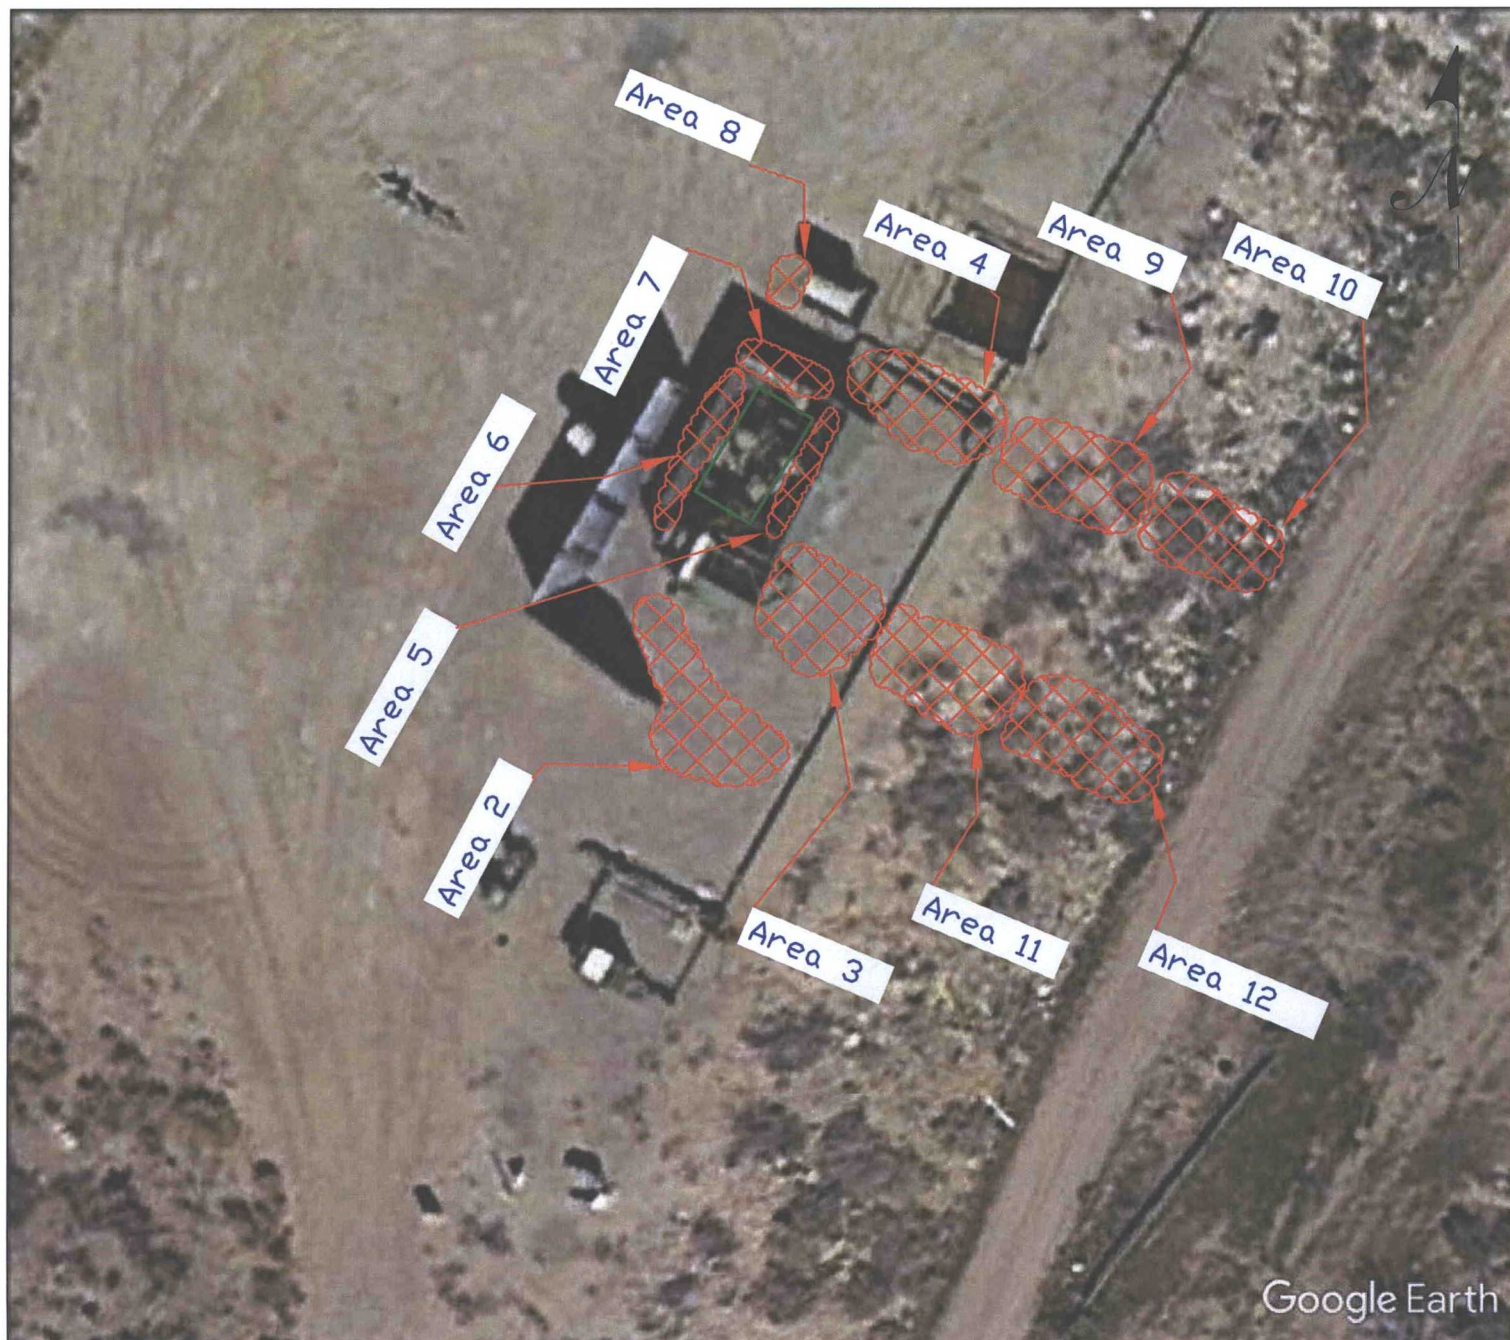
FIGURE NO. 2

SITE MAP

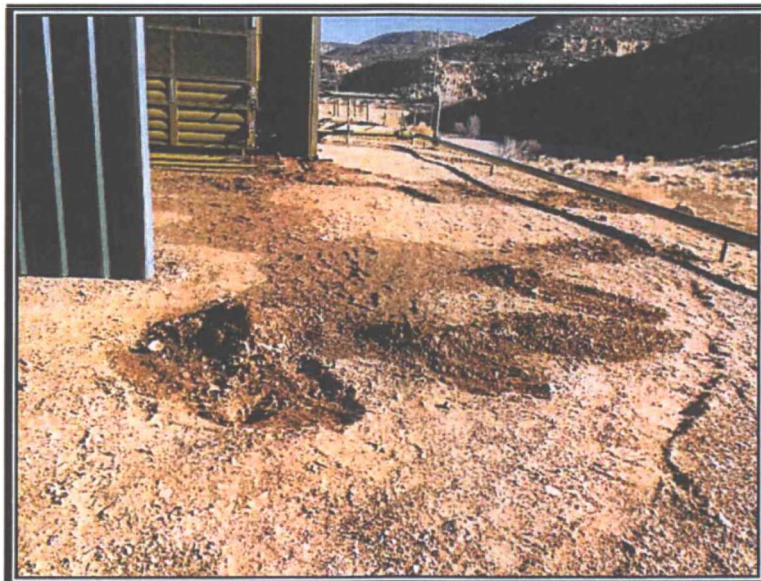
Picture 1: View of Area 2 and Area 3

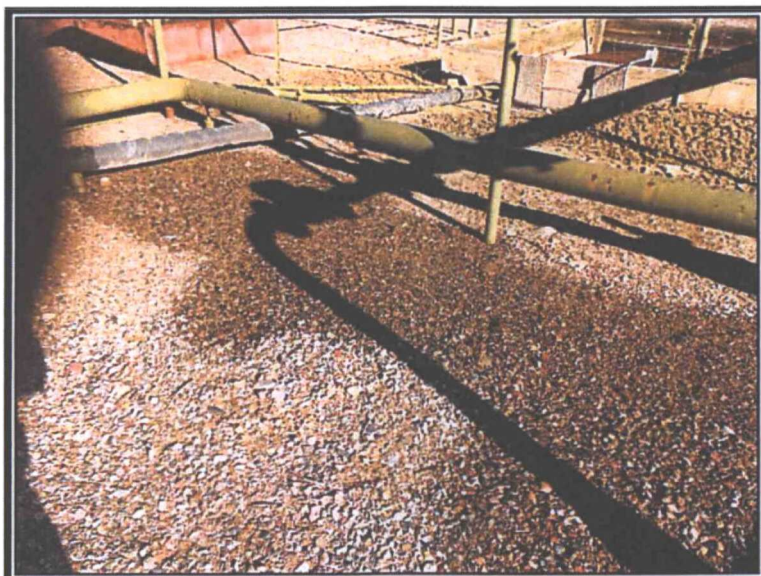
Picture 2: View of Area 4

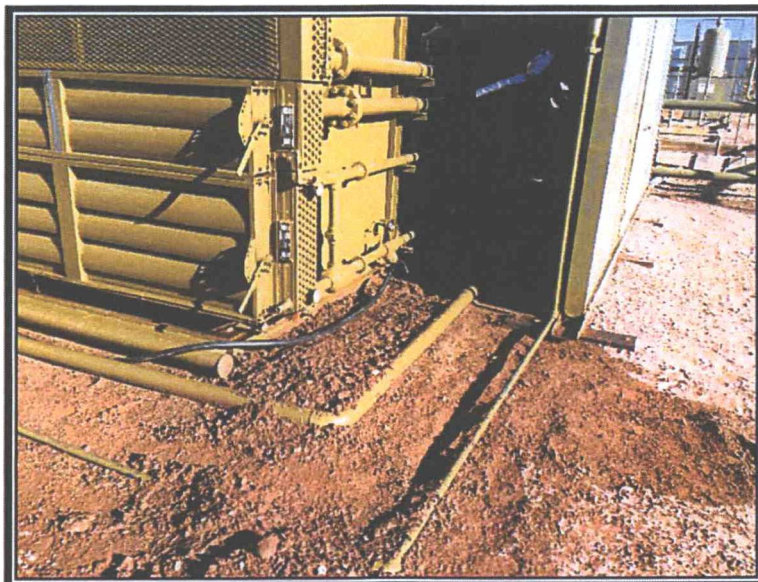
Picture 3: View of Area 5

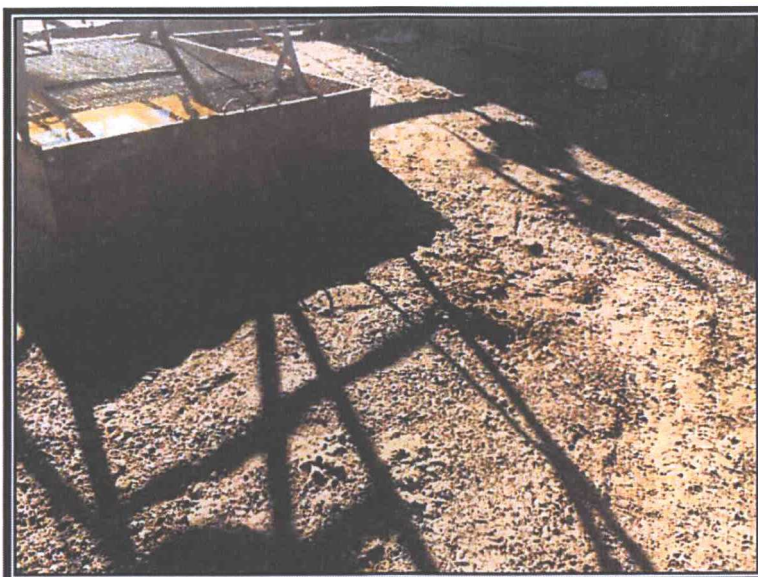
Picture 4: View of Area 8

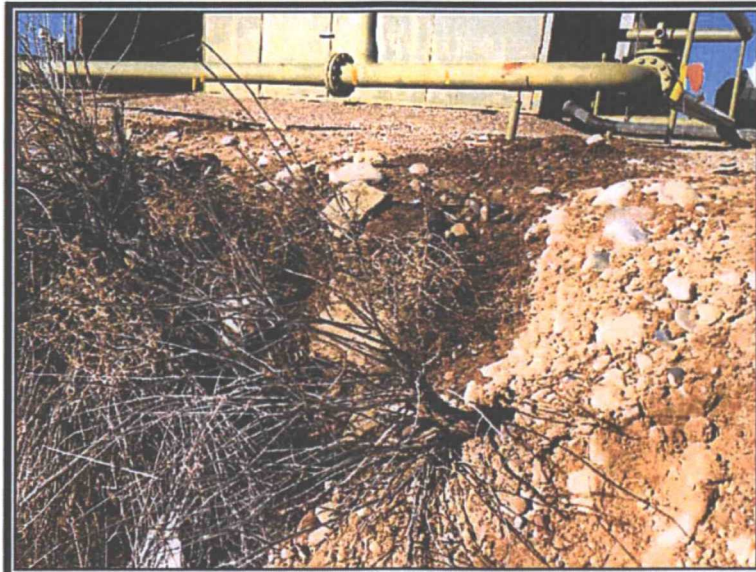
Picture 5: View of Area 9 and Area 10

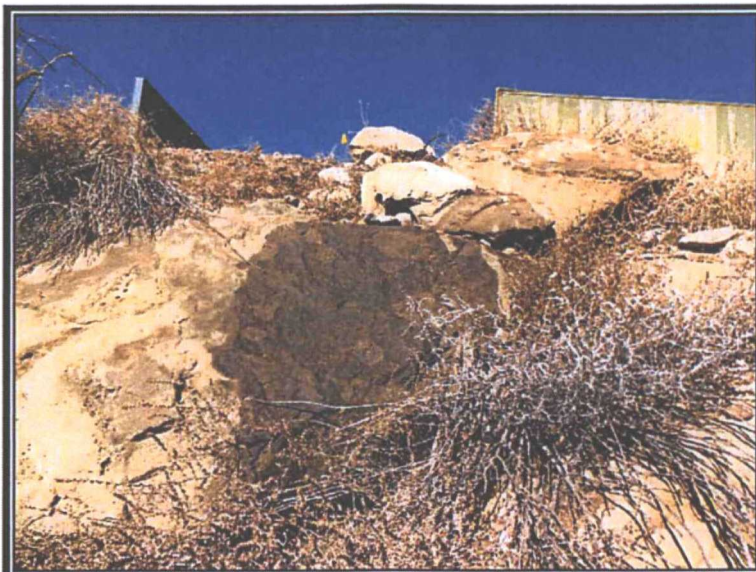
Picture 6: View of Area 11 and Area 12

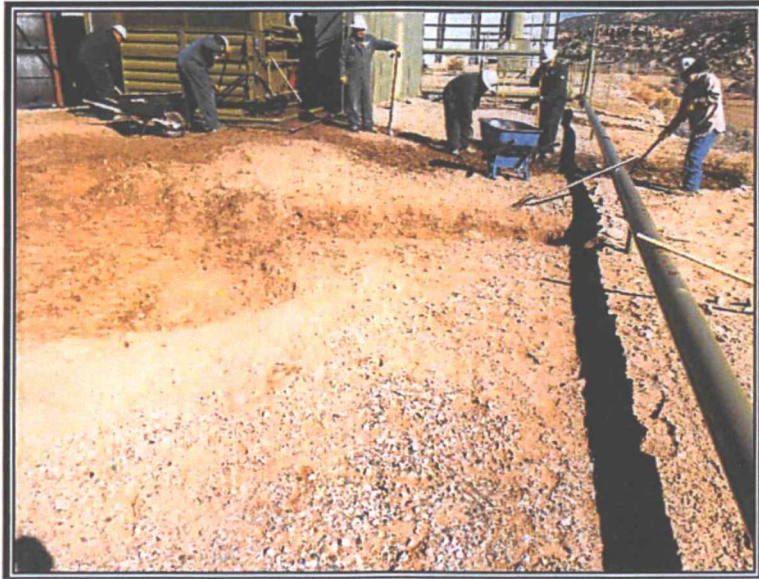
Picture 7: Cleanup Activities Area 2, Area 3, and Around Skid

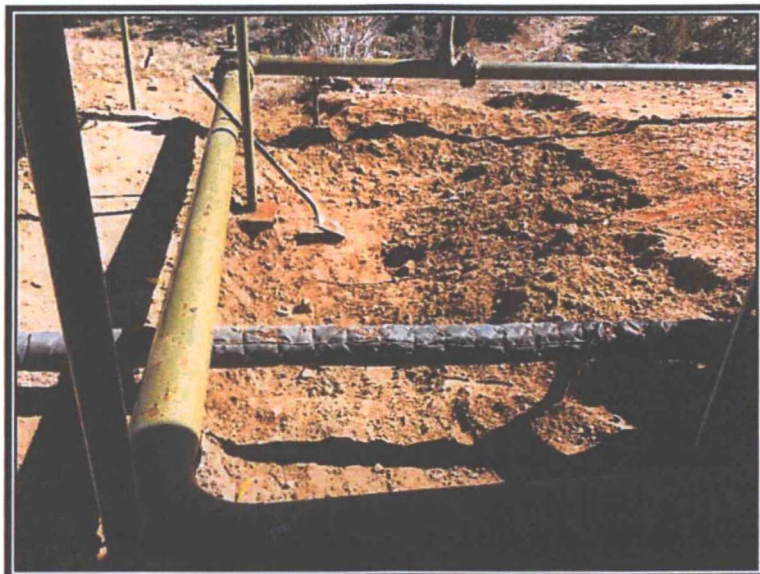
Picture 8: Cleanup of Area 4

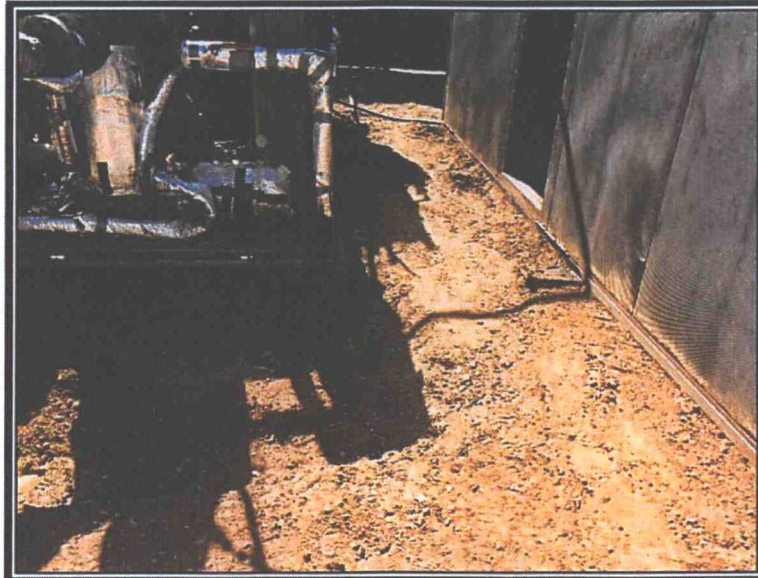
Picture 9: Cleanup of Area 6 and Area 7

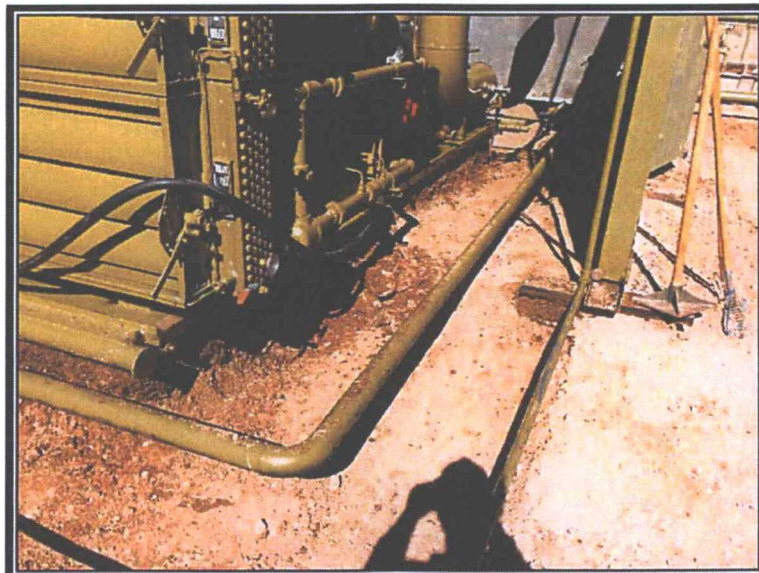
Picture 10: Cleanup Area 5 and Under Skid

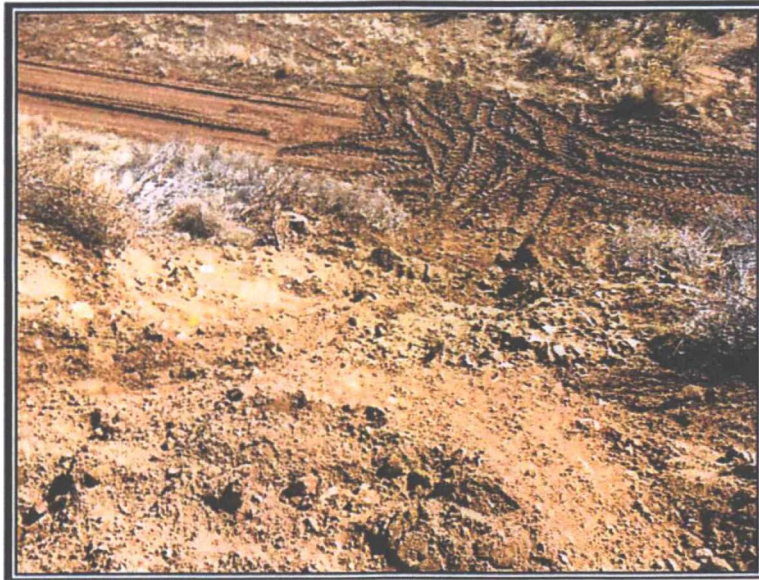
Picture 11: Cleanup of Area 9 and Area 10

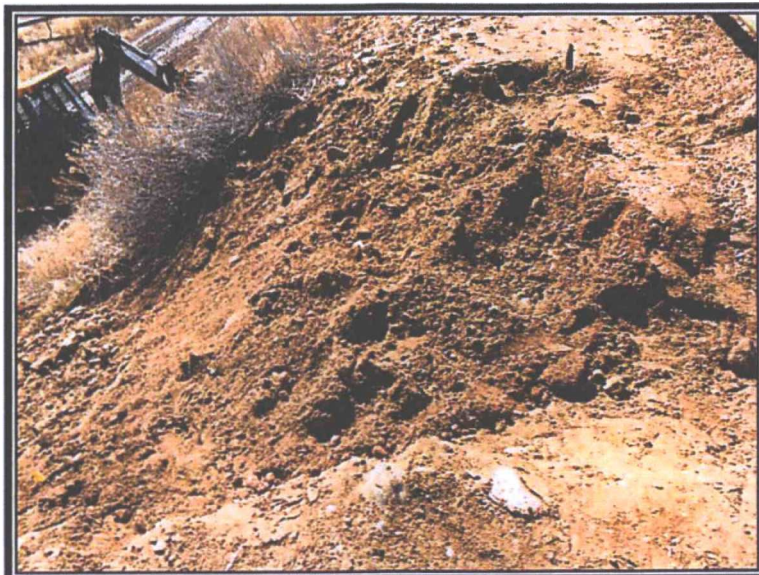
Picture 12: Cleanup of Area 11 and Area 12

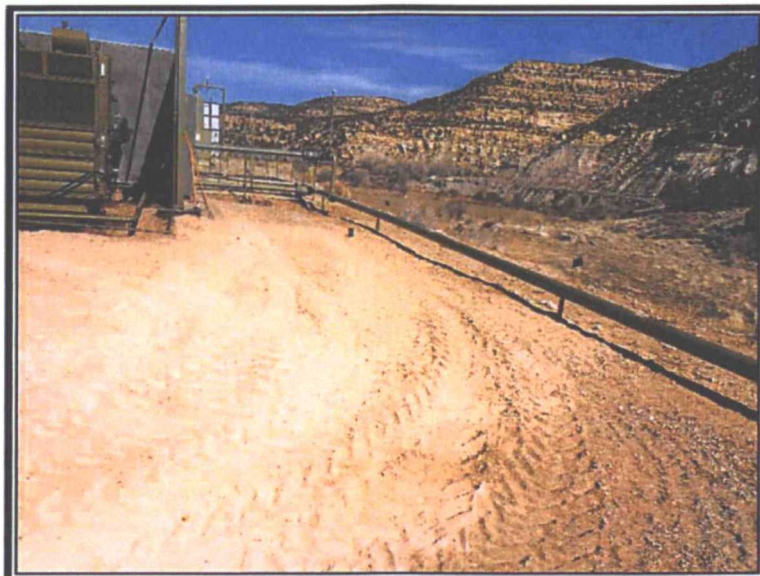
Picture 13: Backfill (View 1)

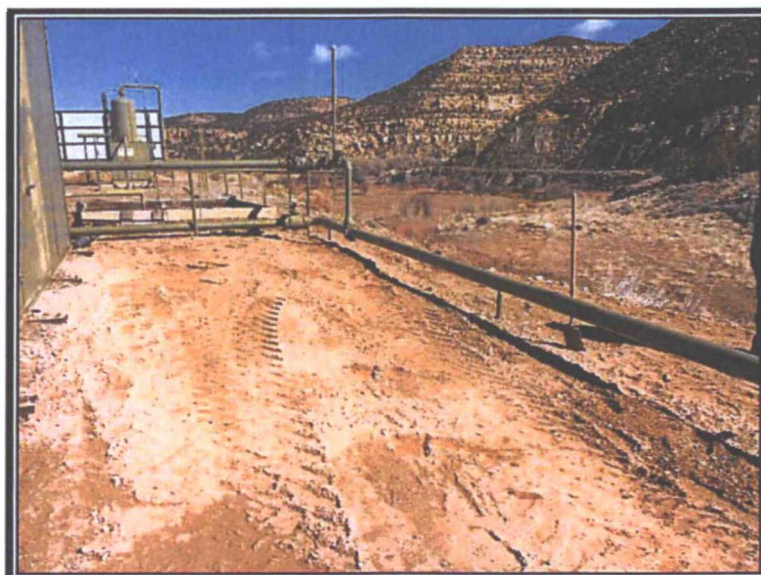
Picture 14: Backfill (View 2)
