Pit, Below-Grade Tank, or
Proposed Alternative Method Permit or Closure Plan Application

ConocoPhillips Company
San Juan Basin: New Mexico Assets
Below Grade Tank Closure Report

Lease Name: Lucerne D 1 – South tank
API No.: 30-045-07278

Rule Engineering Field Work Summary Sheet

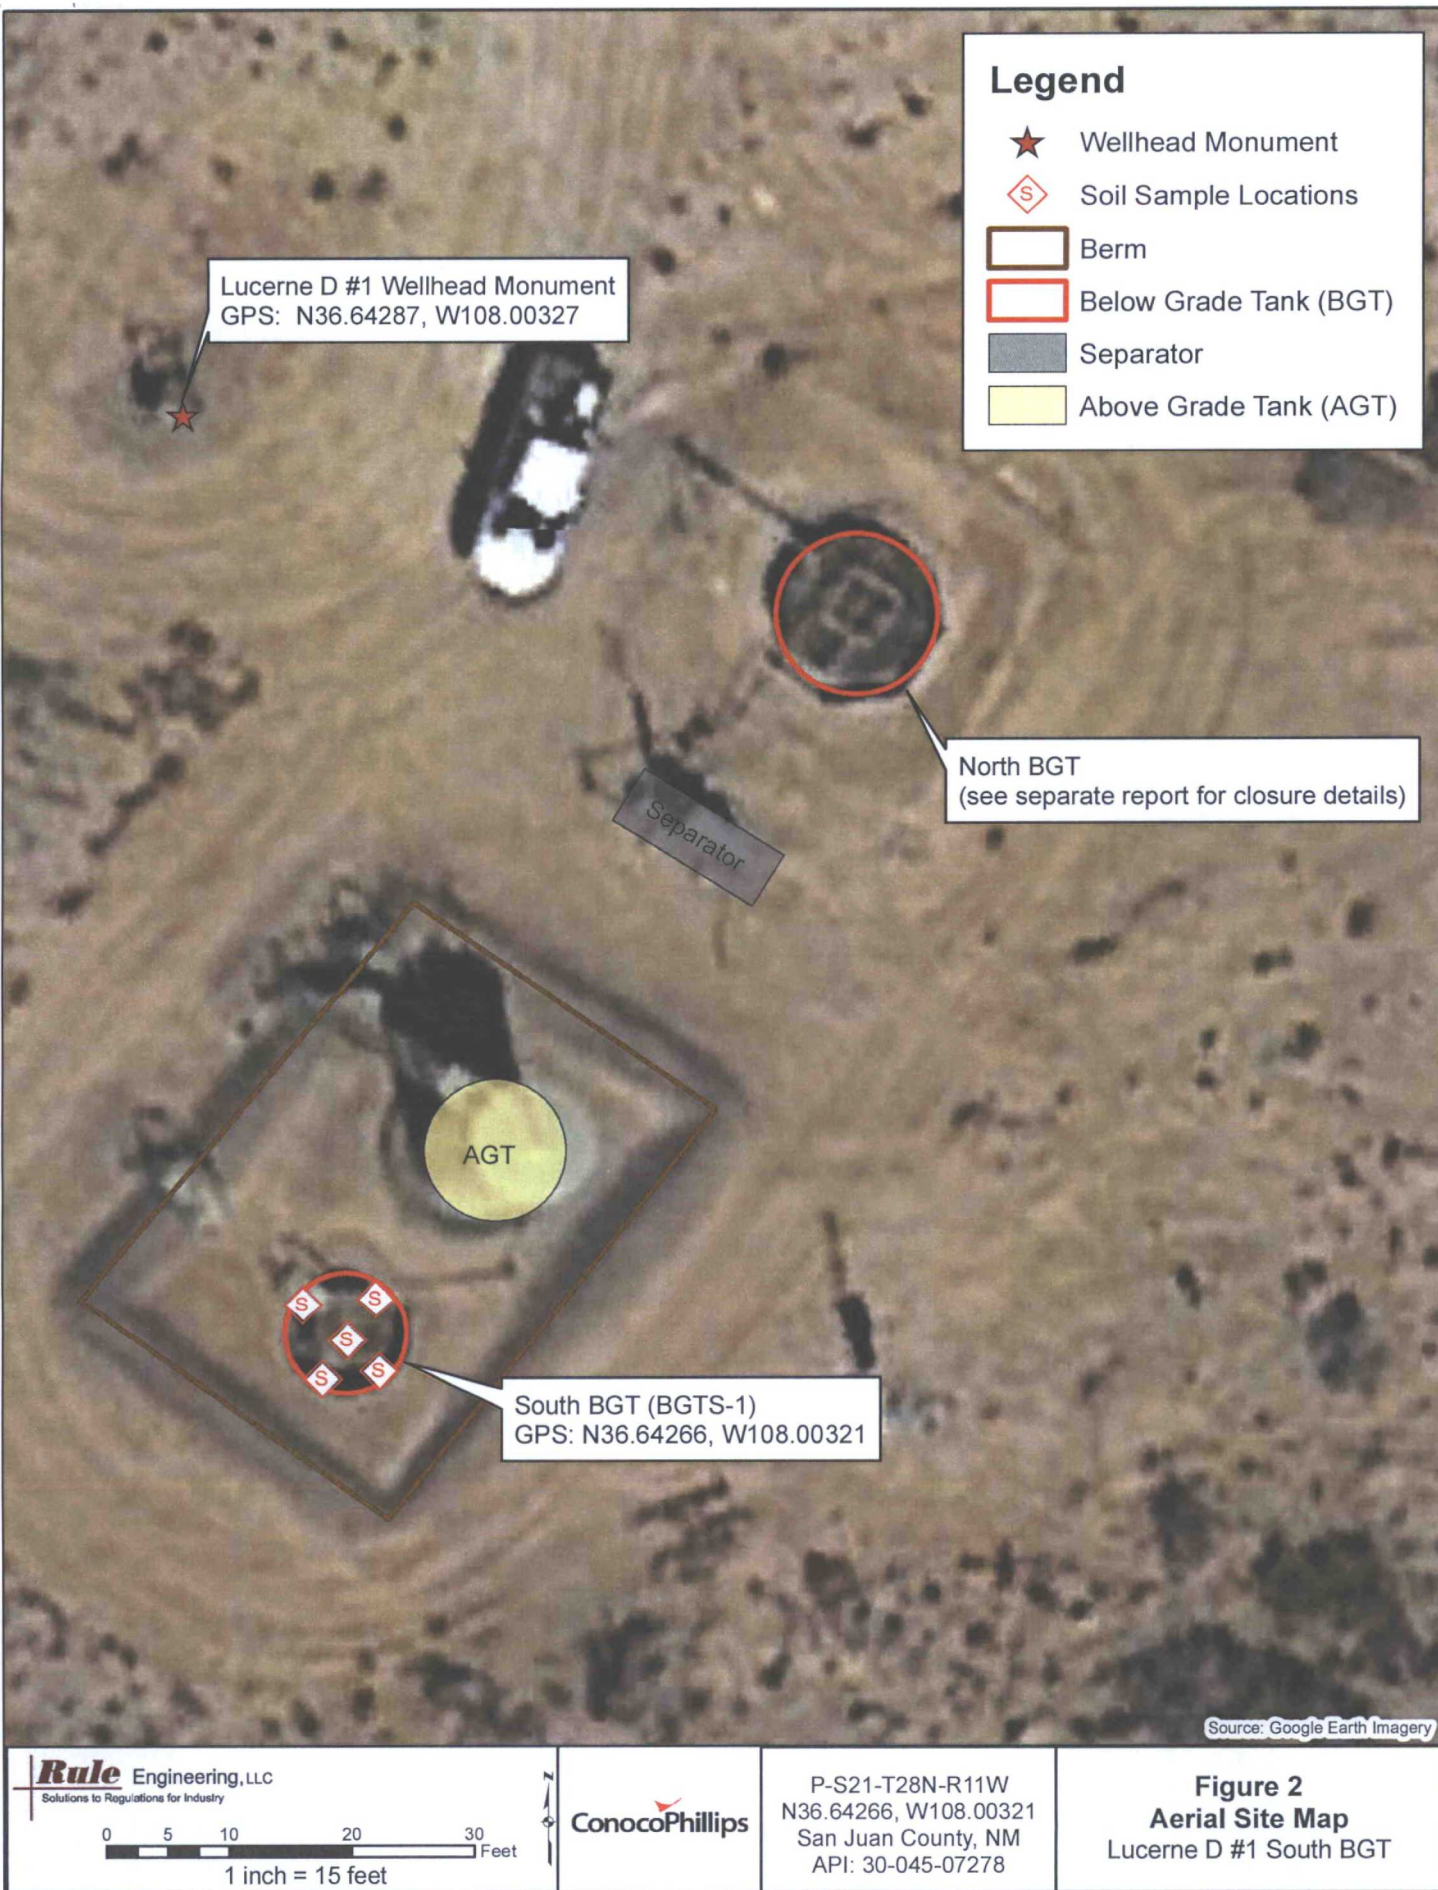
On January 31, 2017, following removal of the BGT and liner, Rule personnel conducted a visual inspection for surface/subsurface indications of a release. No excess moisture or staining were observed in the soils below the tank. Rule

Observations: No staining or excess moisture was observed below the tank.

On January 31, 2017, BGT closure sampling activities were conducted at the ConocoPhillips Lucerne D #1 South BGT. Field and laboratory results for confirmation sample BGTS-1 were reported below the BGT closure standards for benzene, total BTEX, TPH, and chlorides as outlined in 19.15.17.13 NMAC. Based on field sampling and laboratory analytical results, no release occurred from the BGT and no further work is recommended.

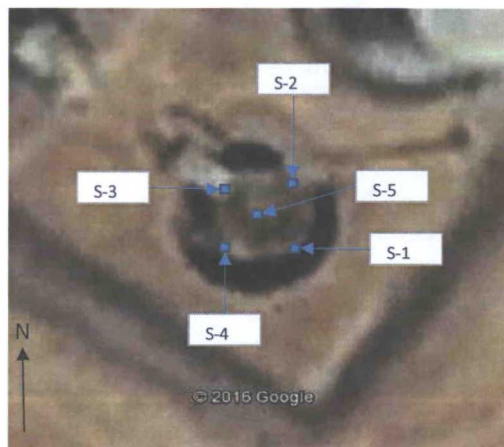
BGTS-1 is a 5-point composite of S-1 through S-5, collected 0.5 ft below BGT.
