Pit, Below-Grade Tank, or  
Proposed Alternative Method Permit or Closure Plan Application

**ConocoPhillips Company  
San Juan Basin  
Below Grade Tank Closure Report**

**Lease Name: RHODES 1**

**API No.: 30-045-11565**

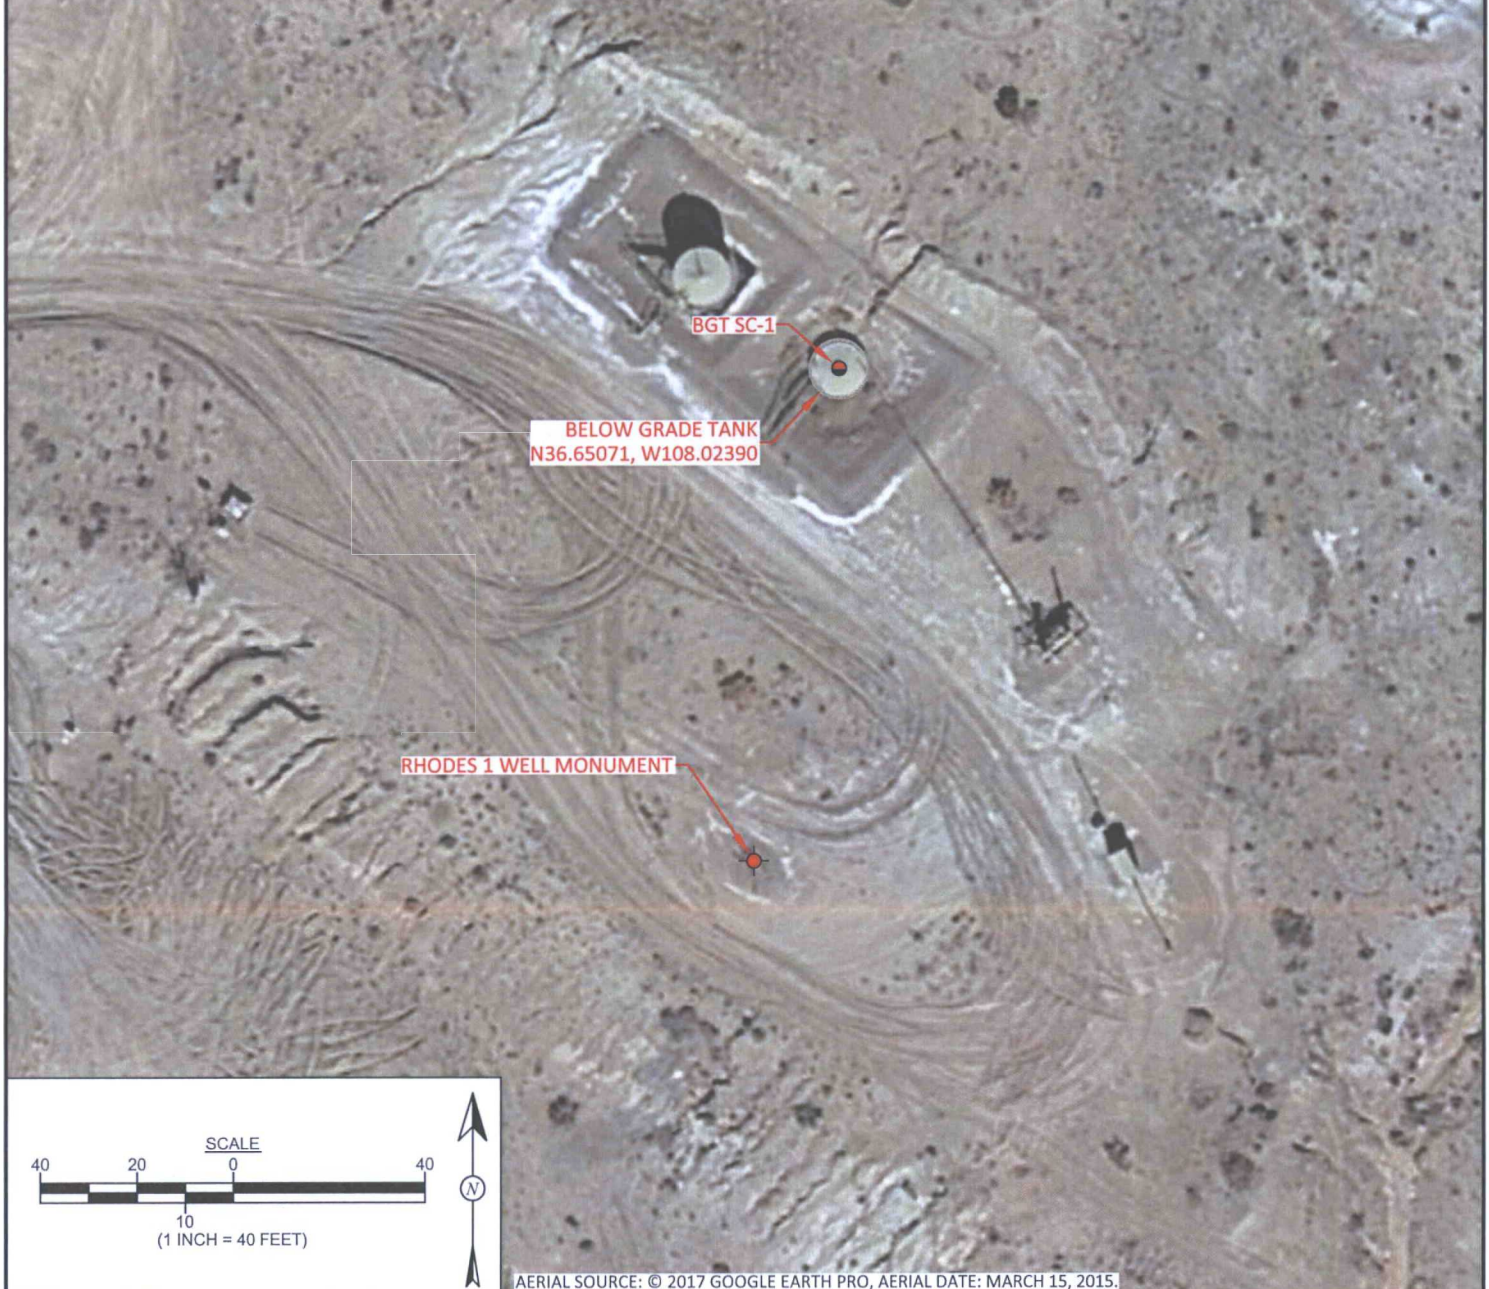
SAMPLE LOCATIONS

Laboratory Analytical Results									
Sample ID	Date	Depth (ft)	Benzene (mg/kg)	Total BTEX (mg/kg)	TPH-GRO (mg/kg)	TPH-DRO (mg/kg)	TPH-MRO (mg/kg)	TPH 418.1 (mg/kg)	Chlorides (mg/kg)
NMOCD ACTION LEVEL			0.2	50	100			100	250
BGT SC-1	7/14/17	0.5	<0.025	<0.221	<4.9	<9.2	<46	24	<30
SAMPLE WAS ANALYZED PER USEPA METHOD 8021B, 8015D, 418.1 AND 300.0.
