**Pit, Below-Grade Tank, or  
Proposed Alternative Method Permit or Closure Plan Application**

**ConocoPhillips Company**  
**San Juan Basin: New Mexico Assets**  
**Below Grade Tank Closure Report**

**Lease Name:** San Juan 28-7 Unit 220M

**API No.:** 30-039-25398

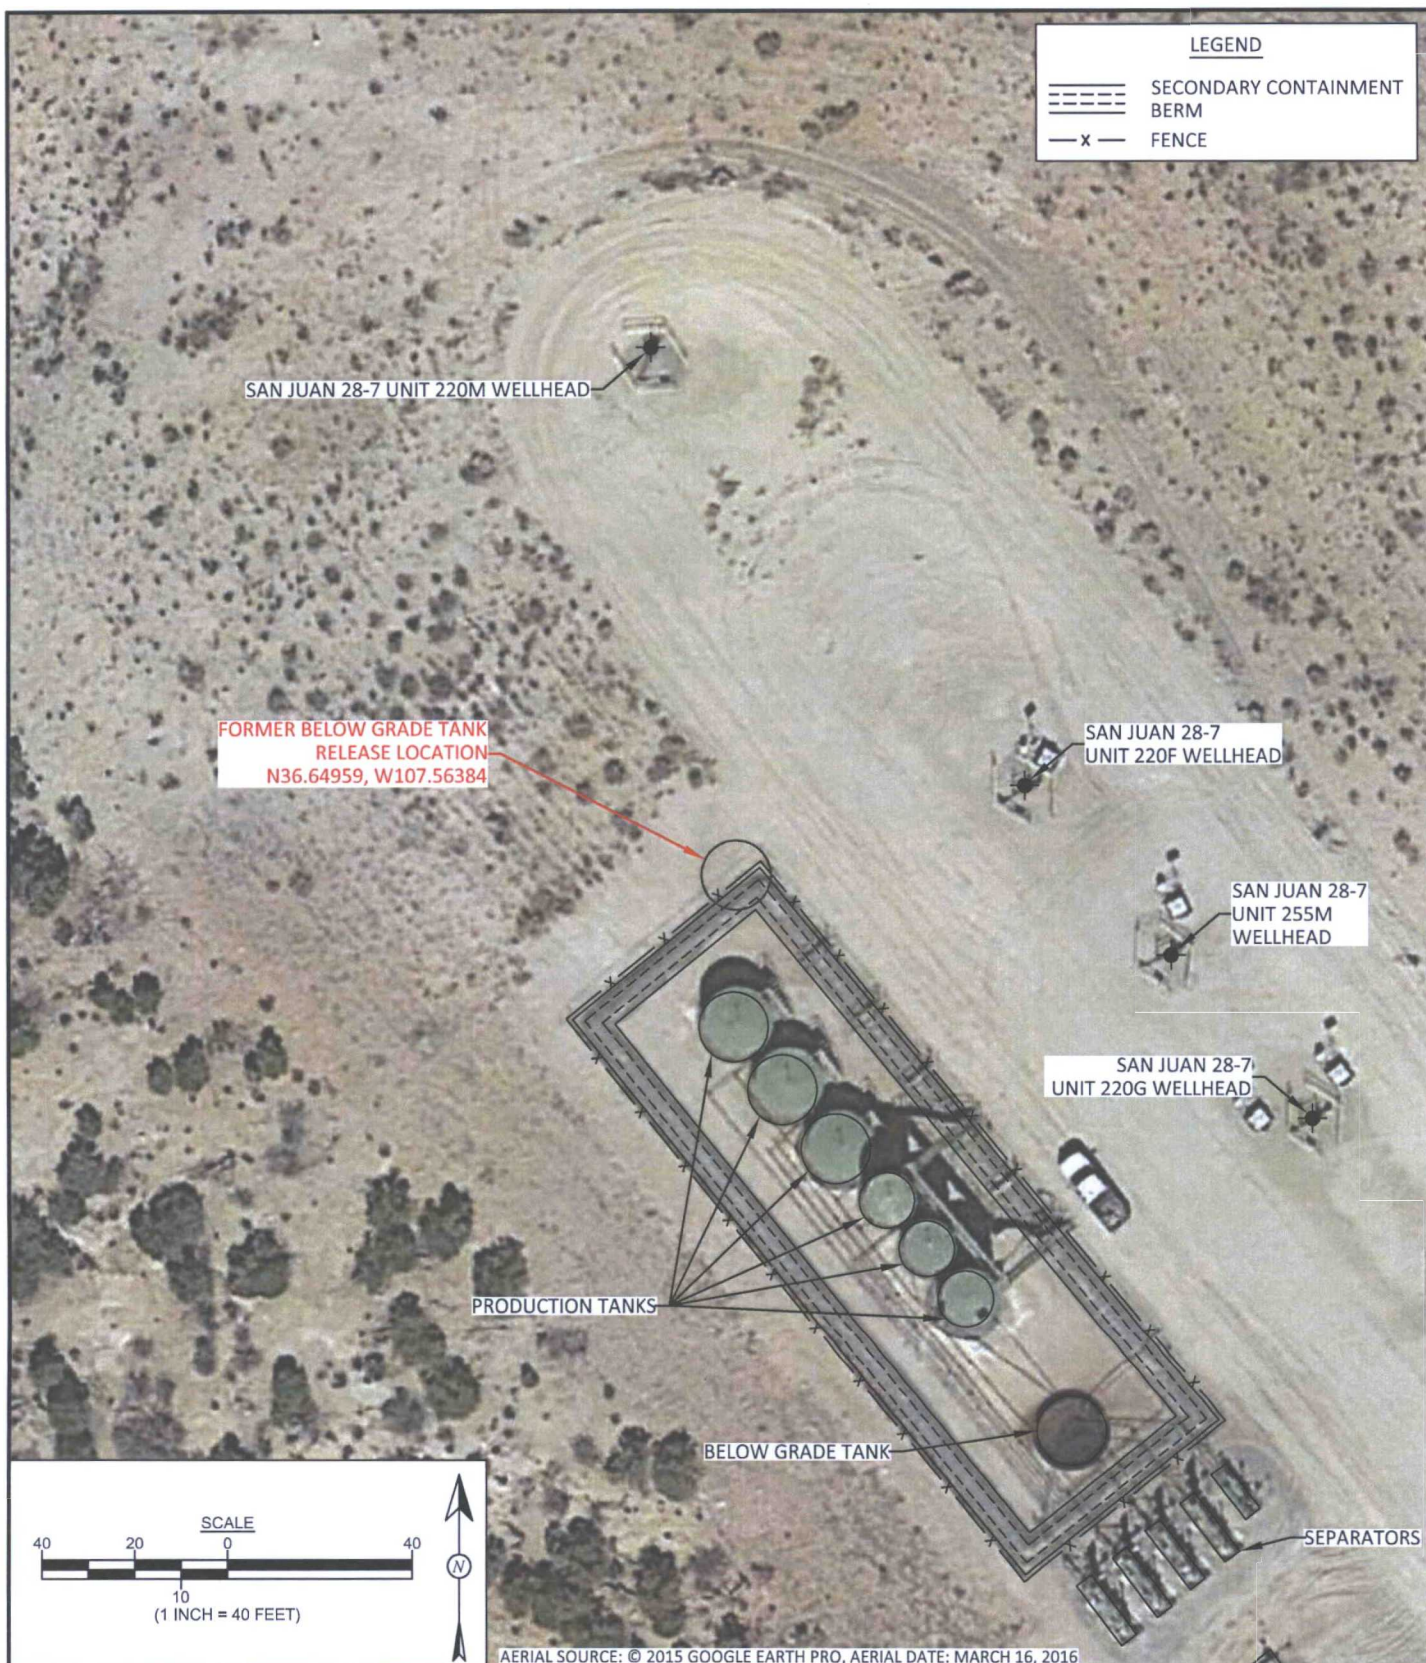
## FIGURE 2

On December 7, 2016, AES personnel returned to the location to complete the release assessment field work. The assessment included collection and field sampling of eight soil samples from seven soil borings (SB-1 through SB-7). Based on field sampling results, AES recommended excavation of the release area. Sample locations are shown on Figure 3.

### AERIAL SITE MAP 2016 AND 2017
