Pit, Below-Grade Tank, or
Proposed Alternative Method Permit or Closure Plan Application

1.
Operator: BP America Production Company OGRID #: 778
Address: 200 Energy Court, Farmington, NM 87401
Facility or well name: Mansfield #1A
API Number: 3004522026 OCD Permit Number: _____
U/L or Qtr/Qtr A Section 19 Township 30N Range 9W County: San Juan
Center of Proposed Design: Latitude 36.80221 Longitude -107.81479 NAD: ☐ 1927 ☒ 1983
Surface Owner: ☒ Federal ☐ State ☐ Private ☐ Tribal Trust or Indian Allotment

BELOW-GRADE TANK CLOSURE PLAN

Mansfield #1A

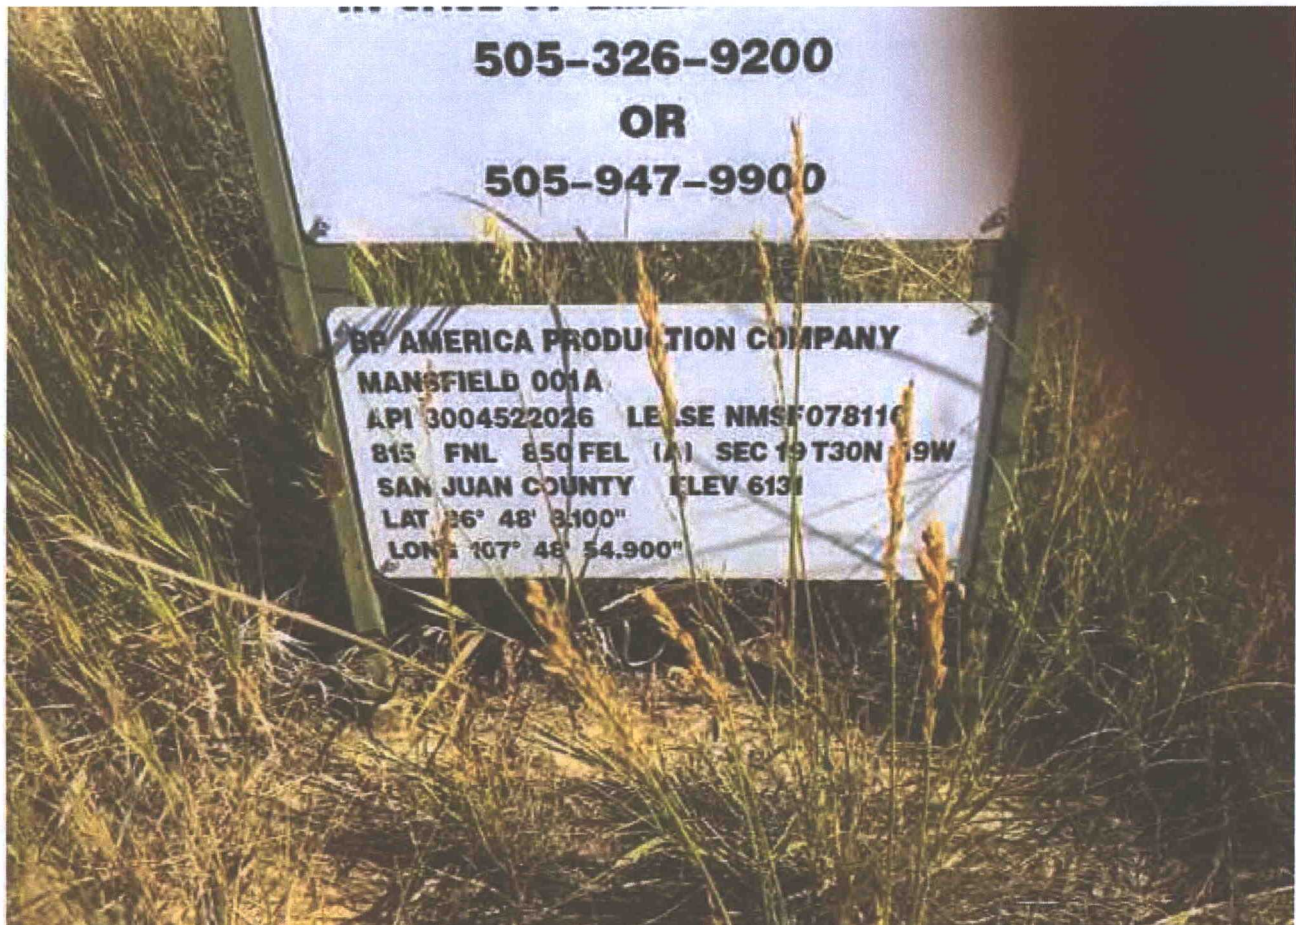
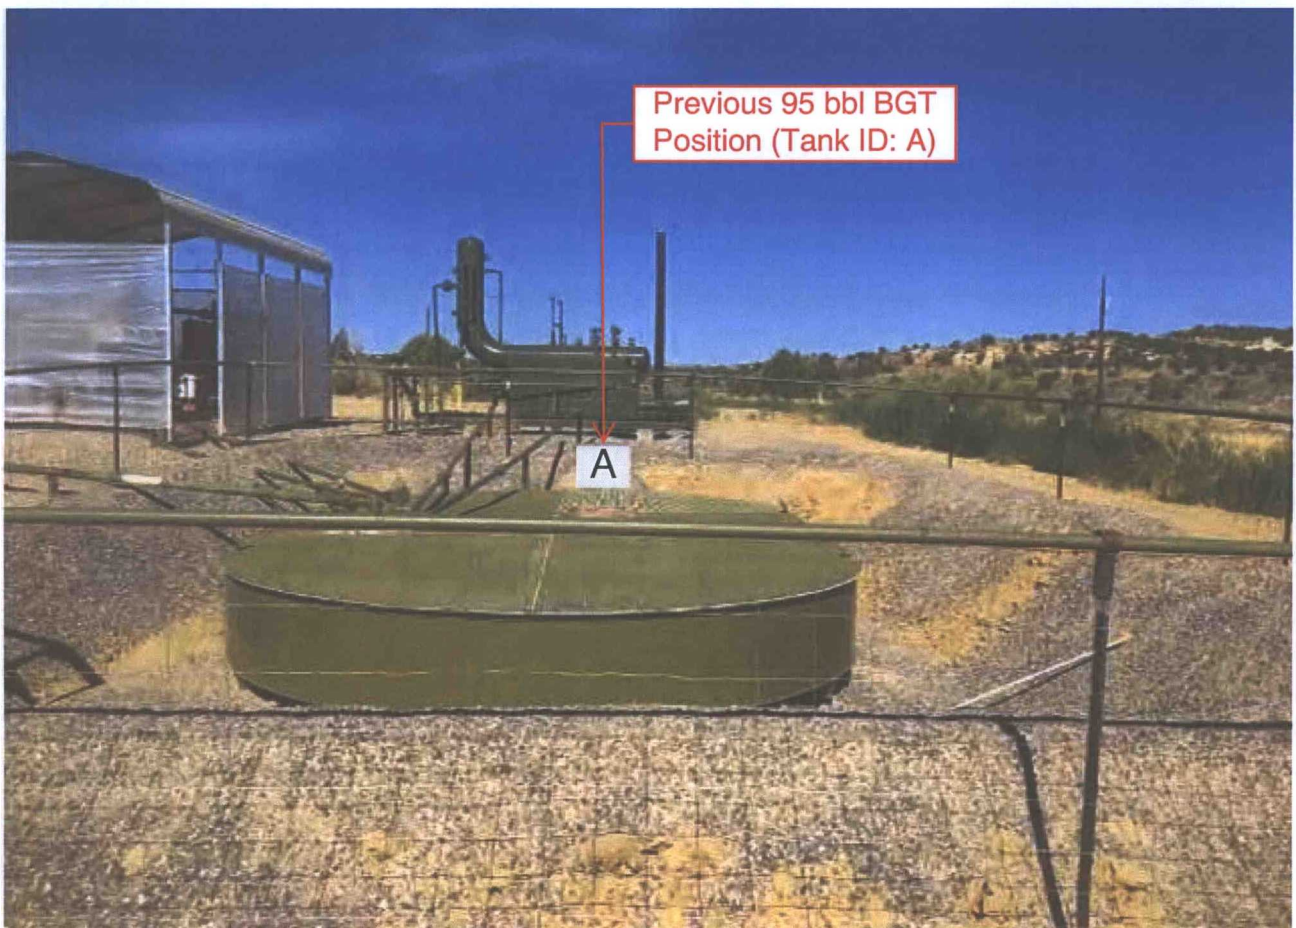
The area has been backfilled and a 105 BBL shallow low profile above-grade tank set on top. The location will be reclaimed once the well is plugged and abandoned.
