Pit, Below-Grade Tank, or
Proposed Alternative Method Permit or Closure Plan Application

BP AMERICA PRODUCTION COMPANY
SAN JUAN BASIN, NORTHWEST NEW MEXICO

BELOW-GRADE TANK CLOSURE PLAN

GCU 155

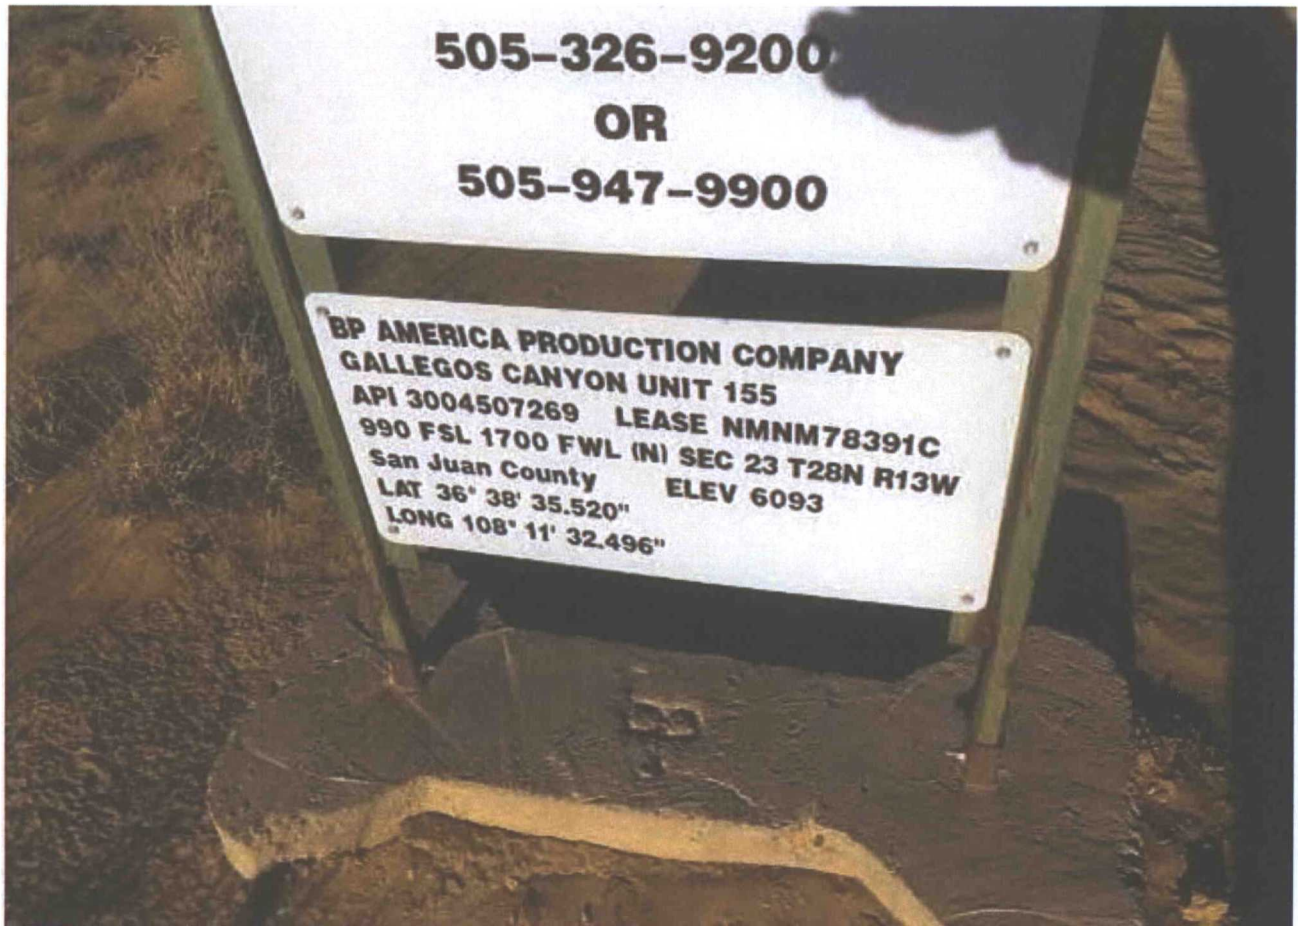
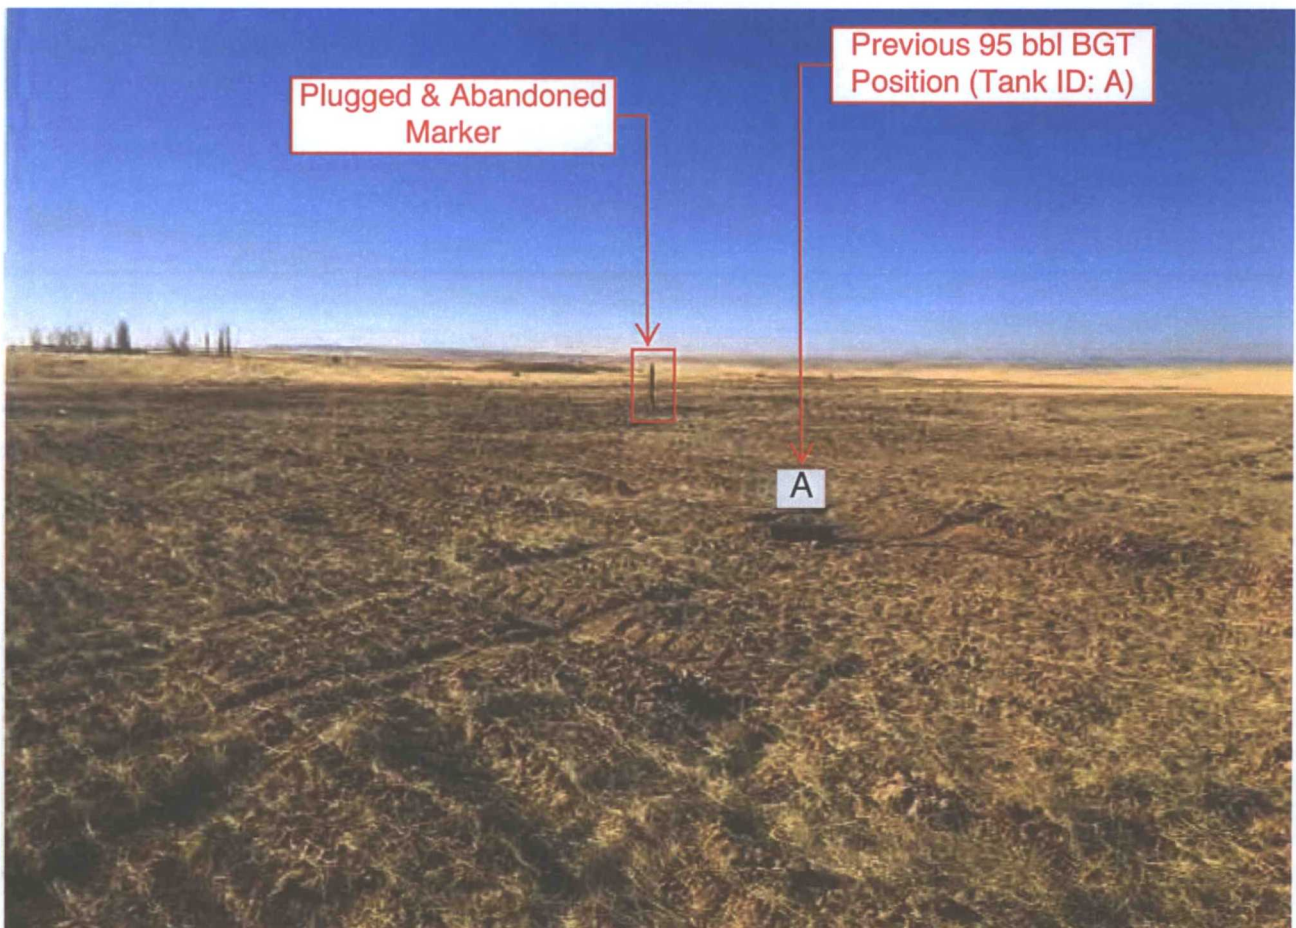
The area has been backfilled and the location has been reclaimed because the well has been plugged and abandoned.
