Pit, Below-Grade Tank, or  
Proposed Alternative Method Permit or Closure Plan Application

1.  
Operator: BP America Production Company OGRID #: 778  
Address: 200 Energy Court, Farmington, NM 87401  
Facility or well name: FLORANCE H 037  
API Number: 3004560189 OCD Permit Number: \_\_\_\_\_  
U/L or Qtr/Qtr H Section 06 Township 30N Range 08W County: San Juan  
Center of Proposed Design: Latitude 36.842885 Longitude -107.711479 NAD83  
Surface Owner: ☒ Federal ☐ State ☐ Private ☐ Tribal Trust or Indian Allotment

3.  
☒ **Below-grade tank:** Subsection I of 19.15.17.11 NMAC **TANK B**  
Volume: 21 bbl Type of fluid: Produced Water  
Tank Construction material: Steel  
☐ Secondary containment with leak detection ☐ Visible sidewalls, liner, 6-inch lift and automatic overflow shut-off  
☐ Visible sidewalls and liner ☐ Visible sidewalls only ☒ Other Single wall/ Double bottom; sidewalls not visible  
Liner type: Thickness \_\_\_\_\_ mil ☐ HDPE ☐ PVC ☐ Other \_\_\_\_\_

☒ Closure Completion Date: 9/29/2017

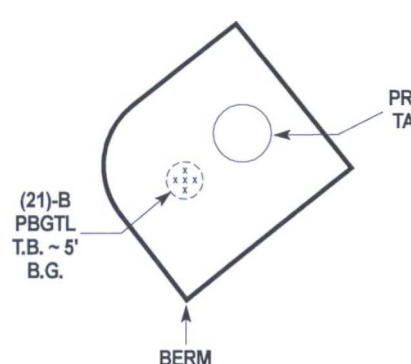
| <b>SOIL DESCRIPTION:</b><br>SOIL TYPE: <u>SAND</u> / <u>SILTY SAND</u> / SILT / SILTY CLAY / CLAY / GRAVEL / <u>OTHER</u> <b>BEDROCK (SANDSTONE)</b><br>SOIL COLOR: <b>MOSTLY DARK YELLOWISH ORANGE</b> PLASTICITY (CLAYS): NON PLASTIC / SLIGHTLY PLASTIC / COHESIVE / MEDIUM PLASTIC / HIGHLY PLASTIC<br>COHESION (ALL OTHERS): <u>NON COHESIVE</u> / SLIGHTLY COHESIVE / COHESIVE / <u>HIGHLY COHESIVE</u> DENSITY (COHESIVE CLAYS & SILTS): SOFT / FIRM / STIFF / VERY STIFF / HARD<br>CONSISTENCY (NON COHESIVE SOILS): LOOSE / <u>FIRM</u> / DENSE / <u>VERY DENSE</u> HC ODOR DETECTED: <u>YES</u> / NO EXPLANATION - <b>DISCOLORED SOIL/SANDSTONE (north corner sidewall only).</b><br>MOISTURE: <u>DRY</u> / <u>SLIGHTLY MOIST</u> / MOIST / WET / SATURATED / SUPER SATURATED ANY AREAS DISPLAYING WETNESS: YES / NO EXPLANATION -<br>SAMPLE TYPE: GRAB / <u>COMPOSITE</u> # OF PTS. <b>3 &amp; 5</b><br>DISCOLORATION/STAINING OBSERVED: <u>YES</u> / NO EXPLANATION - <b>VARYING SHADES OF GRAY, MINOR AMOUNT DARK GRAY TO BLACK.</b> | | |
| <b>SITE OBSERVATIONS:</b><br>LOST INTEGRITY OF EQUIPMENT: YES / <u>NO</u> EXPLANATION -<br>APPARENT EVIDENCE OF A RELEASE OBSERVED AND/OR OCCURRED: <u>YES</u> / NO EXPLANATION: <b>NORTH CORNER SIDEWALL ONLY.</b><br>EQUIPMENT SET OVER RECLAIMED AREA: YES / NO EXPLANATION -<br>OTHER: <b>NMOCD REP. PRESENT TO WITNESS SAMPLING OF 21 BGT. BEDROCK - HARD, FRIABLE STARTS 2'-3' BELOW GRADE AT 21 BGT. GPS COORDINATES OBTAIN USING GOOGLE EARTH PRO.</b><br>EXCAVATION DIMENSION ESTIMATION: <u>NA</u> ft. X <u>NA</u> ft. X <u>NA</u> ft. EXCAVATION ESTIMATION (Cubic Yards): <u>NA</u><br>DEPTH TO GROUNDWATER: <b>&gt;100'</b> NEAREST WATER SOURCE: <b>&gt;1,000'</b> NEAREST SURFACE WATER: <b>&lt;1,000'</b> NMOCD TPH CLOSURE STD: <b>1,000</b> ppm | | |
| <b>SITE SKETCH</b><br>BGT Located: off / <u>on</u> site PLOT PLAN circle: <u>attached</u><br><div style="display: flex; align-items: center;"><div style="flex: 1;"></div><div style="flex: 1; text-align: right;"><b>N</b><br/>↑</div></div> <div style="display: flex; justify-content: space-between; margin-top: 10px;"><div><b>WO:</b><br/><b>REF #: P-863</b><br/><b>VID: VHIXONEV11</b><br/><b>PJ #:</b><br/><b>Permit date(s): 06/10/10</b><br/><b>OCD Appr. date(s): 07/02/17</b></div><div><b>Tank ID</b> OVM = Organic Vapor Meter<br/>ppm = parts per million<br/><b>B</b> BGT Sidewalls Visible: Y / <u>(N)</u><br/>BGT Sidewalls Visible: Y / N<br/>BGT Sidewalls Visible: Y / N</div></div> <div style="text-align: right; margin-top: 10px;"><b>Magnetic declination: 10° E</b></div> | | |

Sampling results indicate a release has occurred but is below regulatory standards. Impacted soils/bedrock were physically observed/detected after the BGT was removed. An additional 3 point composite sample was collected at the northern quadrant area the same day as the confirmation sampling on September 25, 2017. The lab results were well below the Spill & Release Guidelines for TPH, BTEX, & chloride. Attached are laboratory reports and C-141.
