Pit, Below-Grade Tank, or  
Proposed Alternative Method Permit or Closure Plan Application

1.  
Operator: BP America Production Company OGRID #: 778  
Address: 200 Energy Court, Farmington, NM 87401  
Facility or well name: LAWSON 001R  
API Number: 3004524973 OCD Permit Number: \_\_\_\_\_  
U/L or Qtr/Qtr L Section 10 Township 30N Range 08W County: San Juan  
Center of Proposed Design: Latitude 36.82491 Longitude -107.66694 NAD83  
Surface Owner: ☒ Federal ☐ State ☐ Private ☐ Tribal Trust or Indian Allotment

BELOW-GRADE TANK CLOSURE PLAN

**LAWSON 001R**

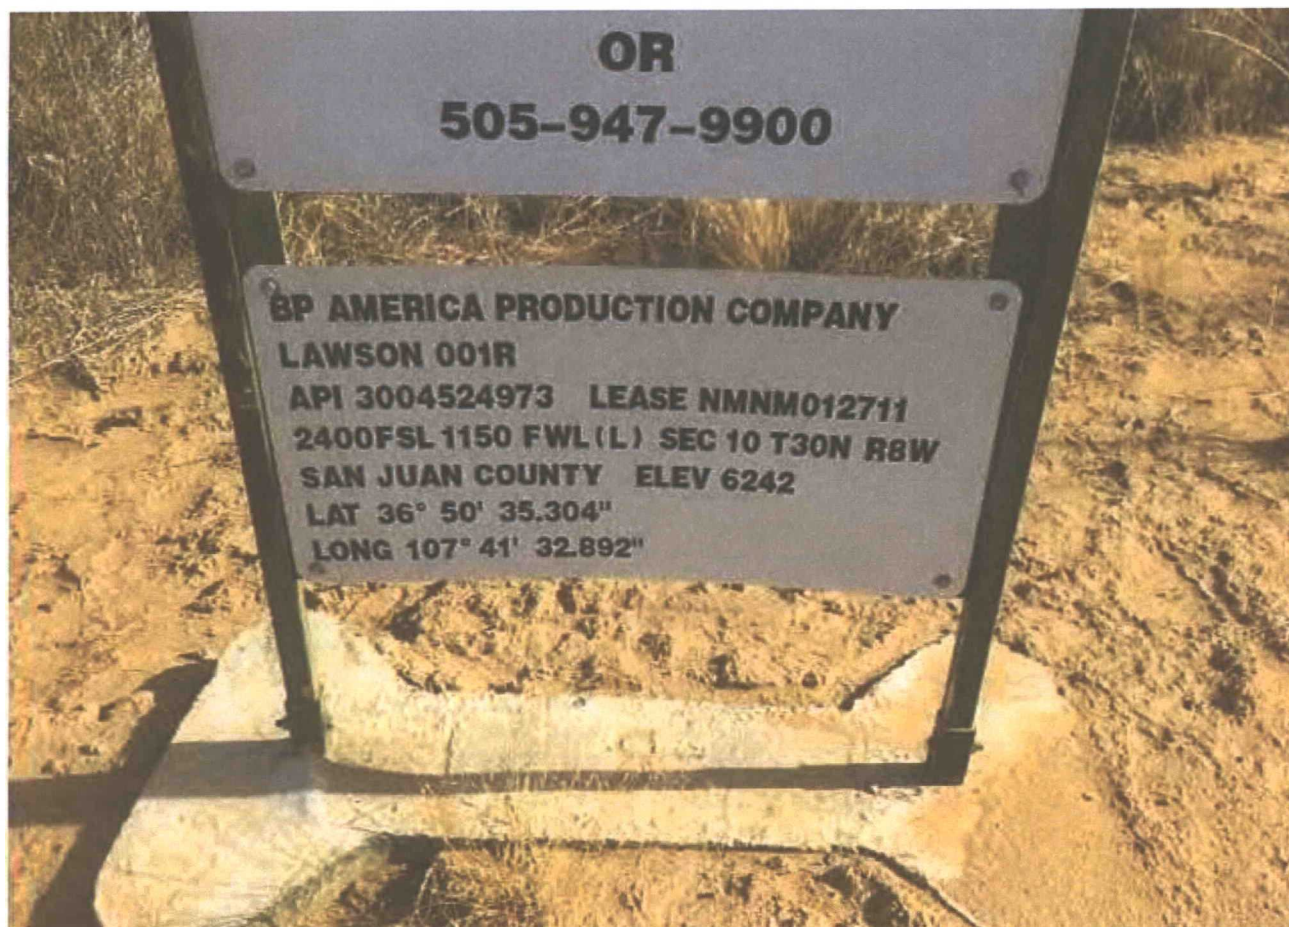
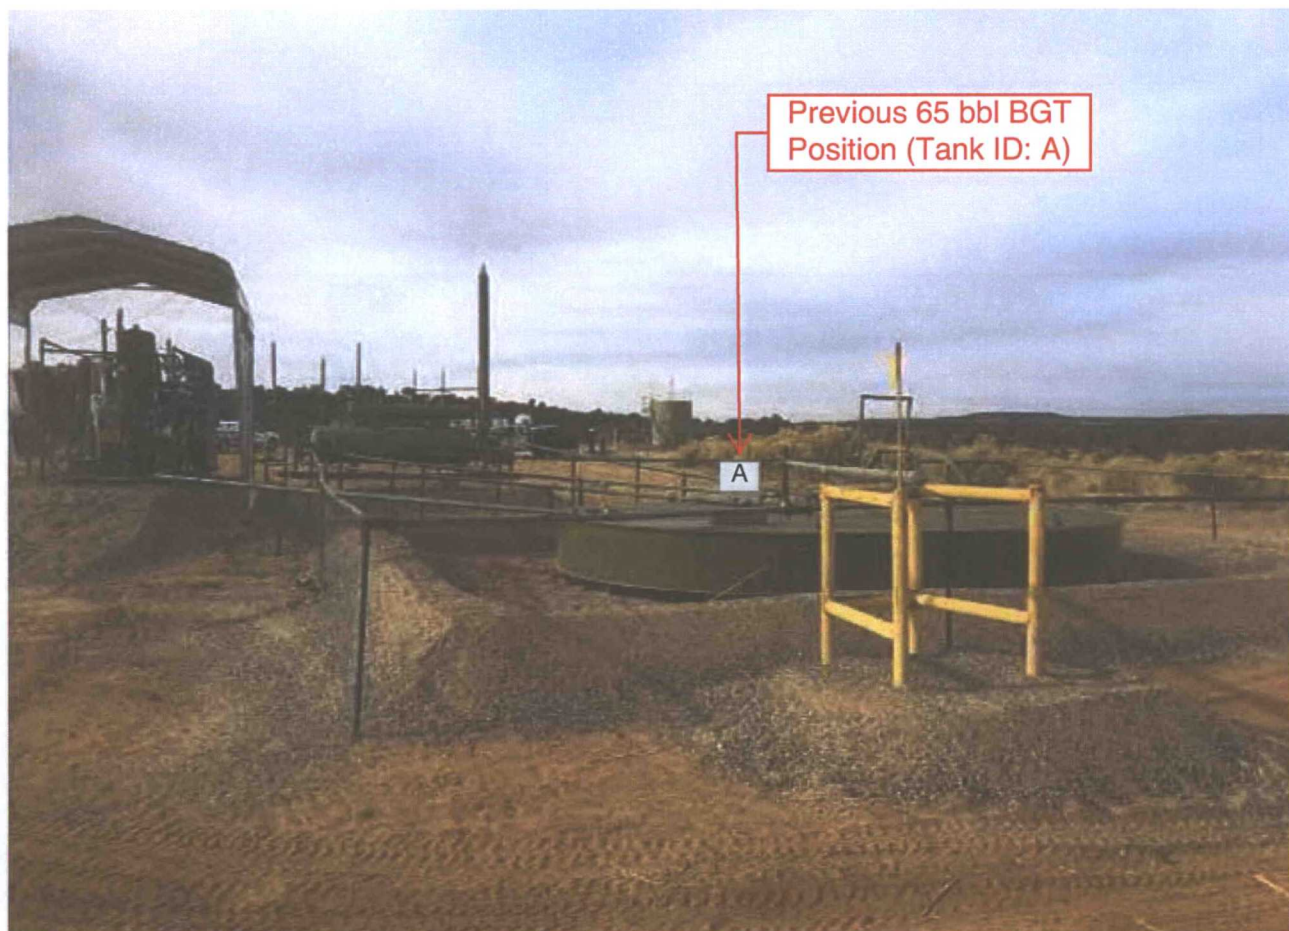
| <input checked="" type="checkbox"/> Site Reclamation (Photo Documentation) |

10. BP shall reclaim the BGT location and all areas associated with the BGT including associated access roads to a safe and stable condition that blends with the surrounding undisturbed area. BP shall substantially restore the impacted surface area to the condition that existed prior to oil and gas operations by placement of the soil cover as provided in Subsection H of 19.15.17.13 NMAC, re-contour the location and associated areas to a contour that approximates the original contour and blends with the surrounding topography and re-vegetate according to Subsection I of 19.15.17.13 NMAC.
