Release Notification and Corrective Action

Name of Company: BP America Production Co.	Contact: Steve Moskal	
Address: 380 Airport Rd., Durango, CO 81303	Telephone No.: 505-330-9179	
Facility Name: Gallegos Canyon Unit 042	Facility Type: Water Disposal Well	
Surface Owner: Fee	Mineral Owner: Federal	API No. 3004507557

January 16, 2018 - Spill Sampling

GALLEGOS CANYON UNIT 042

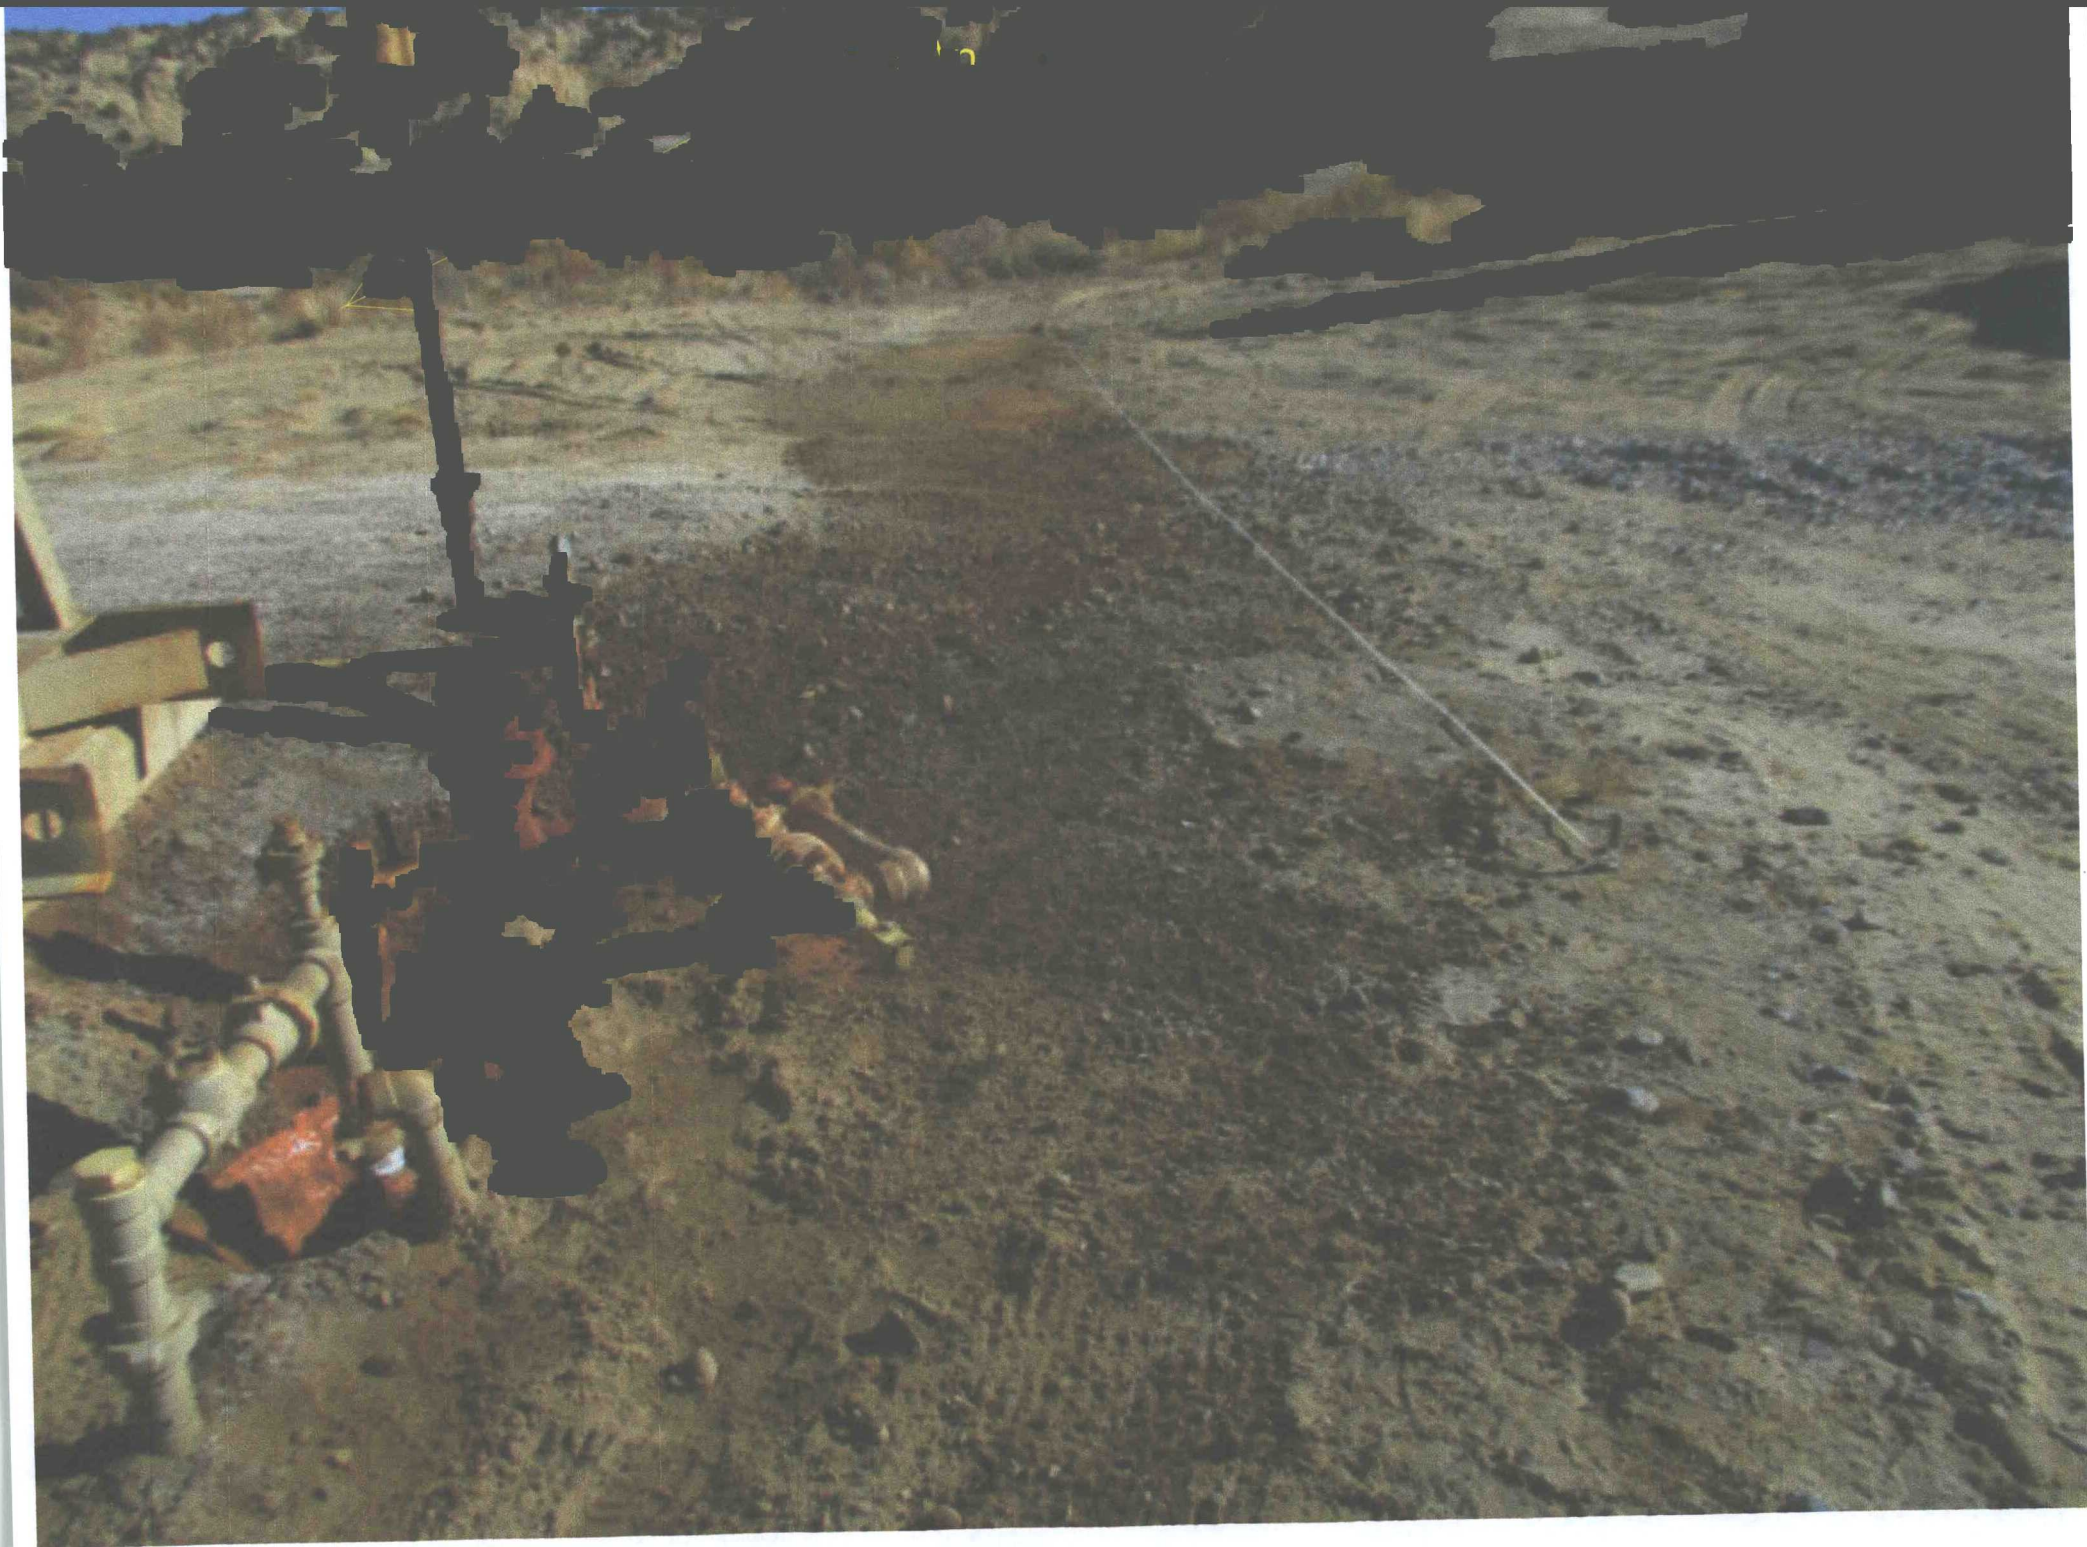
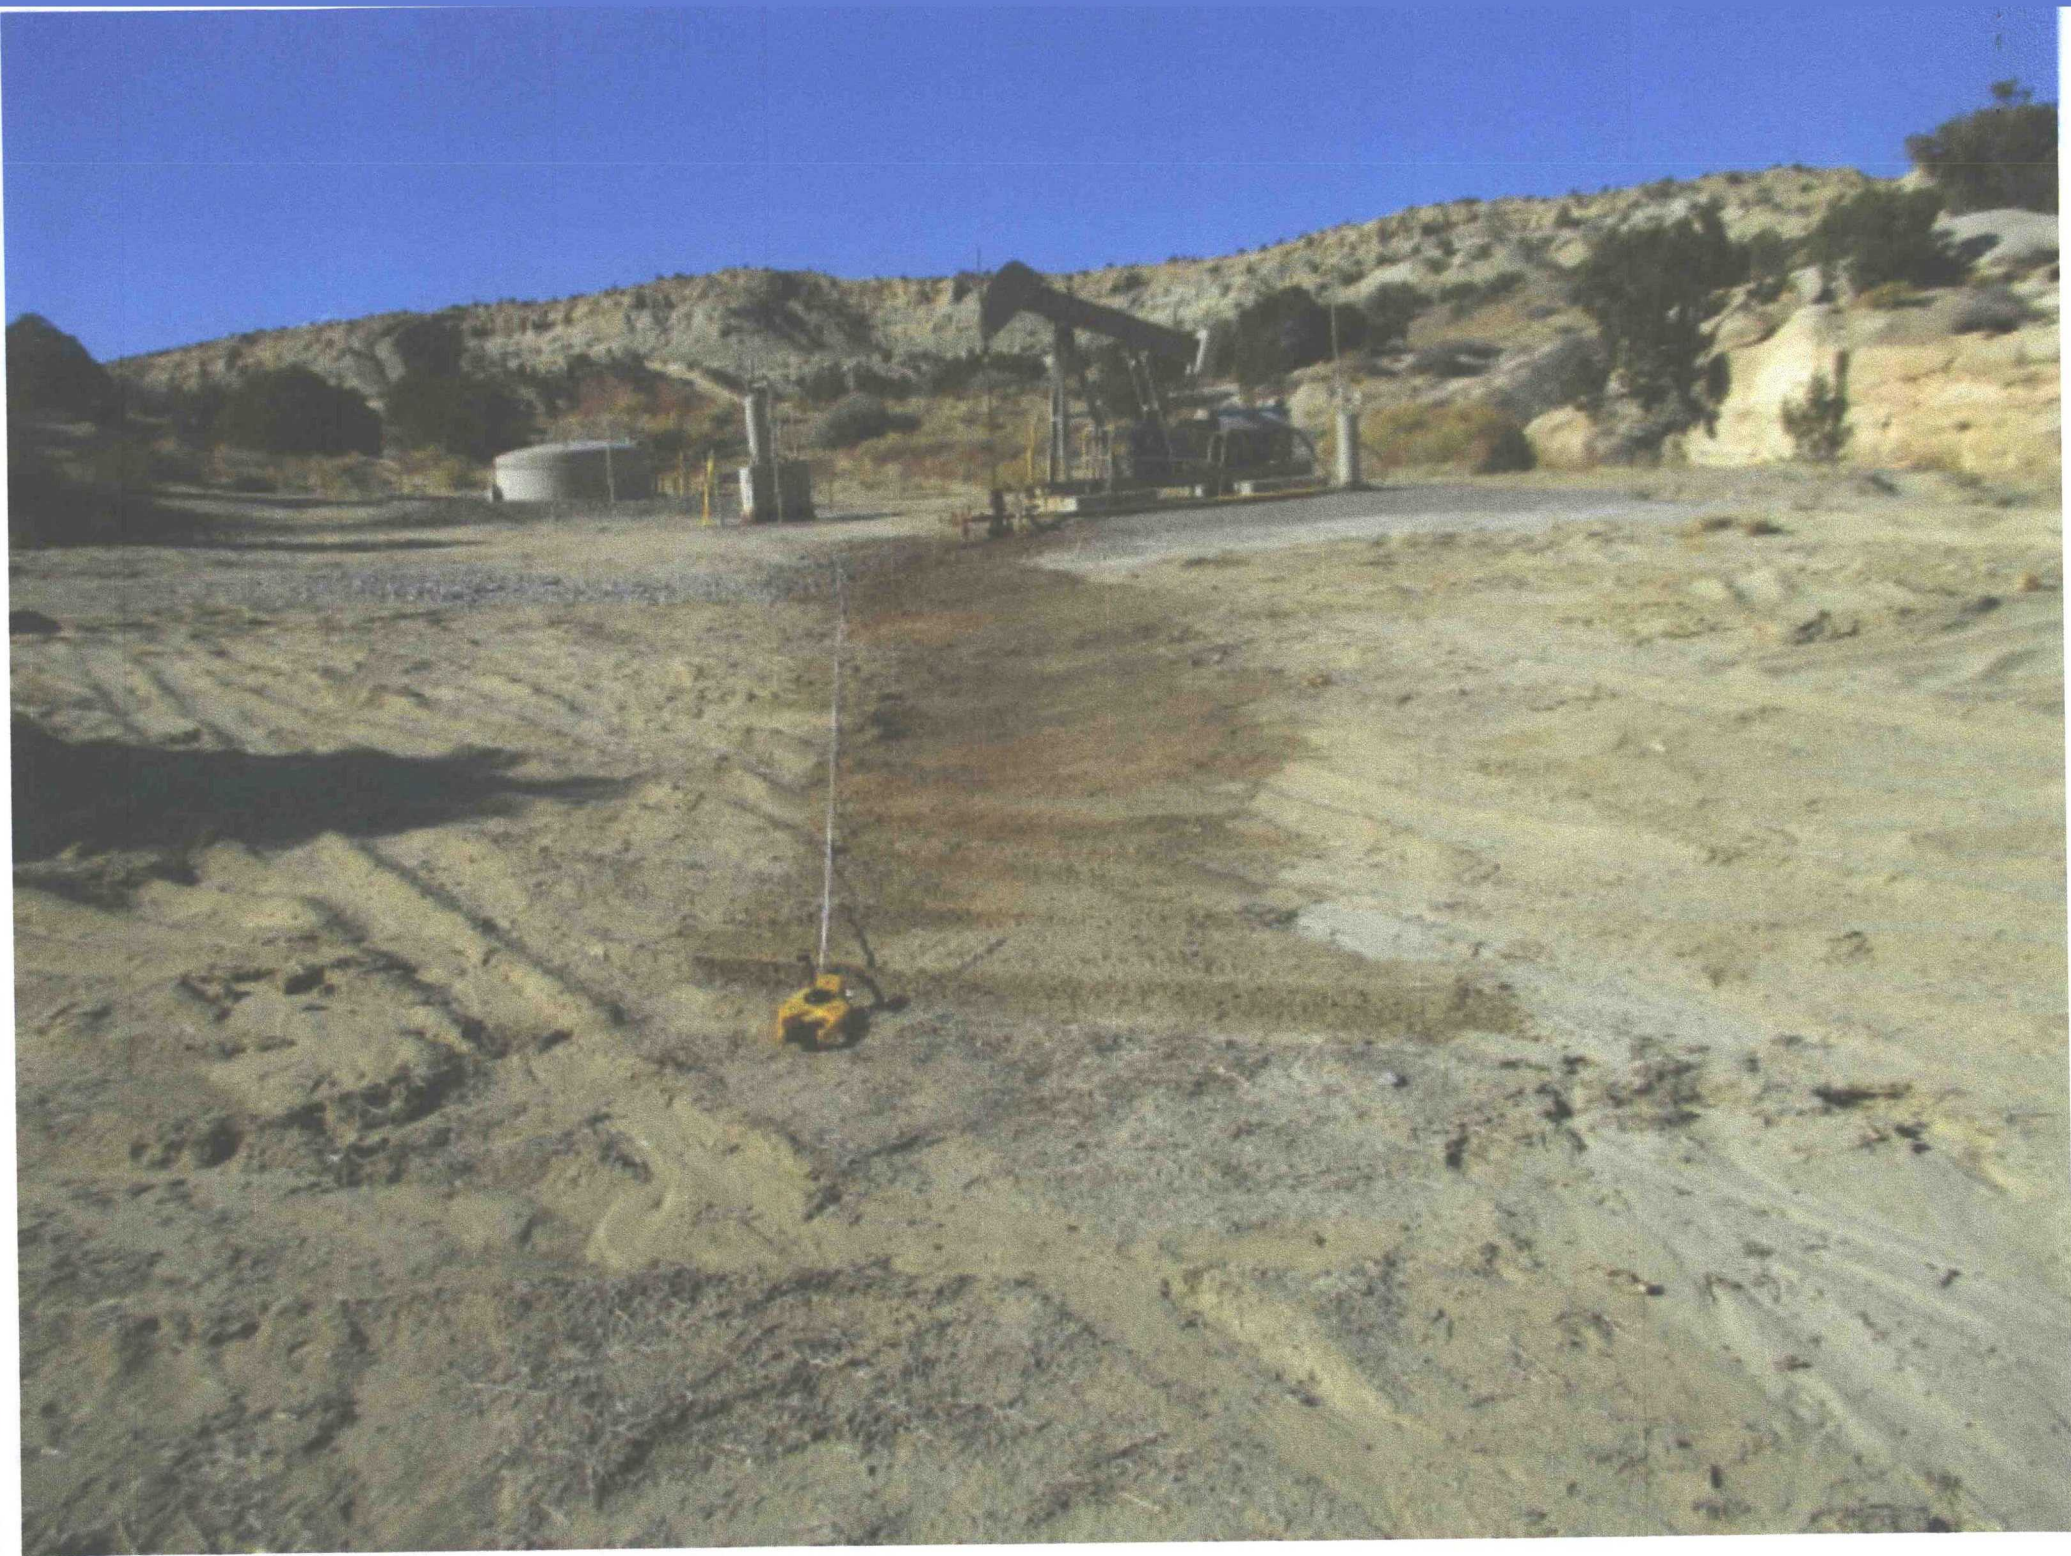
Collect 5-pt composite @ 6" depth along release footprint

Field OVM = 2.0 ppm

Release Footprint
(63' x 6' wide)

63'

Rig Anchors
