Pit, Below-Grade Tank, or
Proposed Alternative Method Permit or Closure Plan Application

1.
Operator: DJR Operating, LLC OGRID #: 371838
Address: PO BOX 156 Bloomfield, NM 87413
Facility or well name: Rincon 10
API Number: 30-039-24451 OCD Permit Number: _____
U/L or Qtr/Qtr G Section 13 Township 23N Range 07W County: Rio Arriba
Center of Proposed Design: Latitude 36.22799 Longitude -107.52465 NAD83
Surface Owner: ☒ Federal ☐ State ☐ Private ☐ Tribal Trust or Indian Allotment

- Figure 1. Topographic Site Location Map
- Figure 2. Aerial Site Map, December 2017
- Hall Analytical Report 1712E63

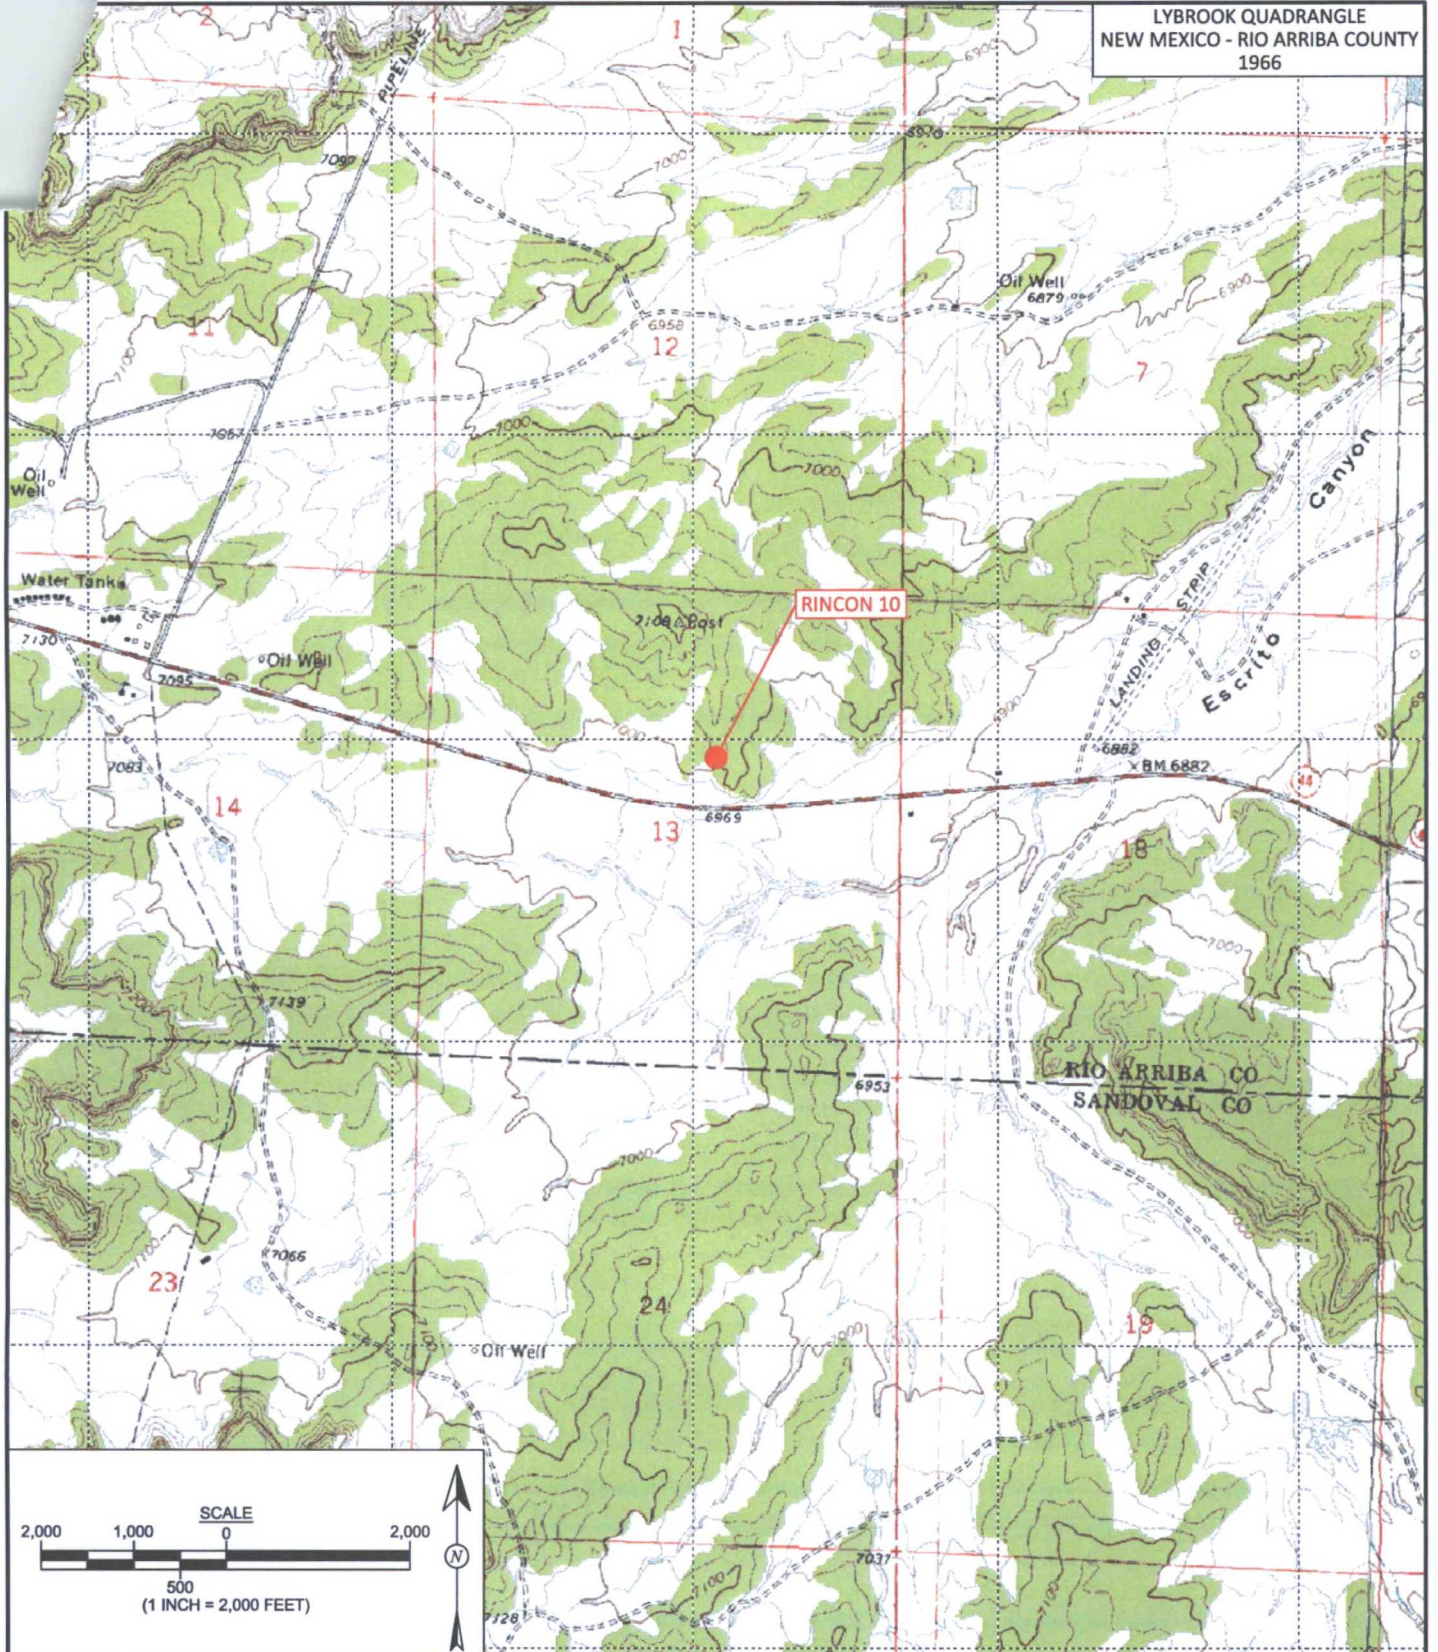
FIGURE 1

TOPOGRAPHIC SITE LOCATION MAP

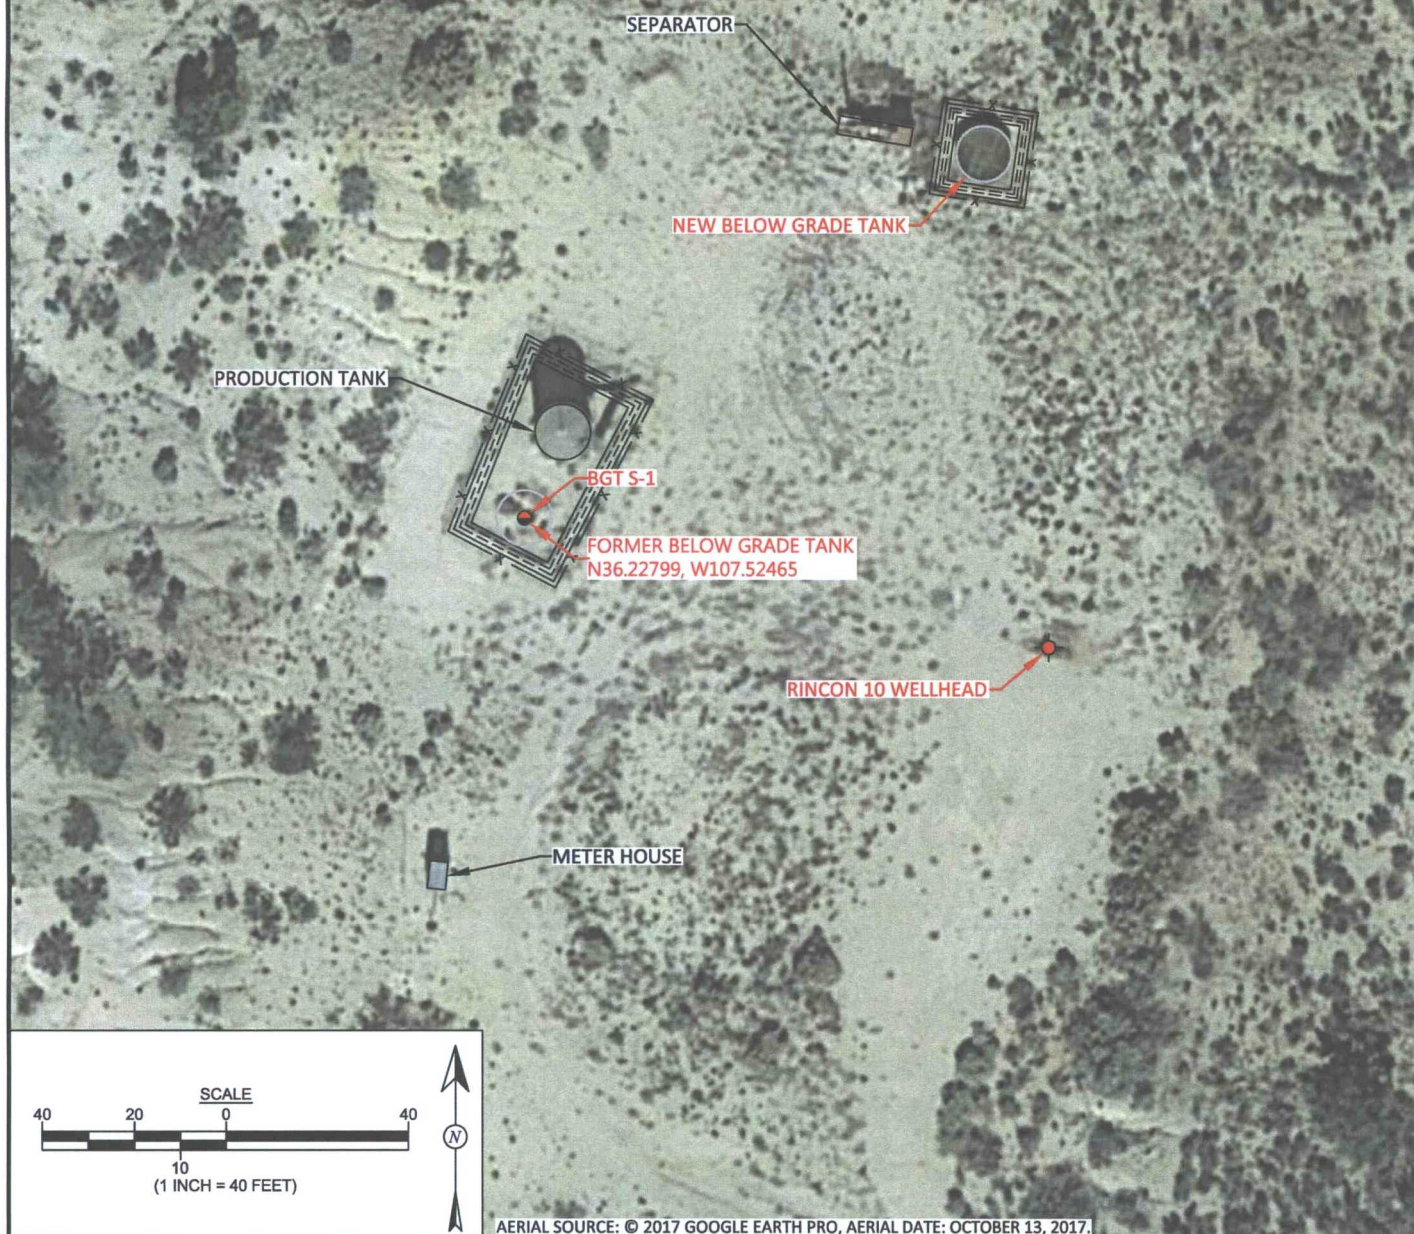
| Laboratory Analytical Results | | | | | | | | |
|---|---|---|---|---|---|---|---|---|
| BGT S-1 | 12/26/17 | 4.5 | <0.025 | <0.221 | <4.9 | 41 | 67 | <30 |

AERIAL SOURCE: © 2017 GOOGLE EARTH PRO, AERIAL DATE: OCTOBER 13, 2017.

Action levels for releases are determined by the NMOCD ranking score per *NMOCD Guidelines for Remediation of Leaks, Spills, and Releases* (August 1993), and the site was assigned a rank of 10. Benzene and total BTEX concentrations in BGT S-1 were below the NMOCD action levels of 10 mg/kg and 50 mg/kg, respectively. TPH concentrations were reported below the NMOCD action level of 1,000 mg/kg. All soil laboratory analyses showed that benzene, total BTEX, TPH, and chloride concentrations were below the respective NMOCD action levels for BGT S-1. Release notification should follow the protocols outlined in NMAC 19.15.29 and 30. No further work is recommended for the Rincon 10.
