Release Notification and Corrective Action

**RE: Final Excavation Report  
San Juan 27-5 Unit 3  
Rio Arriba County, New Mexico**

Site Name – San Juan 27-5 Unit 3

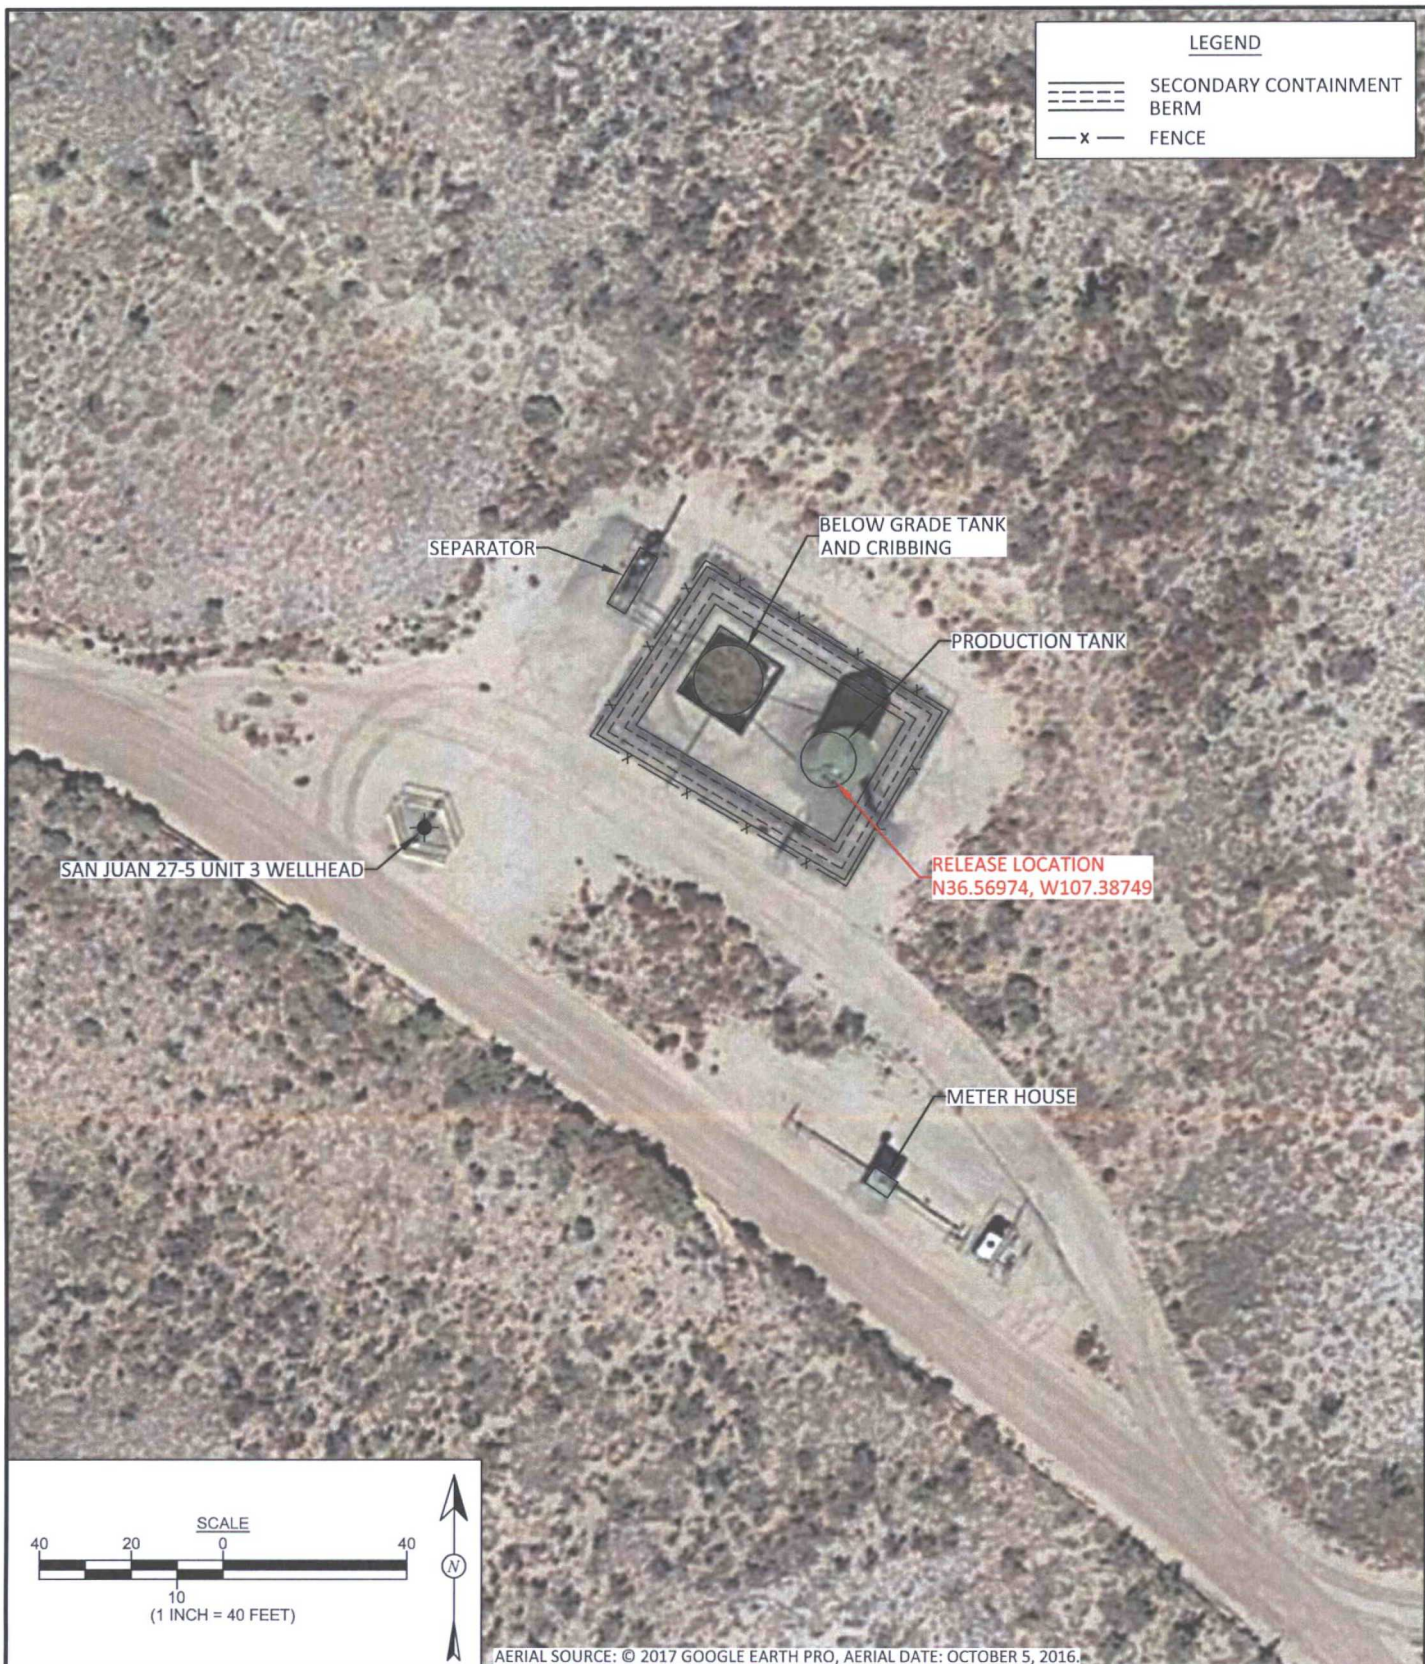
**FIGURE 2**

**OCTOBER 2017  
AERIAL SITE MAP**

HILCORP ENERGY  
SAN JUAN 27-5 UNIT 3  
SW $\frac{1}{4}$  SW $\frac{1}{4}$ , SECTION 17, T27N, R5W  
RIO ARriba COUNTY, NEW MEXICO  
N36.56971, W107.38779

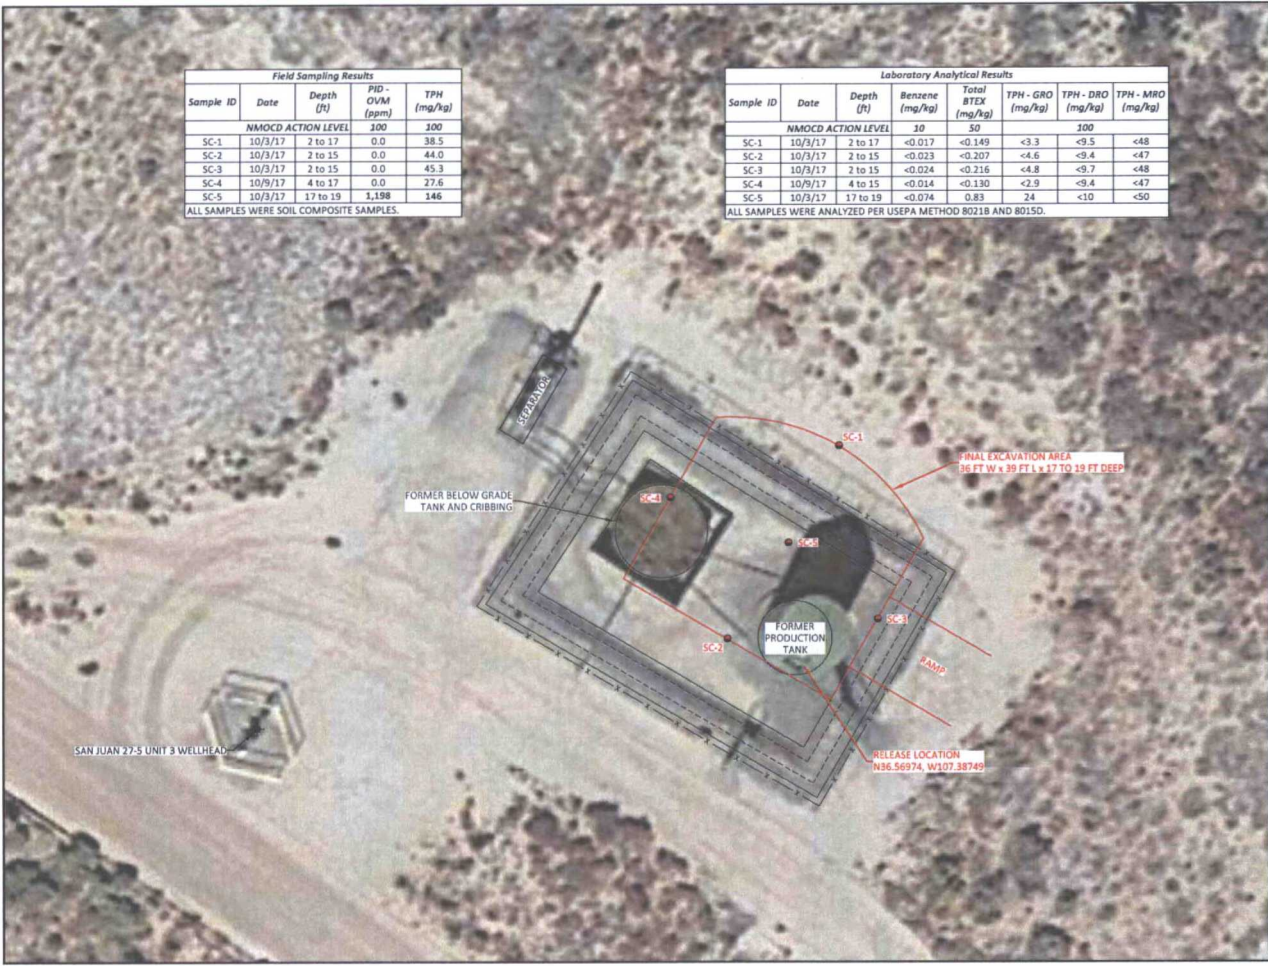
FIGURE 3

AES was initially contacted by Lindsay Dumas of Hilcorp on September 18, 2017, and on October 3 and 9, 2017, Corwin Lameman of AES completed the excavation field work. The field sampling activities included collection of five confirmation soil samples (SC-1 through SC-5) from the walls and base of the excavation. The area of the final excavation measured approximately 36 feet by 39 feet by 17 to 19 feet in depth. Sample locations and final excavation extents are presented on Figure 3.

FINAL EXCAVATION AREA  
SAMPLE LOCATIONS AND RESULTS  
OCTOBER 2017  
HILCORP ENERGY  
SAN JUAN 27-S UNIT 3  
SW¼, SW¼, SECTION 17, T27N, R5W  
RIO ARriba COUNTY, NEW MEXICO  
N36.56971, W107.38779

Field Sampling Results				
Sample ID	Date	Depth (ft)	PIG - OVI/M (ppm)	TPH (mg/kg)
NMOCD ACTION LEVEL			100	100
SC-1	10/3/17	2 to 17	0.0	38.5
SC-2	10/3/17	2 to 15	0.0	44.0
SC-3	10/3/17	2 to 15	0.0	45.3
SC-4	10/9/17	4 to 17	0.0	27.6
SC-5	10/3/17	17 to 19	1,198	146

Laboratory Analytical Results						
Sample ID	Date	Depth (ft)	Benzene (mg/kg)	Total BTEX (mg/kg)	TPH - GRO (mg/kg)	TPH - DRO (mg/kg)
NMOCD ACTION LEVEL			10	50	100	
SC-1	10/3/17	2 to 17	<0.017	<0.149	<3.3	<9.5
SC-2	10/3/17	2 to 15	<0.023	<0.207	<4.6	<9.4
SC-3	10/3/17	2 to 15	<0.024	<0.216	<4.8	<9.7
SC-4	10/9/17	4 to 15	<0.014	<0.130	<2.9	<9.4
SC-5	10/3/17	17 to 19	<0.074	0.83	24	<10

Based on the final field sampling and laboratory analytical results of the excavation of petroleum contaminated soils at the San Juan 27-5 Unit 3, benzene, total BTEX, and TPH concentrations were below the applicable NMOCD action levels for the final sidewalls and base of the excavation. No further work is recommended.
