BP AMERICA PRODUCTION COMPANY
SAN JUAN BASIN, NORTHWEST NEW MEXICO

BELOW-GRADE TANK CLOSURE PLAN

HUGHES 004E

API No. 3004525191

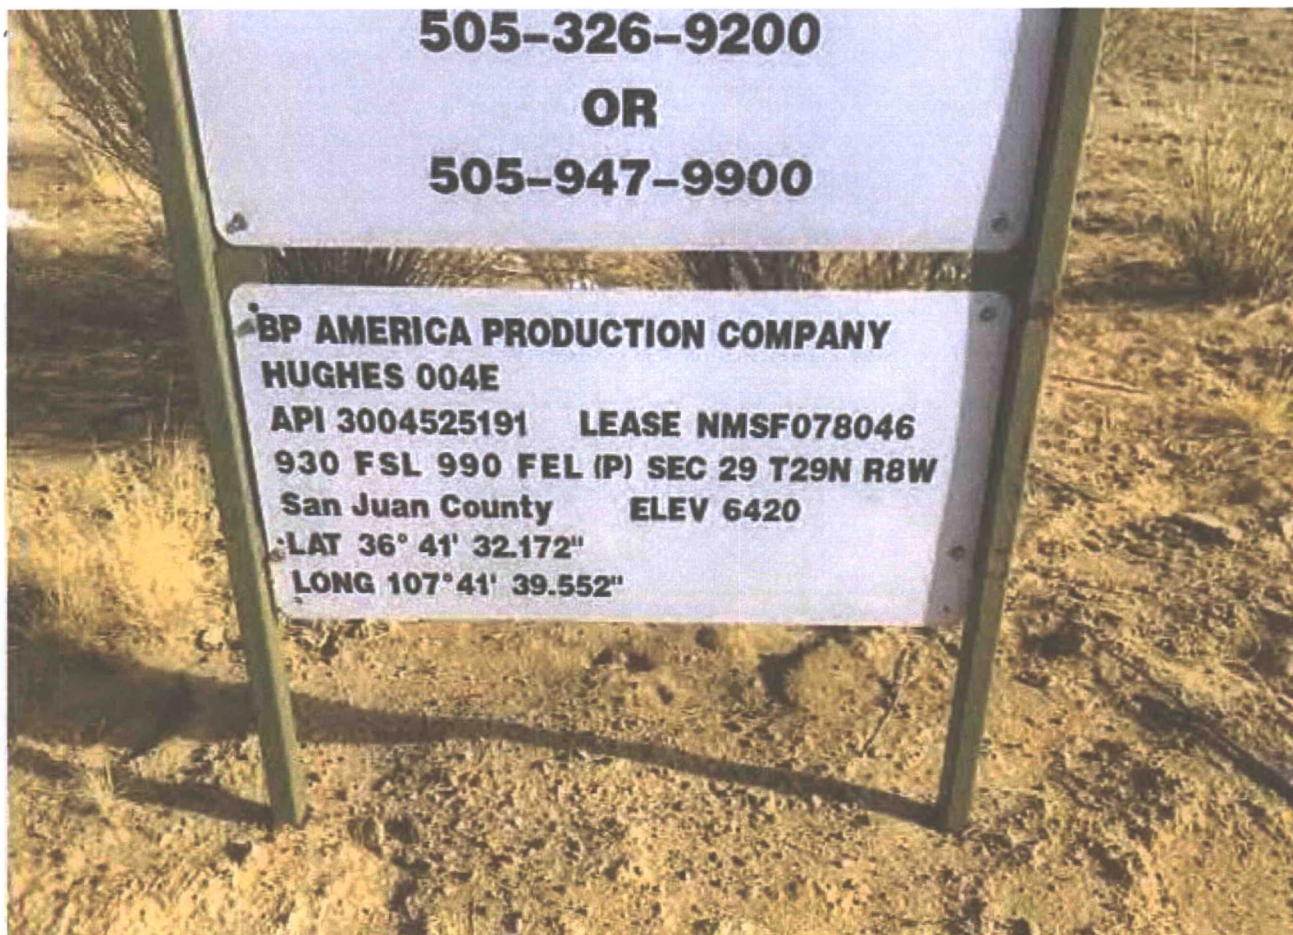
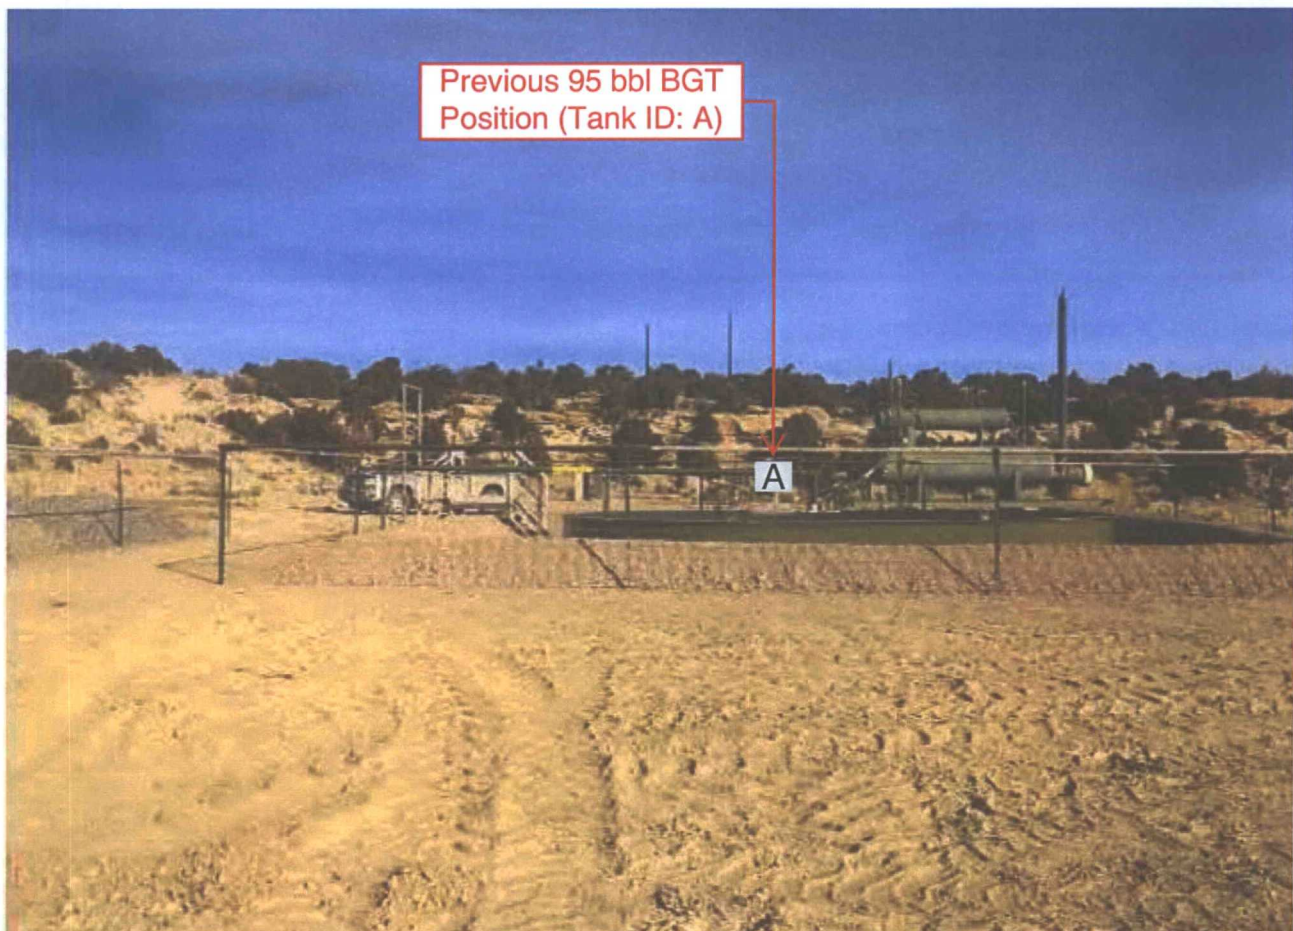
The area has been backfilled and a 105 BBL shallow low profile above-grade tank set atop BGT location. The location will be reclaimed once the well is plugged and abandoned.

Closure report on C-144 form is included including photos of reclamation completion.
