Release Notification and Corrective Action

Name of Company: DJR Operating, LLC	Contact: Amy Archuleta	
Address: PO BOX 156 Bloomfield, NM 87413	Telephone No.: 505-632-3476 x201	
Facility Name: Turtle Mountain 35-1	Facility Type: Well	
Surface Owner: Federal	Mineral Owner: Federal	API No.: 30-045-33935

**RE: Excavation Clearance Report
Turtle Mountain 35 #1 Release
API #3004533935
San Juan County, New Mexico**

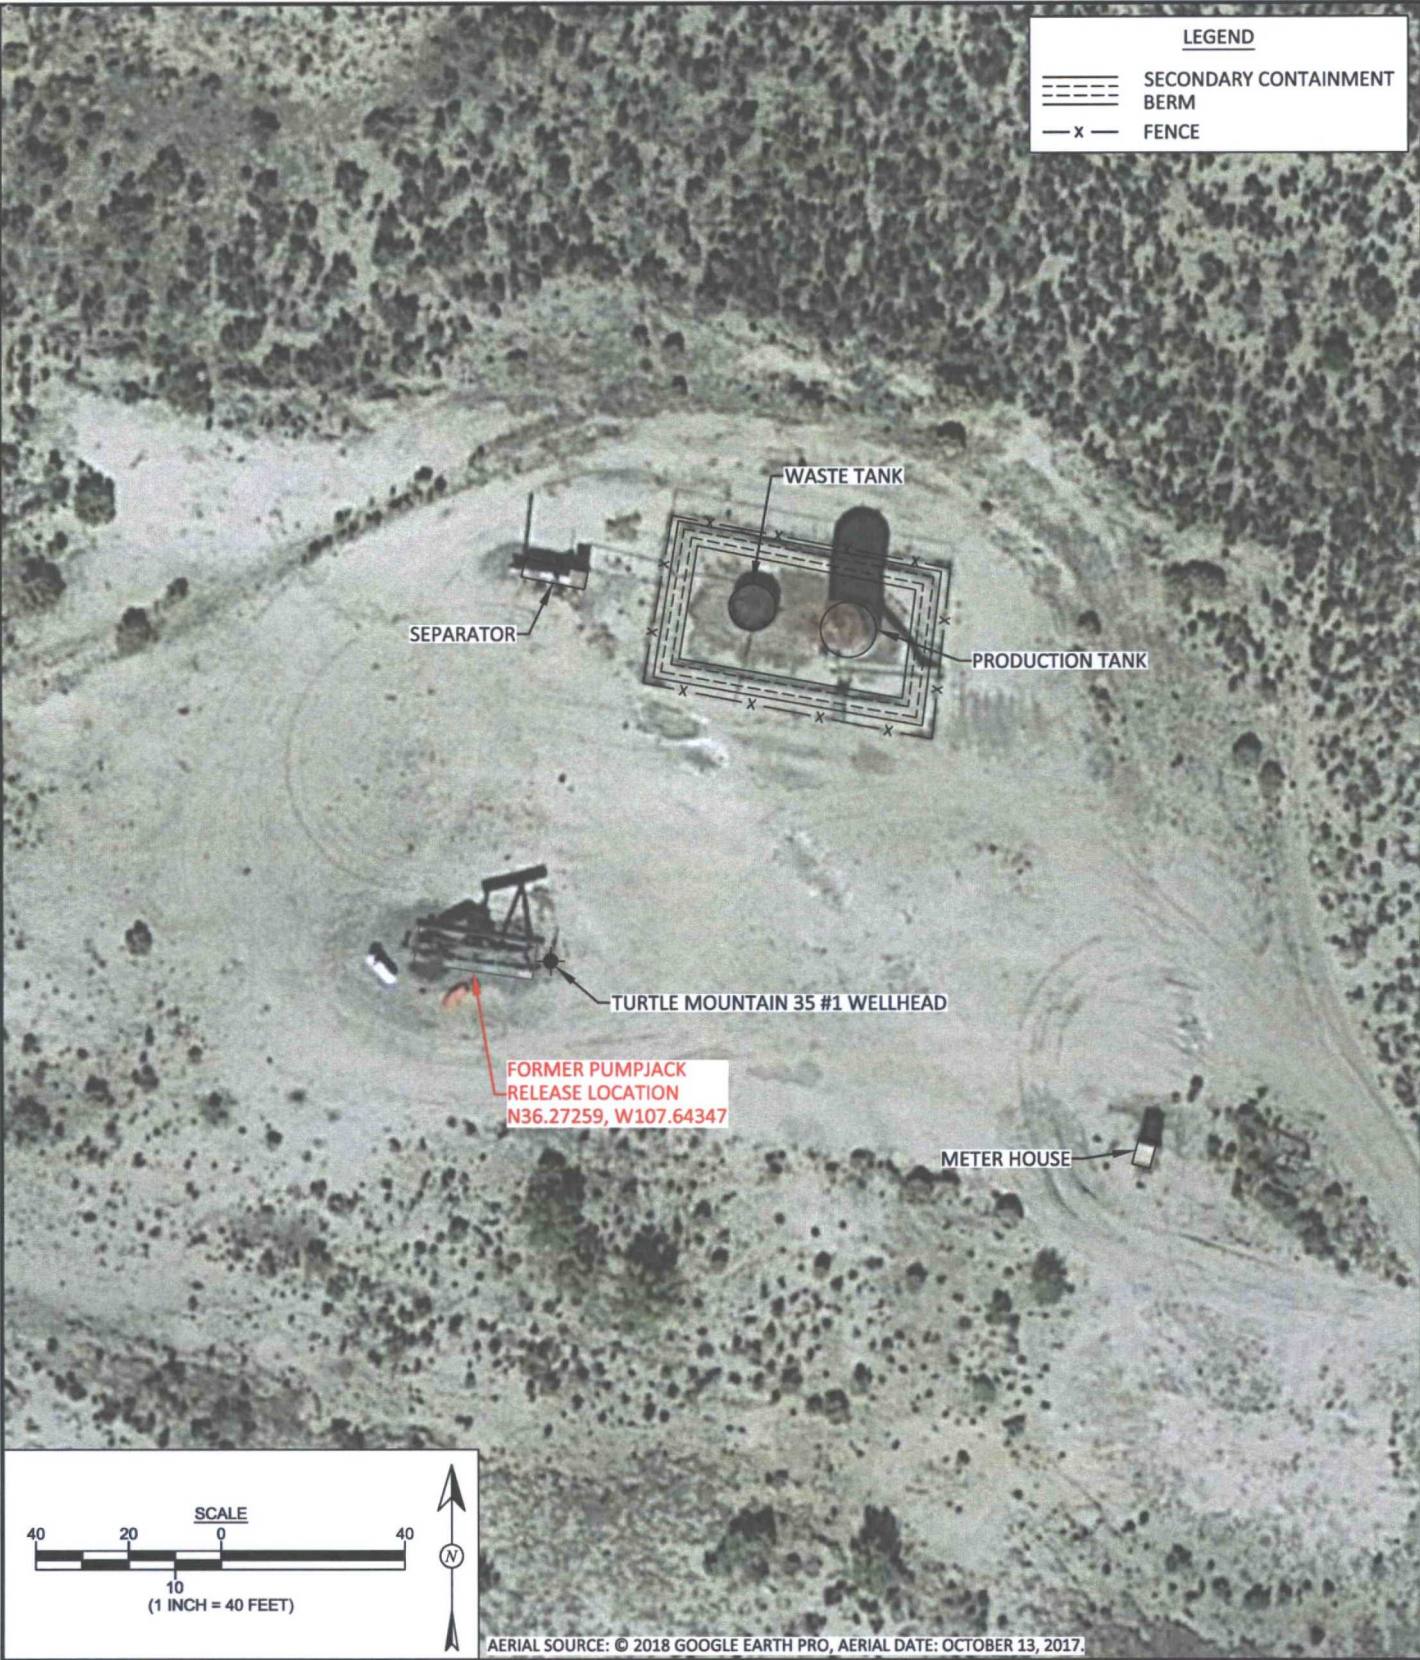
FIGURE 3

On March 5, 2018, DJR contractors completed an excavation of historic contamination discovered during removal of the pump-jack at the location, and AES personnel collected a total of five confirmation soil samples for field screening and laboratory analysis from the walls and bases of the excavation area. The final excavation measured approximately 12 feet by 28 feet by 2 to 3 feet deep. Sample locations and final excavation extents are presented on Figure 3.

EXCAVATION AREA SAMPLE LOCATIONS AND RESULTS MARCH 2018
 DJR OPERATING
 TURTLE MOUNTAIN 35 #1
 API #30-045-33935
 SE1/4 NE1/4, SECTION 35, T24N, R8W
 SAN JUAN COUNTY, NEW MEXICO
 N36.27258, W107.64338

Field Sampling Results				
Sample ID	Date	Depth (ft)	PID-OVM (ppm)	TPH (mg/kg)
NMOCD ACTION LEVEL			100	100
SC-1	3/5/18	3	0.0	NA
SC-2	3/5/18	2	0.0	NA
SC-3	3/5/18	2 to 3	0.0	NA
SC-4	3/5/18	2 to 3	0.0	NA
SC-5	3/5/18	2 to 3	0.0	26.5
ALL SAMPLES WERE COMPOSITE SAMPLES.				
NA - NOT ANALYZED

Laboratory Analytical Results								
Sample ID	Date	Depth (ft)	Benzene (mg/kg)	Total BTEX (mg/kg)	TPH-GRO (mg/kg)	TPH-DRO (mg/kg)	TPH-MRO (mg/kg)	Chlorides (mg/kg)
NMOC ACTION LEVEL			10	50	100		250	
Turtle Mnt 35-1	12/19/17		<0.050	<0.300	<10.0	213	235	32.8
SC-5	3/5/18	2 to 3	NA	NA	<4.6	<9.3	<47	NA
SAMPLE Turtle Mnt 35-1 WAS COLLECTED BY CLIENT AND ANALYZED PER USEPA METHOD 8021B, 8015B AND 300.0.								
SAMPLE SC-5 WAS COLLECTED BY AES AND ANALYZED PER USEPA METHOD 8015D.								
NA - NOT ANALYZED

On March 5, 2018, final clearance of the excavation area was completed. Field sampling results and laboratory analytical results from the excavation extents showed field TPH concentrations were below the applicable NMOCD action level of 100 mg/kg for in SC-5.

Mountain 35 #1, concentrations of contaminants of concern were below the applicable NMOCD action levels for the final base and sidewalls of the excavation pit. No further work is recommended.
