BP AMERICA PRODUCTION COMPANY

BELOW-GRADE TANK CLOSURE PLAN

NEBU 054

API No. 3004510115

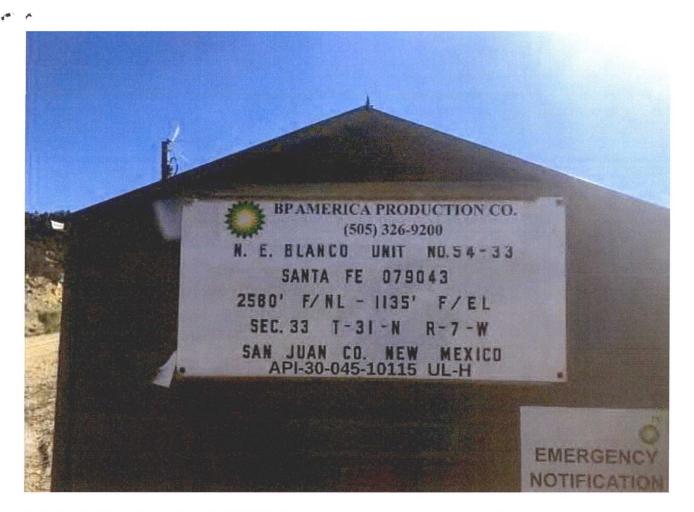
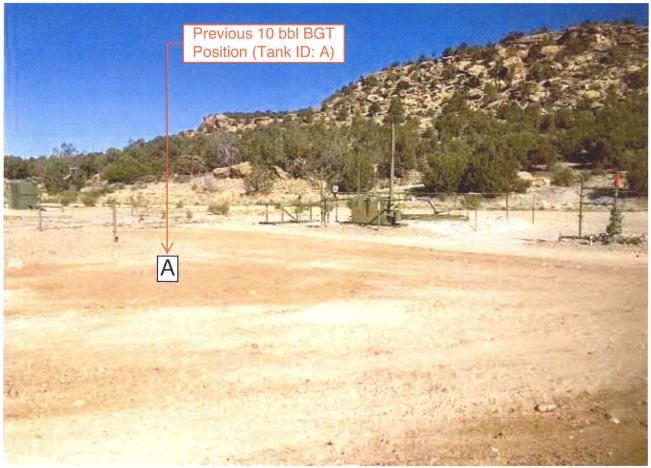
The area has been backfilled and BGT location's surface condition is clear, but within the site's operational area. The location will be reclaimed when the well is plugged and abandoned.

Closure report on C-144 form is included including photos of reclamation completion.
