Release Notification and Corrective Action

Name of Company Hilcorp Energy Company	Contact Lindsay Dumas
Address 1111 Travis St. Houston, TX 77002	Telephone No. (281)794-9159
Facility Name: Chacon Federal 2	Facility Type: Gas

Re: Site Assessment and Remedial Action Plan
Chacon Federal 2 Release
Chacon Dakota Field, Rio Arriba County, New Mexico
Timberwolf Project Number: HEC-180004

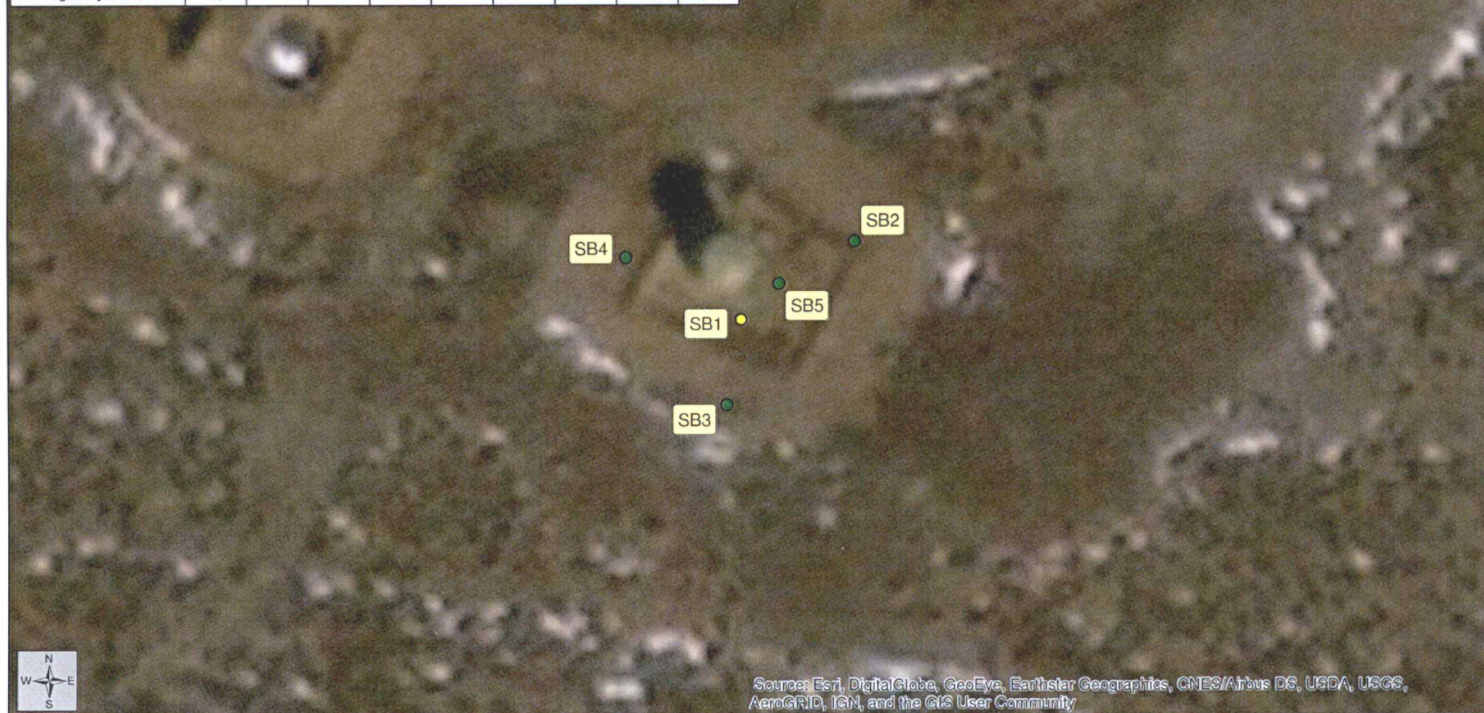
Figure 4
Sample Location Map

Soils encountered at the Site consisted primarily of clay, underlain by sand. Sample locations are shown in Figure 4. The location and purpose of each boring are presented in Table 3 below.

Sample ID	Sample Date	Volatile Organic Compounds (mg/kg)				Total BTEX (mg/kg)	GRO (mg/kg)	DRO (mg/kg)	MRO (mg/kg)	Total TPH (mg/kg)
		B	T	E	X					
SB1 3.0-3.5'	01/25/18	10	120	17	160	307	5,800	760	410	6,970
SB1 5.0-5.5'	01/25/18	33	290	37	350	710	13,000	1,000	370	14,370
SB1 8.5-9.0'	01/25/18	8	110	17	150	285	5,300	620	210	6,130
SB1 20'	01/25/18	110	750	69	700	1,629	17,000	2,400	710	20,110
SB1 23'	01/25/18	< 0.024	< 0.049	< 0.049	< 0.097	< 0.097	< 4.9	< 9.9	< 49	< 49
SB2 23'	01/25/18	< 0.024	< 0.049	< 0.049	< 0.097	< 0.097	< 4.9	< 9.4	< 47	< 47
SB3 23'	01/25/18	< 0.023	< 0.047	< 0.047	< 0.094	< 0.094	< 4.7	< 9.6	< 48	< 48
SB4 23'	01/25/18	< 0.024	< 0.048	< 0.048	< 0.097	< 0.097	< 4.8	< 9.3	< 46	< 46
SB5 23'	01/25/18	< 0.024	< 0.047	< 0.047	< 0.094	< 0.094	< 4.7	< 9.9	< 50	< 50
Regulatory Criteria *		10	--	--	--	50	--	--	--	5,000

- Soil Sample (clean)
- Soil Sample (elevated)

- Benzene exceeded the NMOCD remedial action level in two (2) samples (i.e., SB1 5.0-5.5' and SB1 20')
- Total BTEX and TPH exceeded the NMOCD remedial action level in four (4) samples (i.e., SB1 3.0-3.5', SB1 5.0-5.5', SB1 8.5-9.0, and SB1 20')
- Vertical delineation was achieved; SB1 23' and SB1 26' were below NMOCD remedial action level for all constituents
- Horizontal delineation was achieved; SB2 23', SB3 23', SB4 23', and SB5 23' were below NMOCD remediation action level. Furthermore, all PID readings from borings SB2 – SB5 were below 1.0 ppm.
- Based on the delineation effort, the volume of impacted soil is estimated at 490 cubic yards (yds³)
