Pit, Below-Grade Tank, or
Proposed Alternative Method Permit or Closure Plan Application

**Hilcorp Energy Company
San Juan Basin
Below Grade Tank Closure Report**

Lease Name: Allison Unit 26

API No.: 30-045-11480

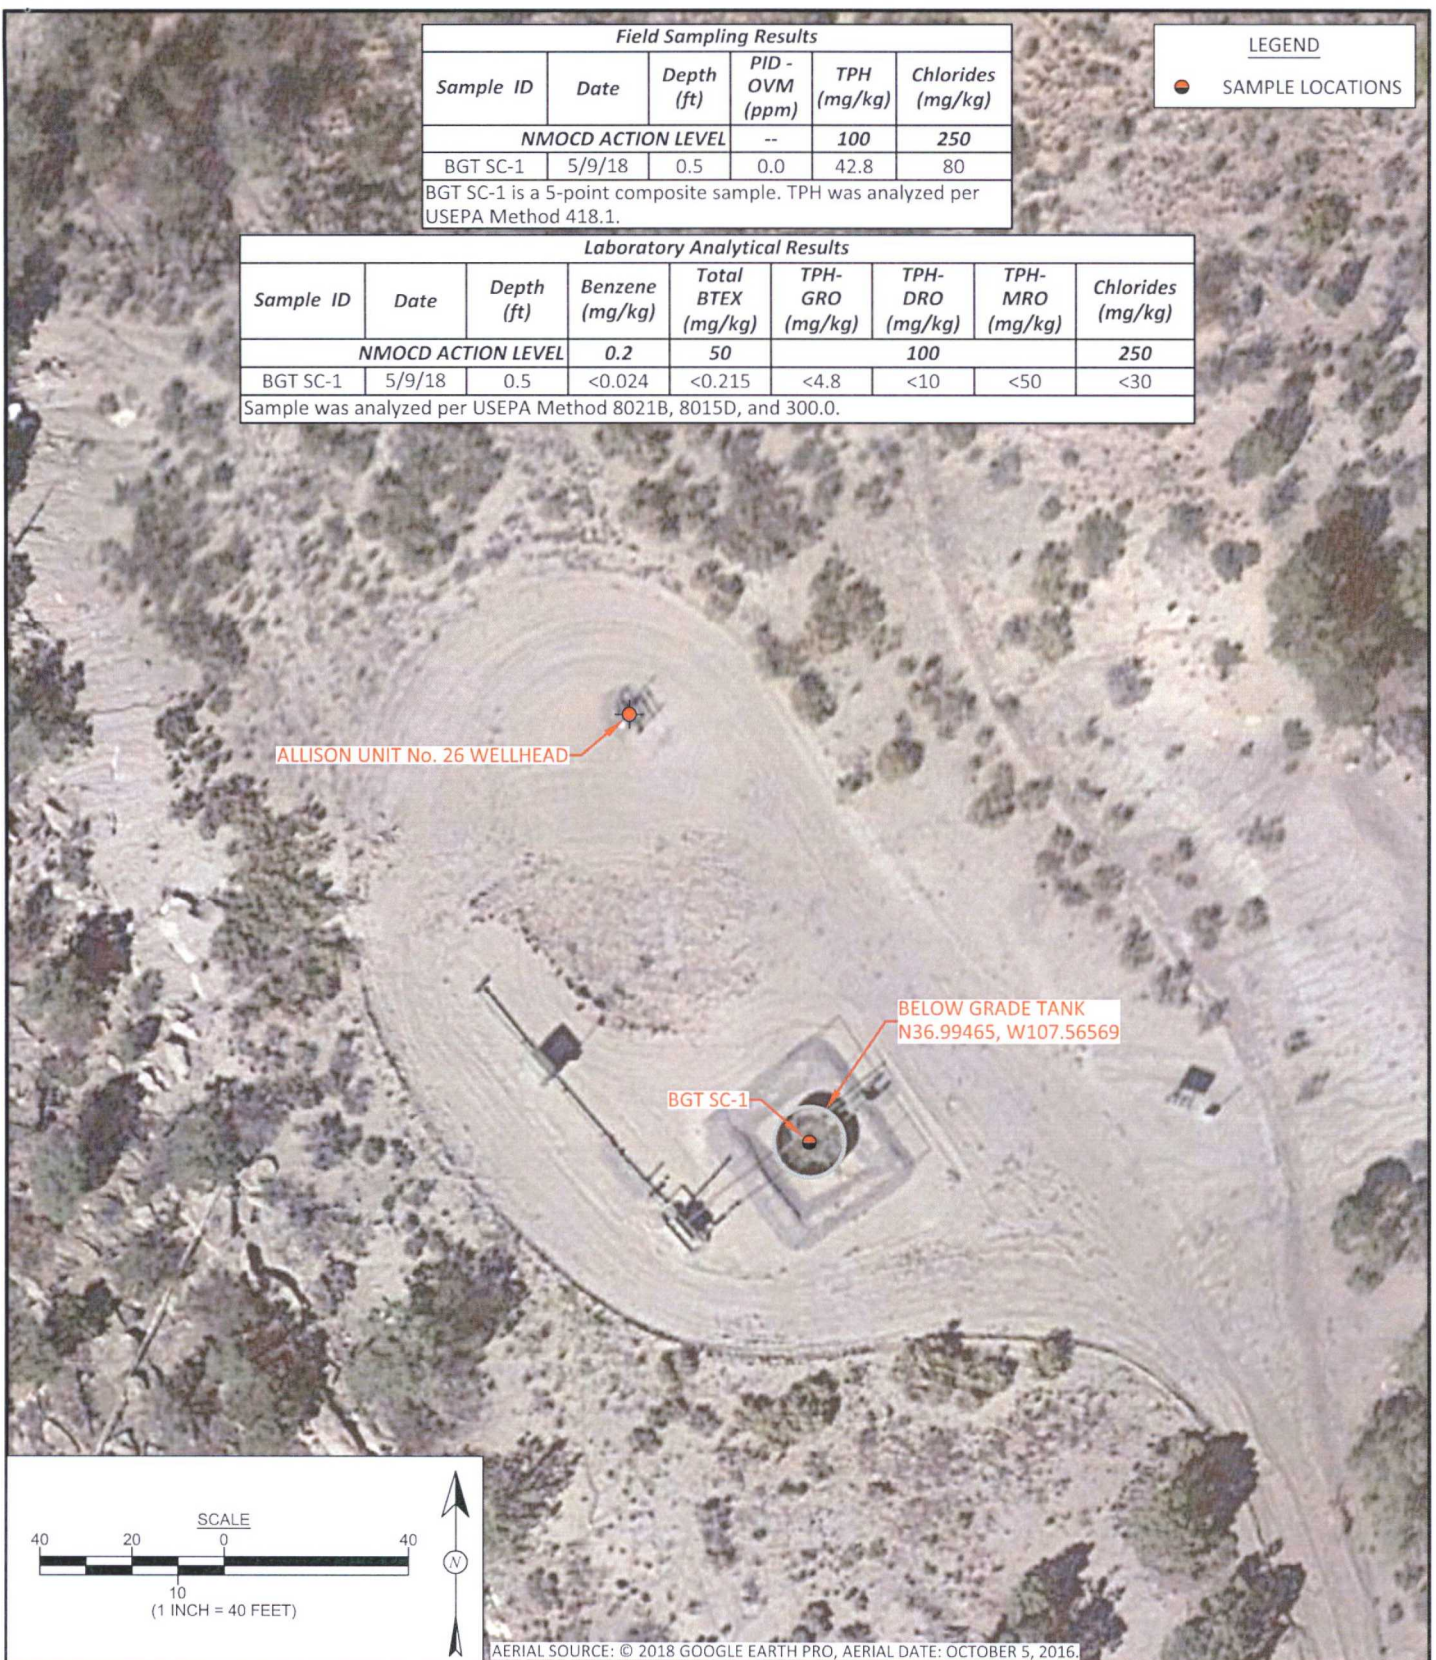
AERIAL SOURCE: © 2018 GOOGLE EARTH PRO, AERIAL DATE: OCTOBER 5, 2016.
