BP AMERICA PRODUCTION COMPANY

BELOW-GRADE TANK CLOSURE PLAN

GCU # 343

API No. 3004526105

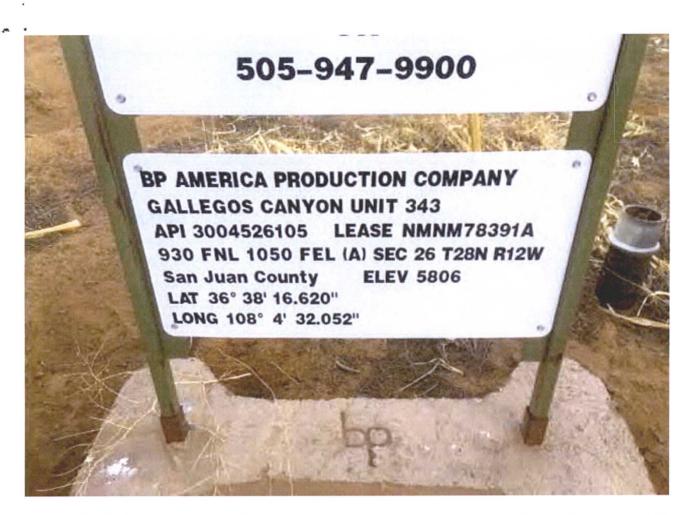
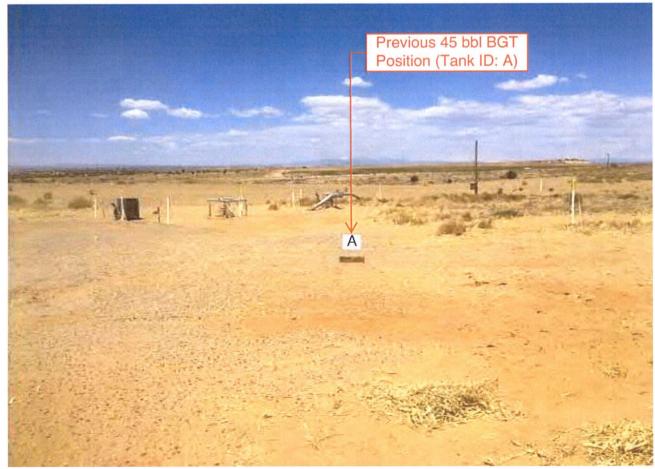
The gas well has been plugged & abandoned, BGT location's surface condition is clear.

Closure report on C-144 form is included including photos of reclamation completion.
