Release Notification and Corrective Action

**RE: BELOW-GRADE TANK CLOSURE DOCUMENTATION FOR THE HORTON #3B WELL SITE
LOCATED AT SECTION 13, TOWNSHIP 32 NORTH, RANGE 12 WEST, SAN JUAN
COUNTY, NEW MEXICO**

SITE MAP					
Hallador Energy					
Horton #3B Well Site					
SECTION 13, TWP 32 NORTH, RANGE 12 WEST					
SAN JUAN COUNTY, NEW MEXICO					
SCALE:	NTS	FIGURE NO.	2	REV	
PROJECT NO18010-0003					
REVISIONS					
NO.	DATE	BY	DESCRIPTION		
MAP DRWN	BH	2/15/18	BASE DRWN	IG	11/7/17

FIELD REPORT: BELOW GROUND TANK VERIFICATION

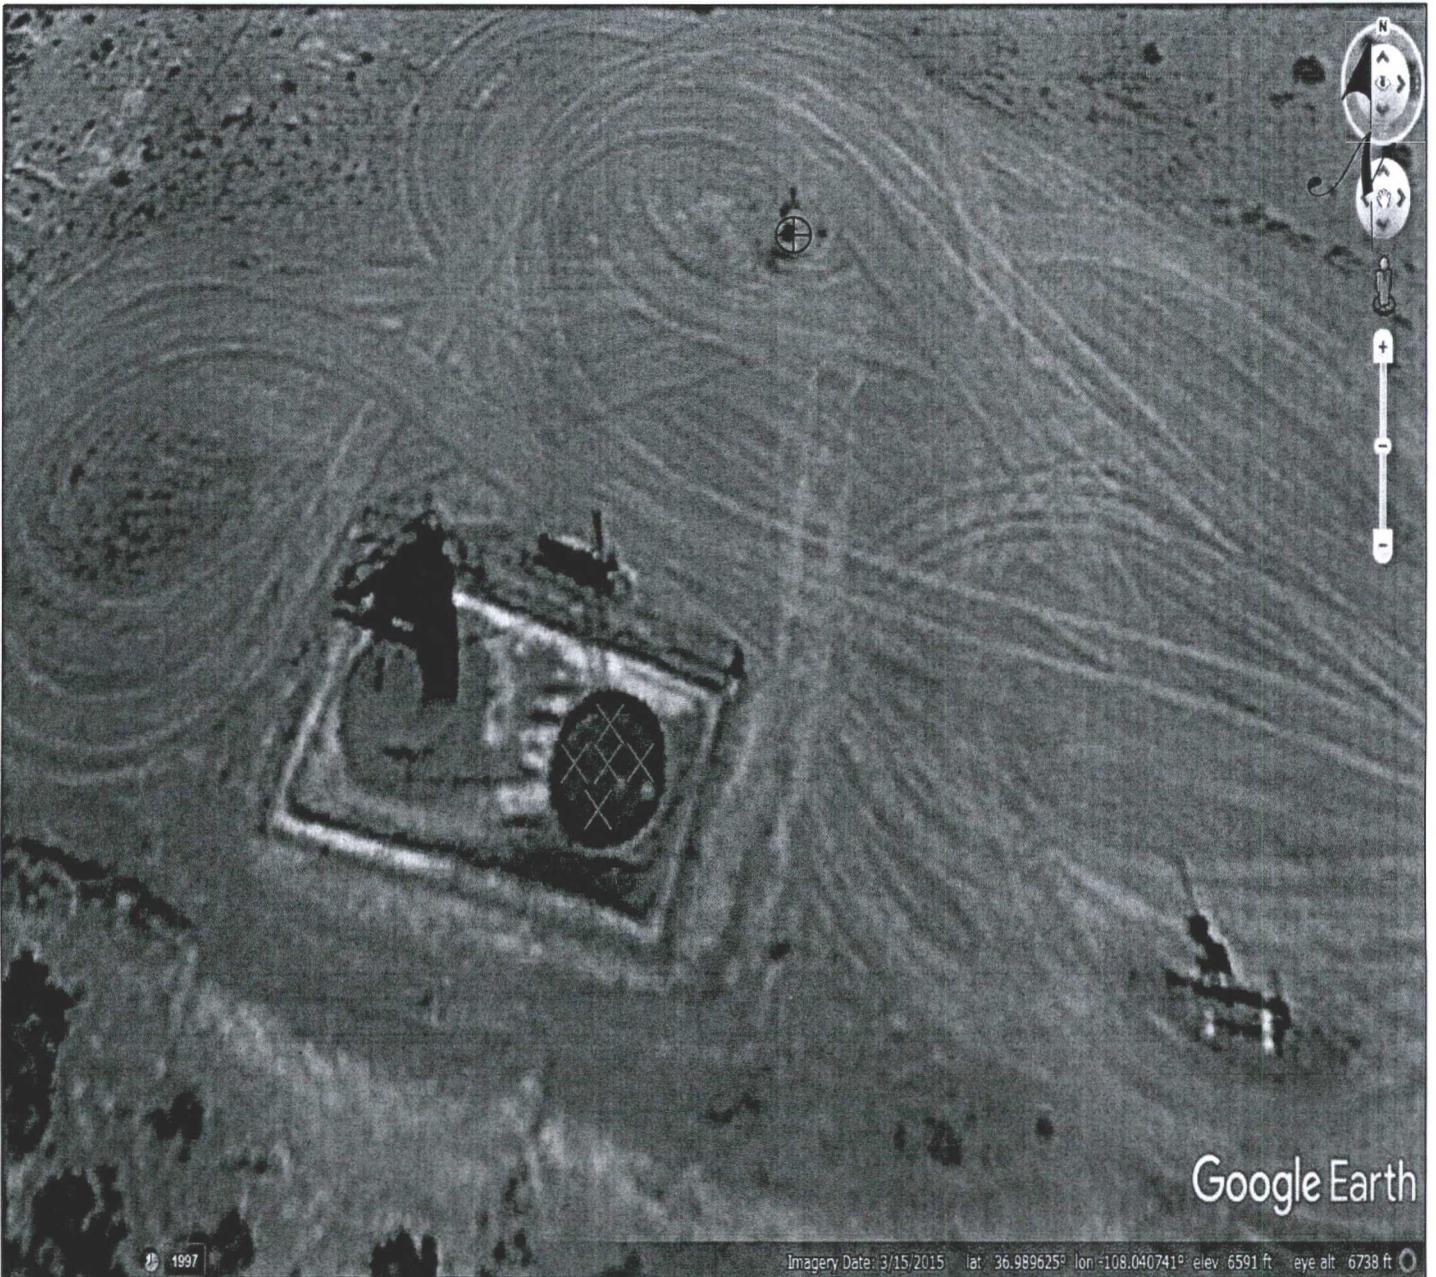
The BGT was removed and staged on-site with Envirotech representative Brittany Hall and New Mexico Oil and Gas Conservation Division (NMOCD) representative Cory Smith as witnesses. One (1) five (5)-point composite sample was collected from directly beneath the former BGT; see enclosed *Field Notes*. The sample was analyzed in the field for organic vapors using a photoionization detector (PID) and returned a result of 0.0 mg/Kg; see enclosed *Field Notes*. Additionally, the sample was placed into a four (4)-ounce glass jar, capped headspace free, and transported on ice, under chain of custody, to Envirotech's Analytical Laboratory to be analyzed for TPH using USEPA Method 8015B (GRO, DRO, and ORO), for benzene and total BTEX using USEPA Method 8021B and for chlorides using USEPA Method 300.0. The sample returned results below the regulatory limits for all constituents analyzed except TPH, which returned results above the BGT closure standard of 100 parts per million (ppm) TPH using USEPA Method 8015B; therefore, confirming a release had occurred.

area, pursuant to the NMOCD Guidelines for Remediation of Spills, Leaks, and Releases. The sample from beneath the former BGT returned results below the regulatory standard for all constituents analyzed; see enclosed *Analytical Results*. Envirotech, Inc. recommends *No Further Action* in regards to this incident.

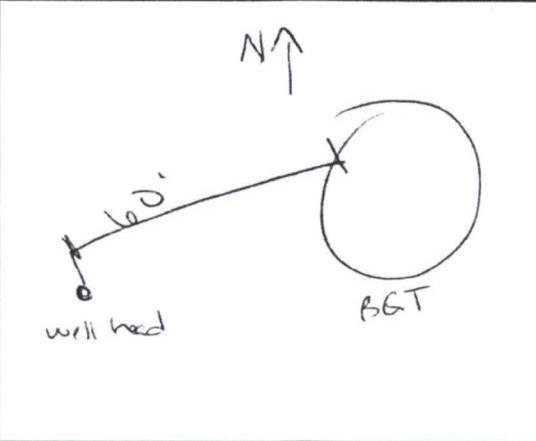
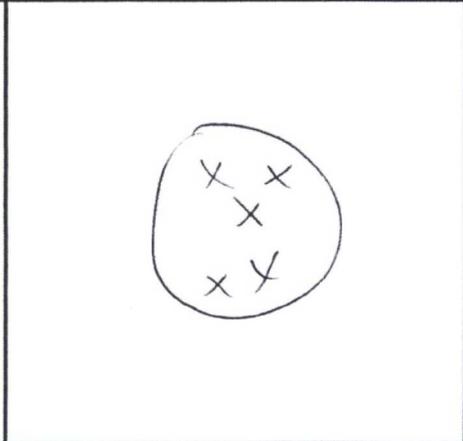
Excavation Approx _____ Feet X 15 Feet X 15 Feet Deep 3 Cubic Yardage _____

SITE PERIMETER

SAMPLE PROFILE
