Release Notification and Corrective Action

Name of Company Hilcorp Energy Company	Contact Clara Cardoza
Address 382 CR 310 Aztec NM 87410	Telephone No. 505-564-0733
Facility Name Omler A 2E	Facility Type Well

On March 14, 2018, Hilcorp personnel discovered a pinhole leak in the side of a condensate tank. The leak resulted in approximately 6.8 barrels (bbls) of condensate draining onto the ground and infiltrating the subsurface. The release was contained within the earthen berm, but no liquids were recovered. The defective tank was immediately shut-in, drained of remaining liquids, and repaired in place. Some of the immediate hydrocarbon saturated soil was removed from beneath the tank and set aside for disposal. The release was reported to the New Mexico Oil Conservation Division (NMOCD) by Hilcorp on a Form C-141 Release Notification and Corrective Action Form dated April 12, 2018.

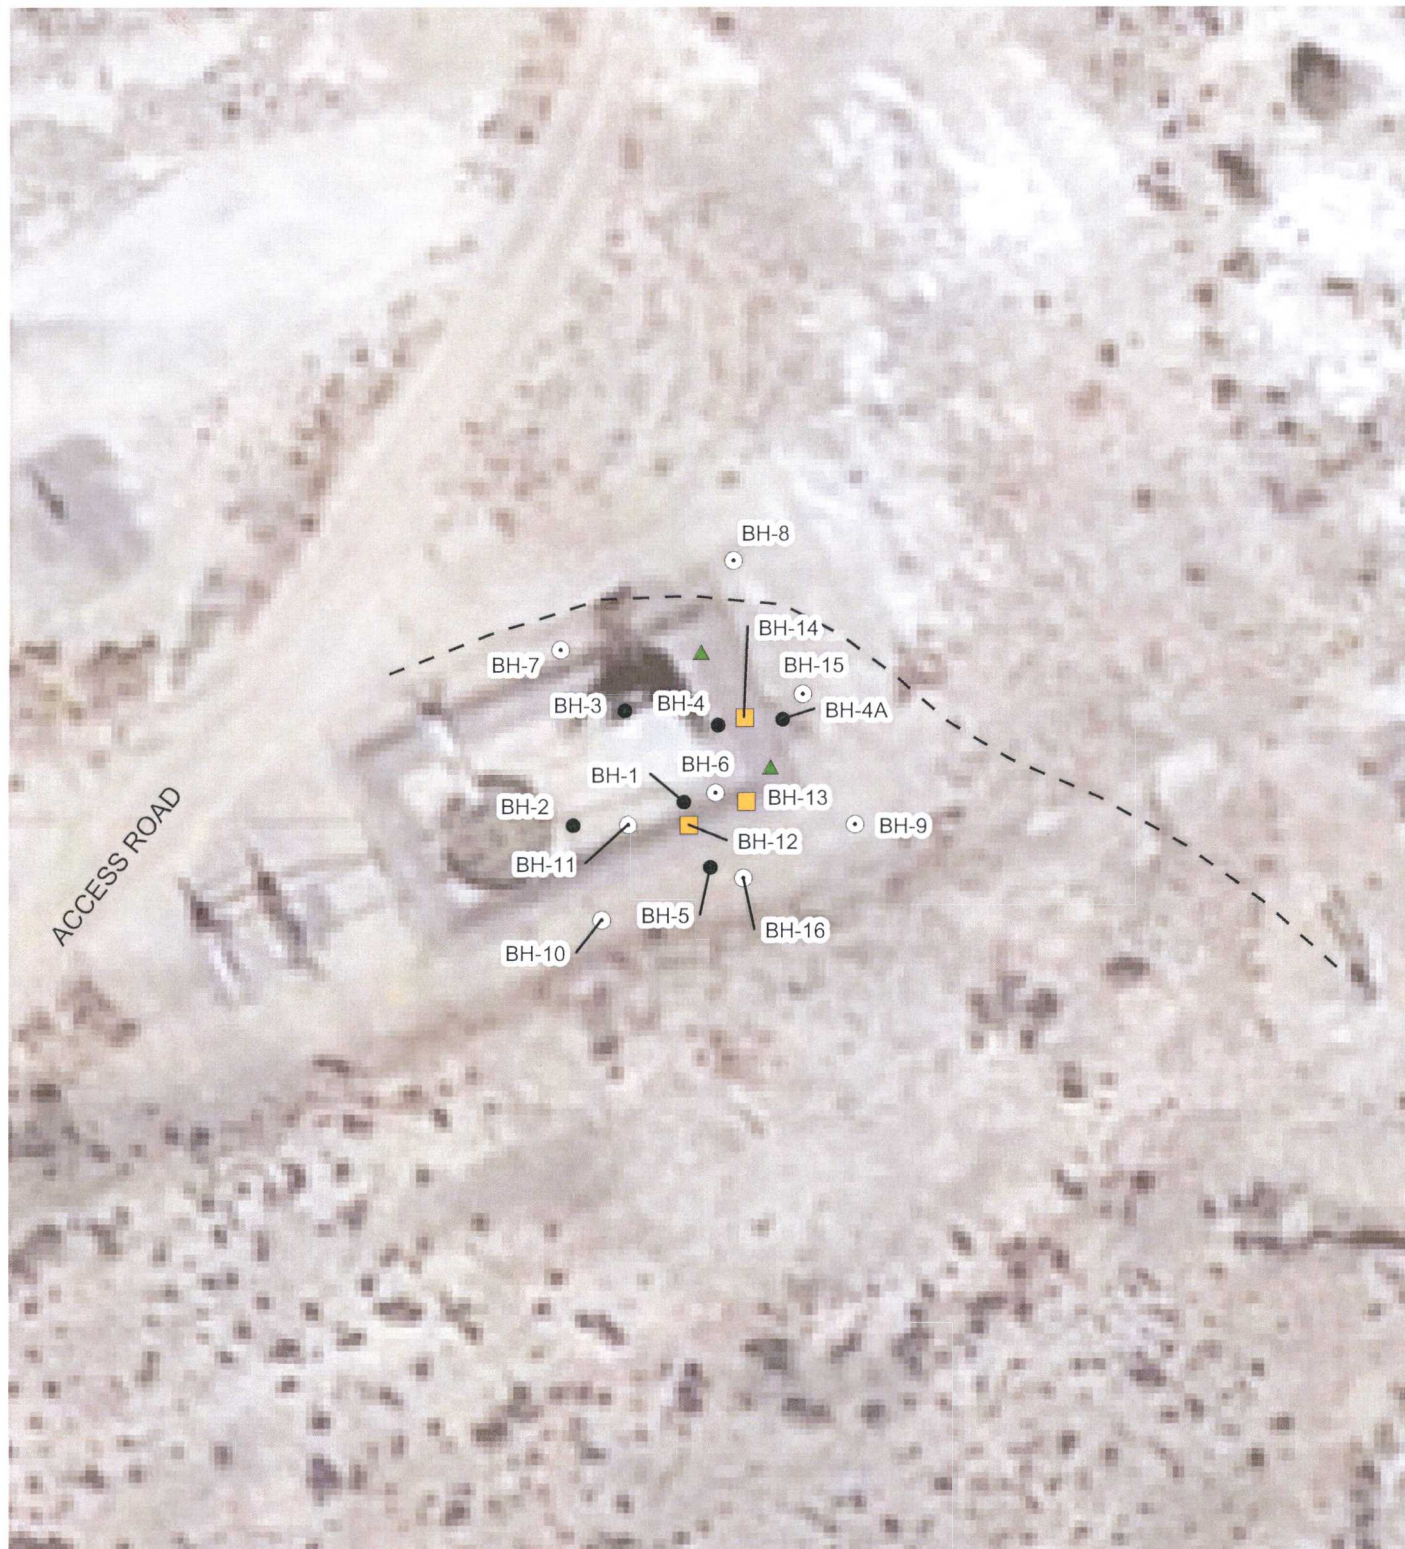
- HAND AUGER BOREHOLE
- ⊙ HOLLOW STEM AUGER
- SOIL VAPOR EXTRACTION WELL
- ▲ PROPOSED AIR SPARGE WELL
- - - ELECTRICAL LINE

During the June 2018 soil delineation event, soil borings BH-12, BH-13, and BH-14 were completed as potential soil vapor extraction (SVE) wells in anticipation of future remedial activities. The soil vapor extraction wells were completed with 2-inch diameter schedule 40 polyvinyl chloride (PVC) casing with 0.010" slotted screened intervals placed in the zone where field identified impacts were observed. Due to the limited area of impact and the isolated soil boring that exceeds the NMOCD remediation action level by a marginal amount, LTE recommends a multi-tiered, in-situ, passive SVE remediation approach.

LTE also proposes installing two additional temporary 1-inch PVC wells via hand auger to be utilized as bioventing wells. Ambient air from the portable air compressor will be directed via a manifold into the wells to introduce supplemental oxygen into the subsurface to promote biological activity and the biodegradation of recalcitrant hydrocarbon impacts. Indigenous aerobic bacterial activity is enhanced with the addition of oxygen and encourages the biodegradation of excess organic material, such as hydrocarbons, in an in-situ remediation method known as bioventing. Additionally, the bioventing wells will facilitate ambient air advection and optimize the SVE progress.

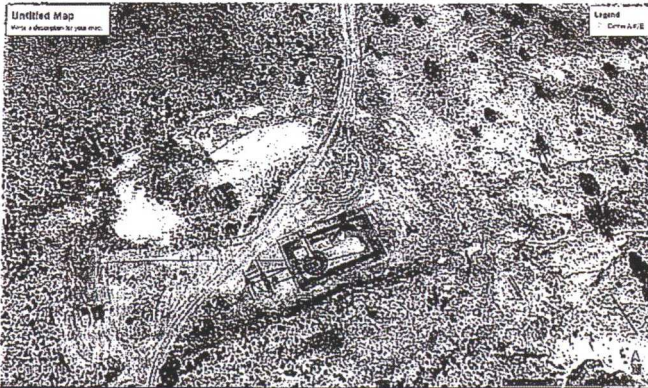
Penetration Resistance	Moisture Content	Vapor (ppm)	HC Staining?	Sample #	Depth (ft. bgs.)	Sample Run	Recovery	Soil/Rock Type	Lithology/Remarks	Well Completion
					0				ALREADY Removed	
					1					
					2					
	M	2654	Yes, black	SCOT BH-1 @ 3' 1150	3	2-3		SM	red/brown silty sand, low plasticity, non-cohesive	
		1592	"		4	5-4		SM	black stained sand intermixed	
	M	1069	NO		5	4-5		SC	brown clayey sand (>15% fines)	
	M	803	but strong HC odor		6	5-6		SC	medium plasticity, cohesive	
	M	684			7			SC	SAA w/ less fines + more sand	
					7				SAA	
	M	1195	HC odor		8	7-8		SM	reddish/brown silty sand, low plas. non-cohesive	
	M	1442	HC odor		9			SW-SM	brown well graded sand w/ silt low plas. non-cohesive	
	M	1183	HC odor		10			SW-SM	SAA	
	M	1328	HC odor		11			SW-SM	SAA	
	M	1958	Slight HC odor		12	11-12		SC	dark brown clayey sand, high pls, cohesive	
	M	2039	Slight HC odor	BH-1 @ 13' 1155	13	12-13		ML	dark brown sandy silt high pls, cohesive fissile claystone/siltstone

14					
					15				refusal @ 13.5'

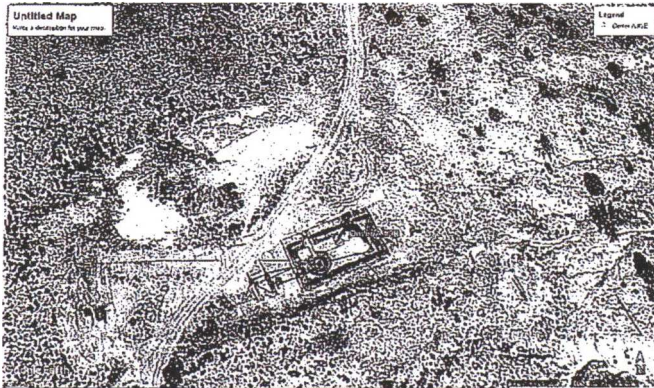
Penetration Resistance	Moisture Content	Vapor (ppm)	HC Staining?	Sample #	Depth (ft. bgs.)	Sample Run	Recovery	Soil/Rock Type	Lithology/Remarks	Well Completion
	M	4.1	NO		0	0-1		SM	brown silty sand, cohesive, low plas.	
					1					
	M	2.2	NO		2			CL	brown lean clay, cohesive, high plas.	
		2.1			3					
	M	2.1	NO		4			SM	brown silty sand, cohesive, med. plas.	
		2.4			5					
		1.4			6			SM-SU	light brown, well graded sand w/ silt	
		0.8			7				non-cohesive, non-plas.	
		1.2	NO		8				SAA	
	M	1.3			9				SAA	
		0.0			10				SAA	
		0.5			11				SAA w/ more fines	
	M	3.3	NO	BH-2 @ 12.5'	12			CL	brn/grey lean clay, cohesive, high plas.	
					13					
					14					
					15				refusal @ 12.5' silty stone

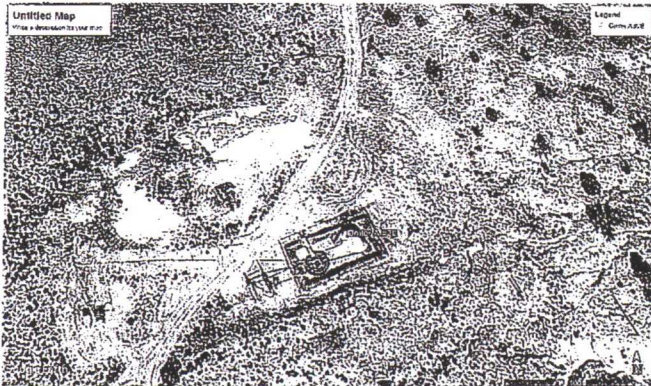
Penetration Resistance	Moisture Content	Vapor (ppm)	HC Staining?	Sample #	Depth (ft. bgs.)	Sample Run	Recovery	Soil/Rock Type	Lithology/Remarks	Well Completion
	M	17.4	degraded binder		0			CL	brown lean clay, cohesive, high plasticity	
					1					
					2					
		1629			3					
					4					
					5					
					6					
					7					
					8					
					9					
					10					
					11					
					12					
					13					
					14					
					15
