Release Notification

Site Name Chaco 23 08 03 1H and 2H	Site Type Oil well
Date Release Discovered: 8/11/2018	API# (if applicable) 30-045-35647 and 30-045-35646

Re: Chaco 2308 03 1H & 2H Remediation Activities

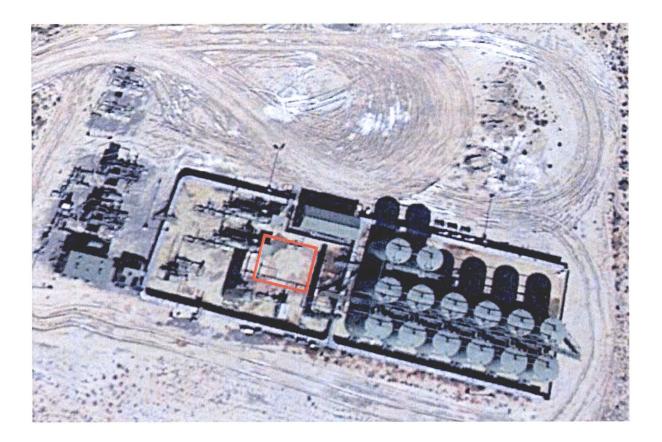
Thank you, Vanessa Fields Environmental Specialist Oil Conservation Division Energy, Minerals, & Natural Resources 1000 Rio Brazos, Aztec, NM 87410 (505)334-6178 ext 119 Cell: (505) 419-0463 vanessa.fields@state.nm.us Chaco 2308 03 1H and 2H Site Map

LOGOS Operating, LLC immediately shut in well. All contaminated soil was dug out and hauled to an approved remediation facility. There were 5 composite samples taken. One composite sample collected from each side wall and one from the bottom. All samples were analyzed for BTEX, Chlorides, GRO and DRO. All constituents came in under the Table I thresholds for \leq 100' for groundwater depth. Excavation area has been backfilled.
