### BP AMERICA PRODUCTION COMPANY SAN JUAN BASIN, NORTHWEST NEW MEXICO

#### **BELOW-GRADE TANK CLOSURE PLAN**

#### Gallegos Canyon Unit Con API No. 3004507805

#### Unit Letter K Section 26 T 29N R 12W

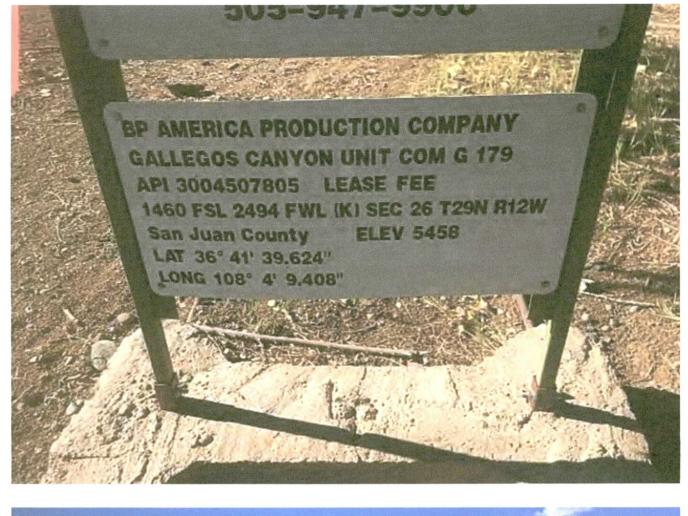
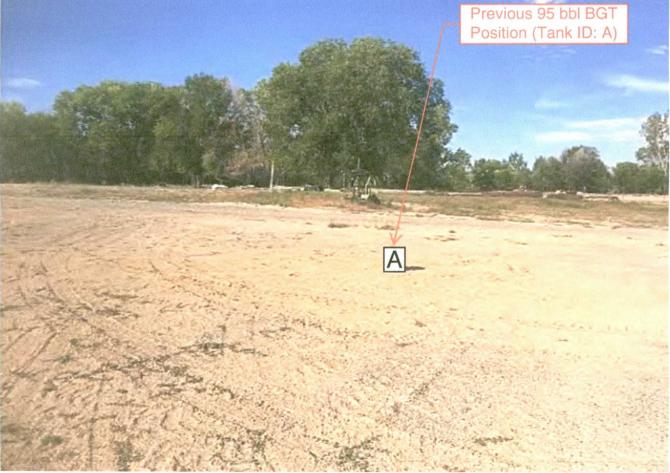
# Closure report on C-144 form is included including photos of reclamation completion.

# The area has been backfilled and BGT location's surface condition is clear. The location will be reclaimed when the well is plugged and abandoned.
