BELOW-GRADE TANK CLOSURE PLAN

GCU 211

API No. 3004511651

Unit Letter G Section 32 T 29N R 12W

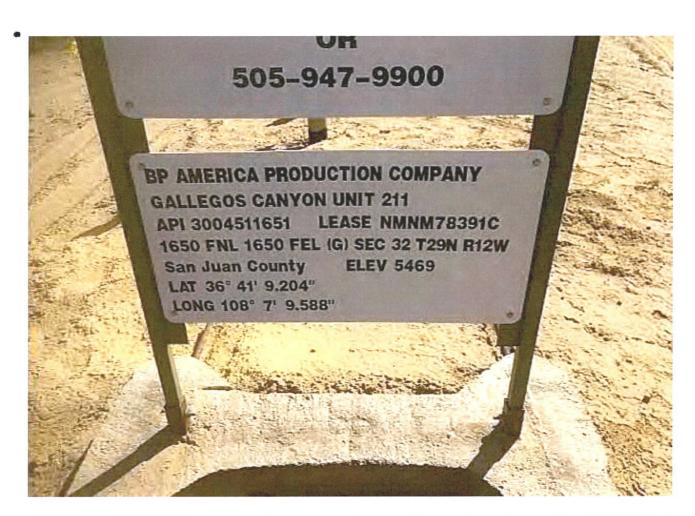
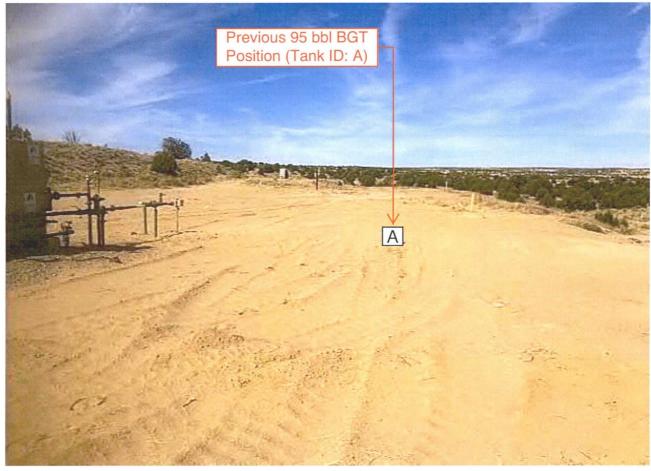
The area has been backfilled and BGT location's surface condition is clear. The location has been reclaimed as the well has been plugged and abandoned.

Closure report on C-144 form is included including photos of reclamation completion.
