BP AMERICA PRODUCTION COMPANY

SAN JUAN BASIN, NORTHWEST NEW MEXICO

BELOW-GRADE TANK CLOSURE PLAN

Riddle C LS # 2A - Tank ID: A API #: 3004522451 Unit Letter I, Section 30, T31N, R09W

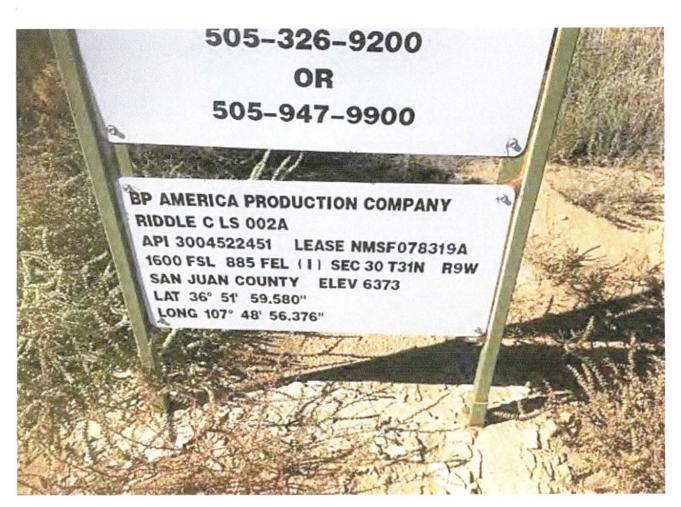
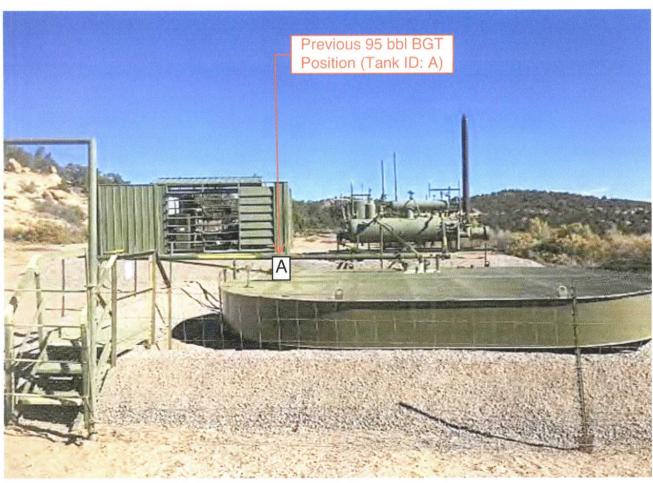
<u>Closure report on C-144 form is included & contains a photo of the reclamation completion.</u>
