BP AMERICA PRODUCTION COMPANY

BELOW-GRADE TANK CLOSURE PLAN

BLANCO #1A

API No. 3004523259

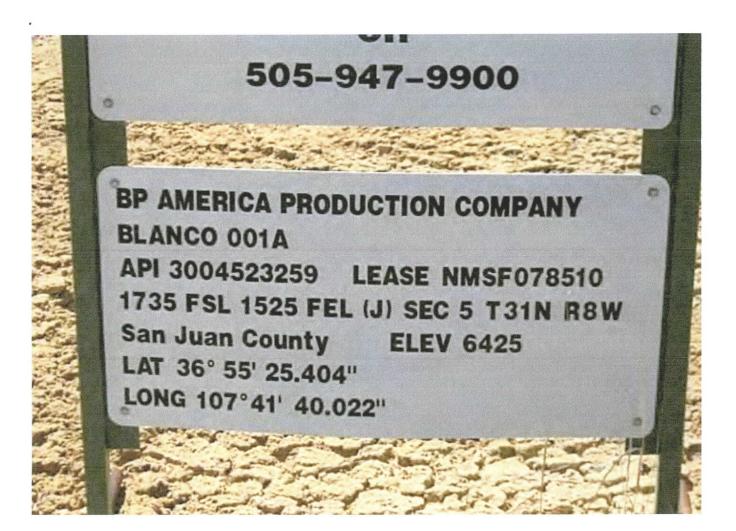
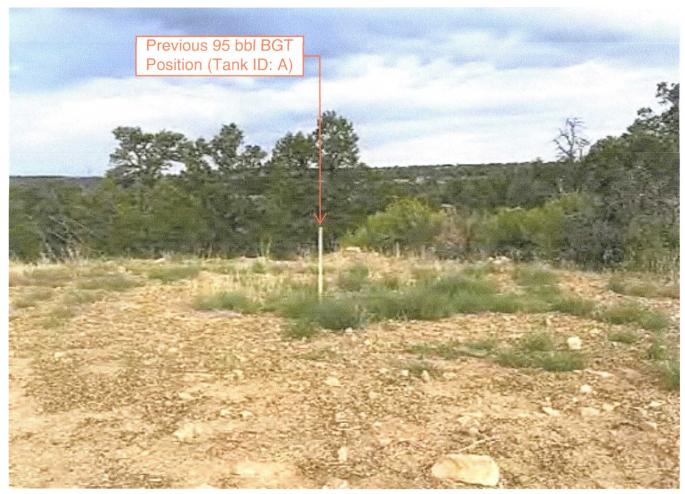
The area has been backfilled and BGT location's surface condition is clear. The location has been reclaimed.

Closure report on C-144 form is included including photos of reclamation completion.
