Pit, Below-Grade Tank, or  
Proposed Alternative Method Permit or Closure Plan Application

1.  
Operator: BP America Production Company OGRID #: 778  
Address: 380 North Airport Road, Durango, CO 81303  
Facility or well name: GCU 211E  
API Number: 3004524173 OCD Permit Number: \_\_\_\_\_  
U/L or Qtr/Qtr C Section 32 Township 29N Range 12W County: San Juan  
Center of Proposed Design: Latitude 36.68816 Longitude -108.12501 NAD83  
Surface Owner: ☐ Federal ☐ State ☒ Private ☐ Tribal Trust or Indian Allotment

**GCU 211E**

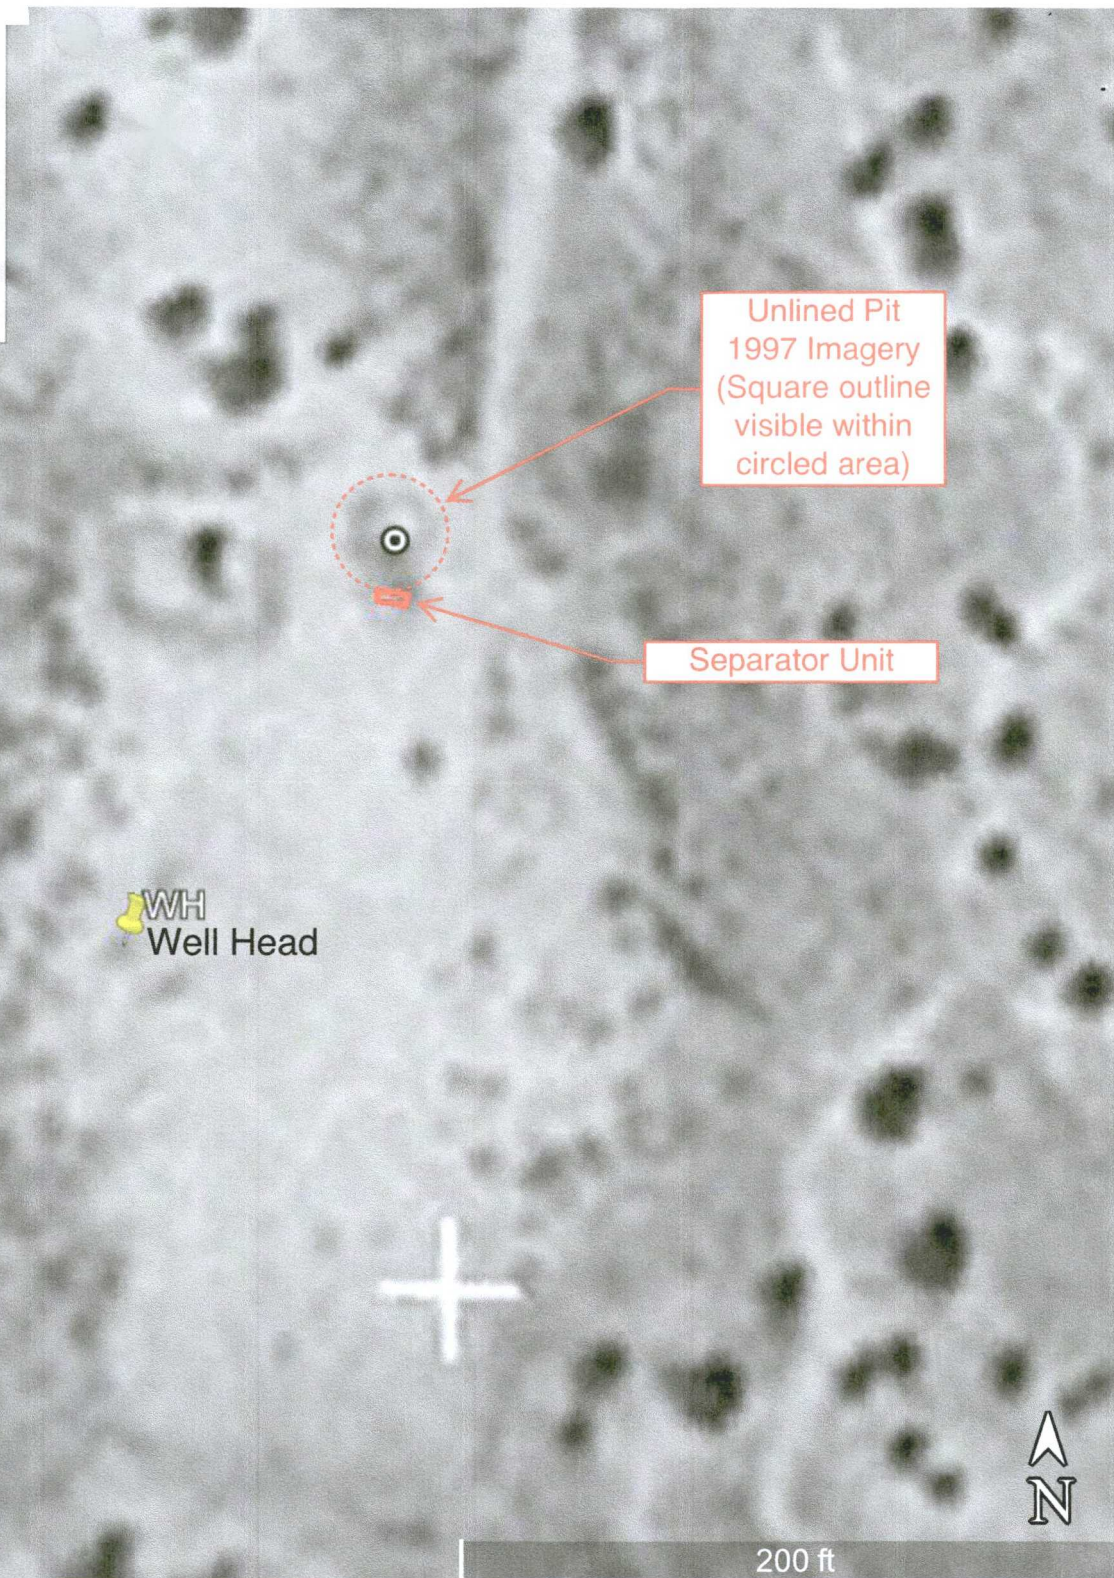
Imagery date: 1997 Historical  
WH GPS Coord.: 36.687799,-108.125342 - 2018 Google  
BGT GPS Coord.: 36.688163,-108.125036 - 2018 Google

(C) Section 32, T29N, R12W  
API #: 3004524173

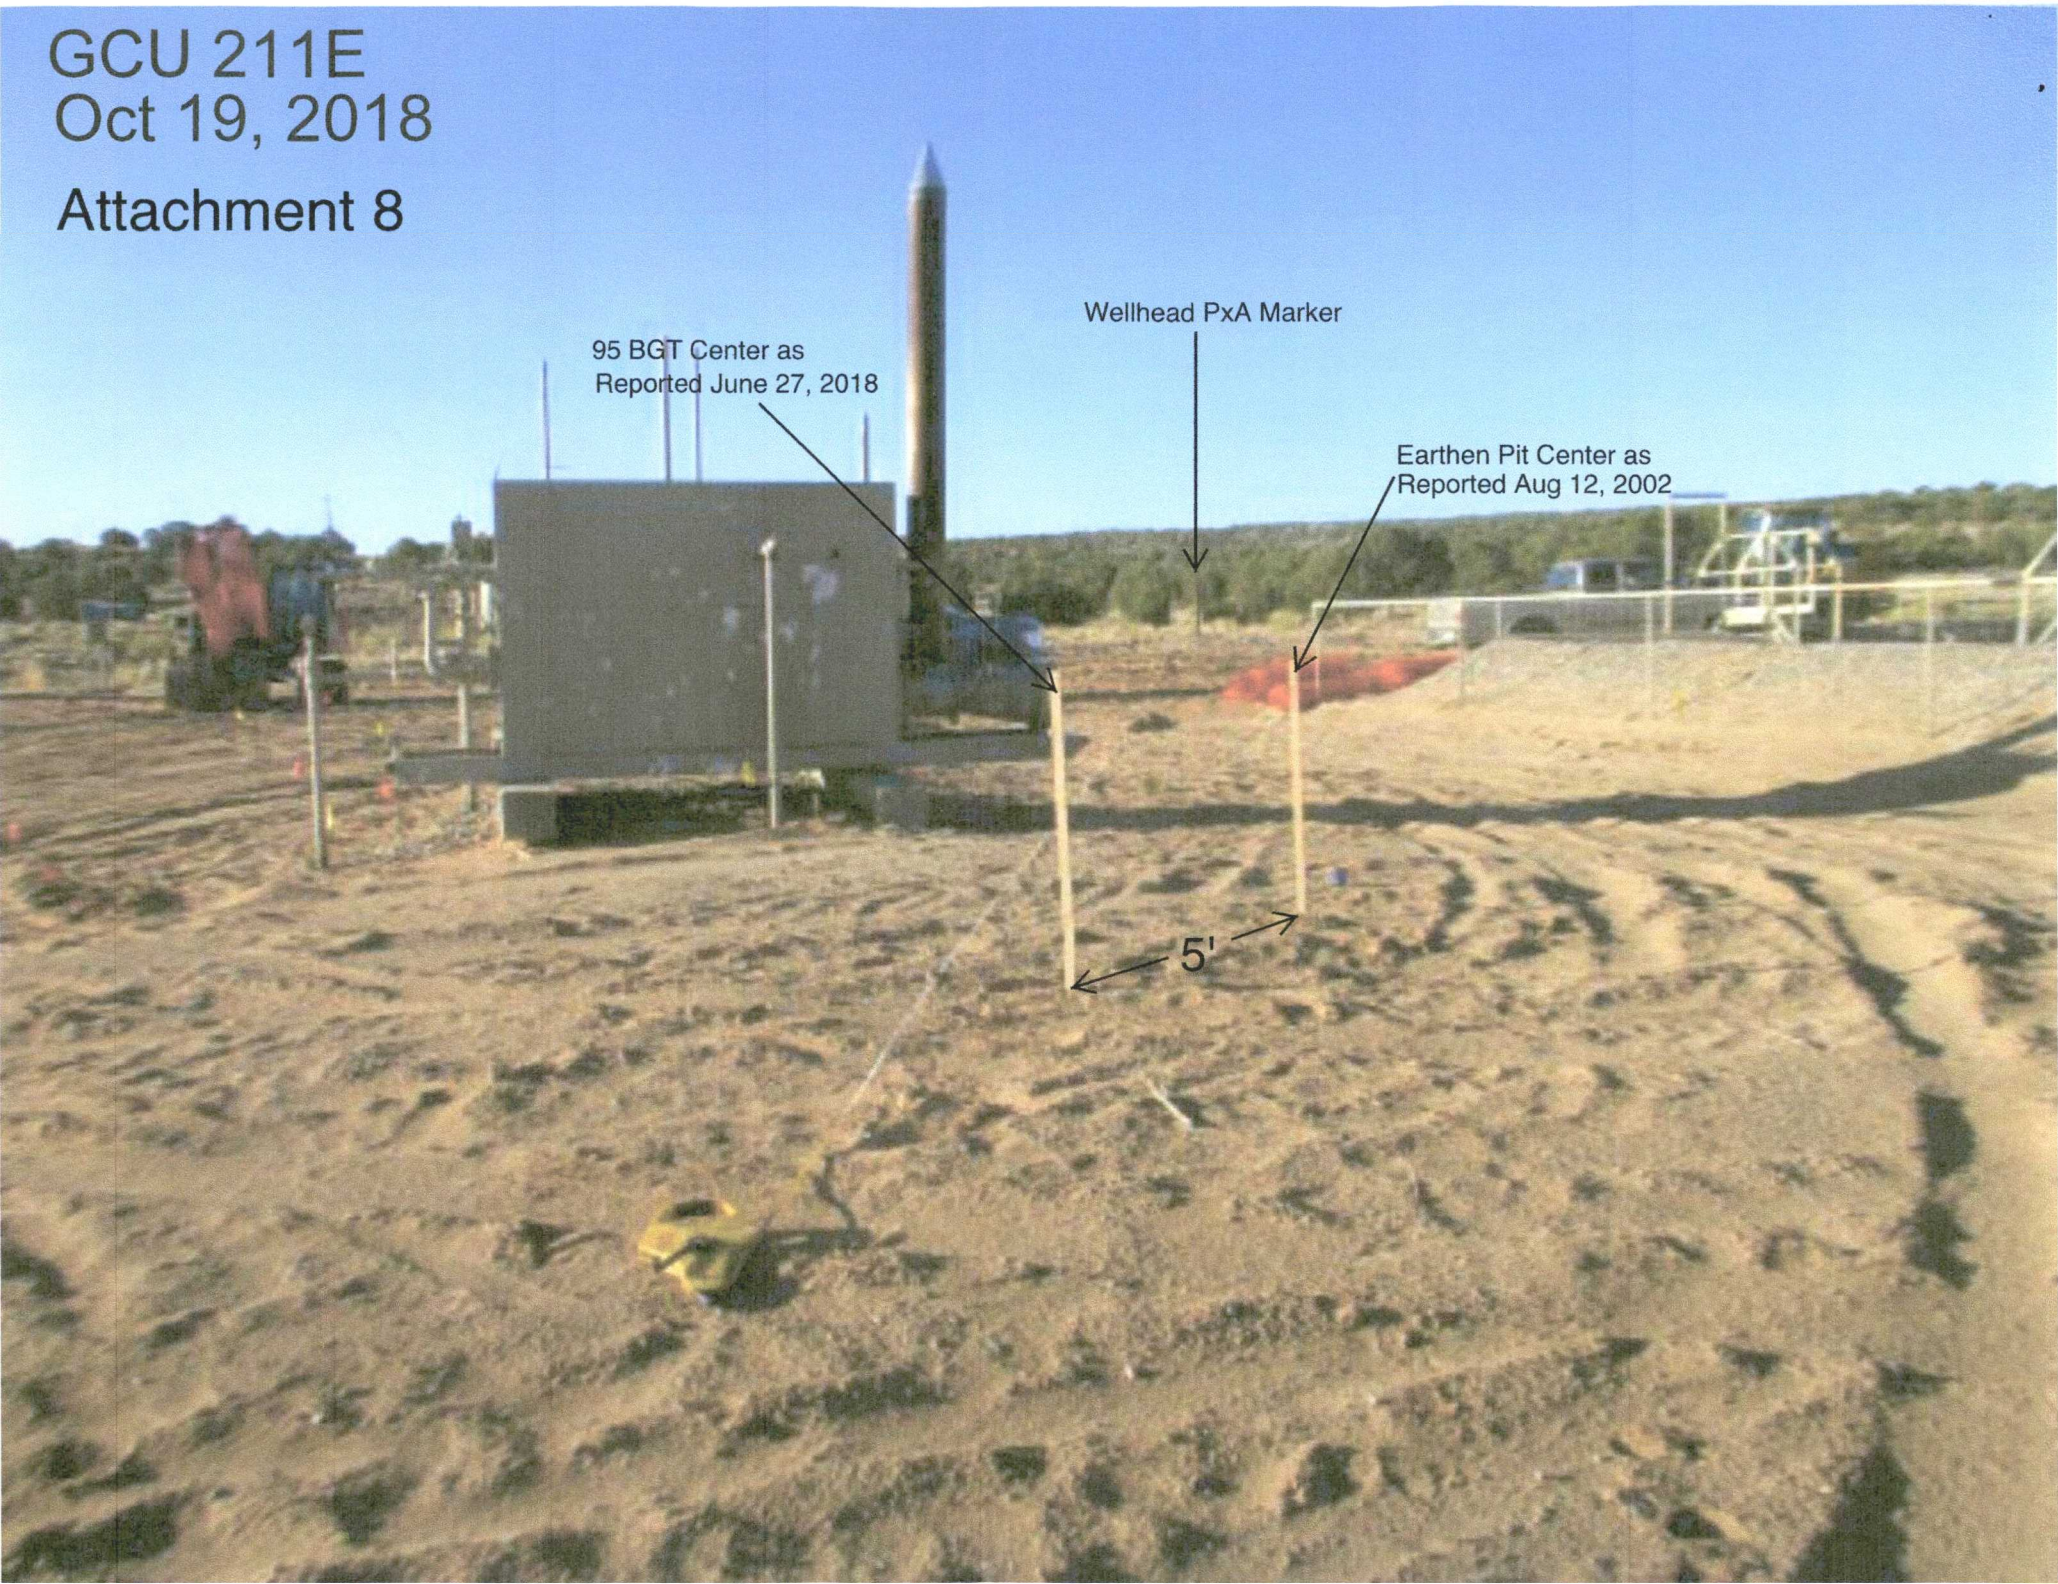
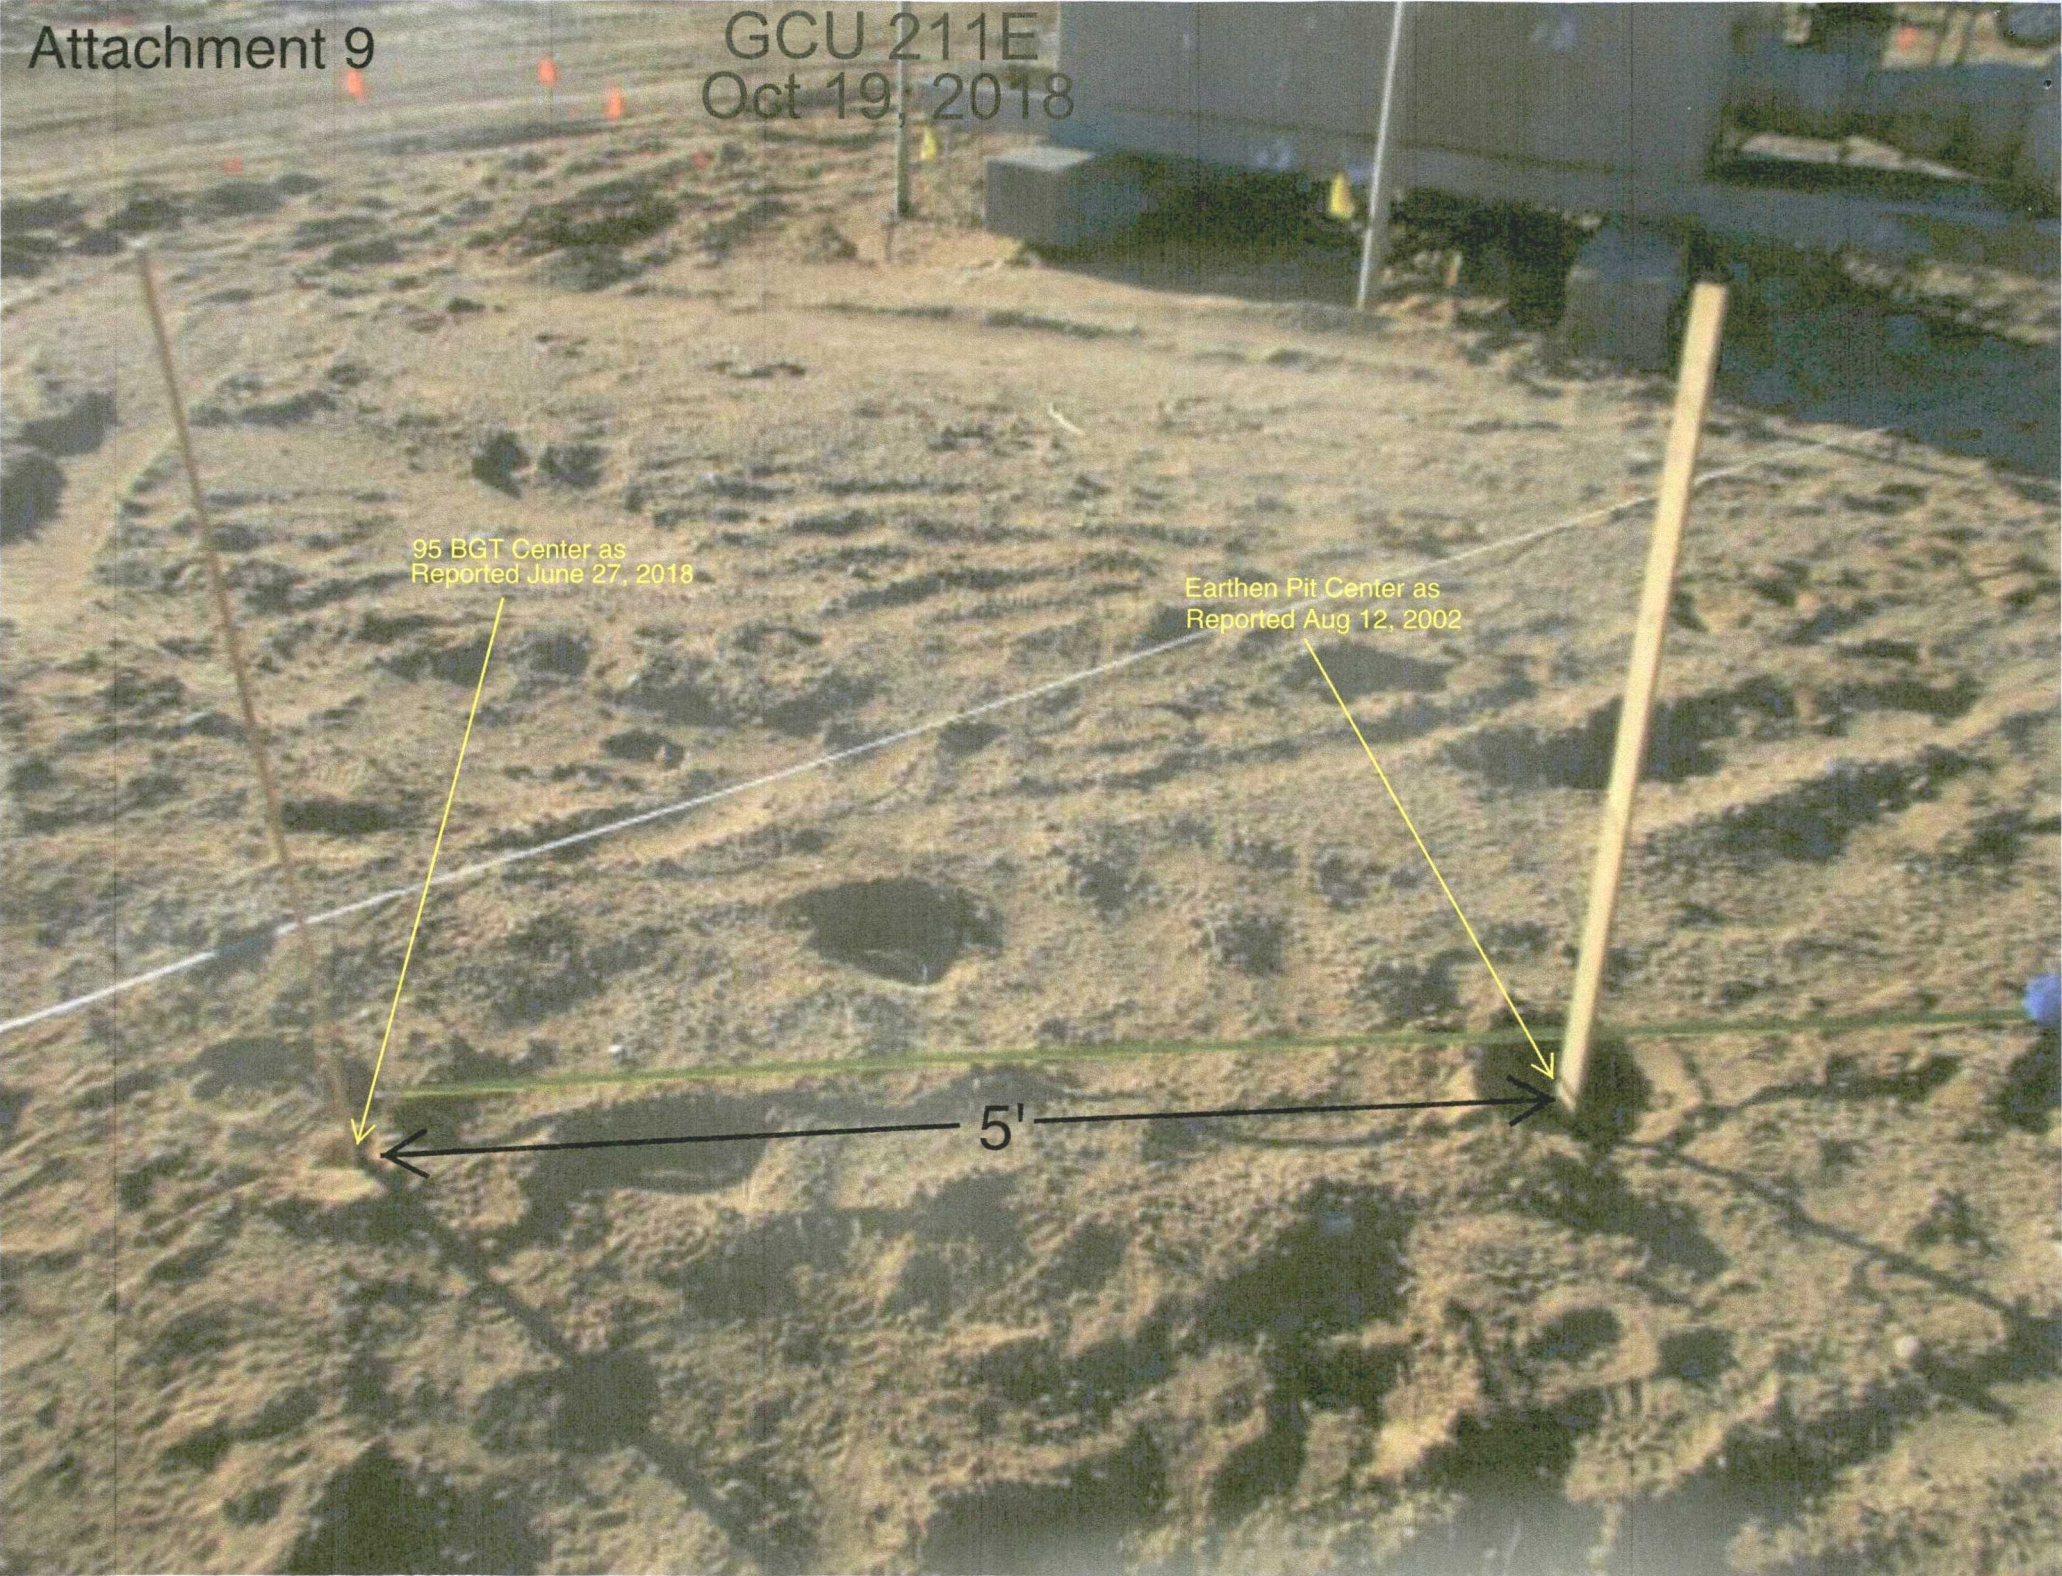
Attachment 8: October 19, 2018 - photograph of current site conditions at the separator. The relative positions of the previous unlined pit closed out in August 2002 and the 95 BGT closed out in June 2018 are indicated. It is evident that the 95 BGT was placed in the depression of the previous unlined pit.

Earthen Pit Center as  
Reported Aug 12, 2002

95 BGT Center as  
Reported June 27, 2018
