Release Notification

**RE: Closure Request
Rosa UT 272A
Incident Number # NCS1828940855
LOGOS Resources II, LLC
Rio Arriba County, New Mexico**

FIGURE 1
SITE LOCATION MAP
ROSA UT 272A RELEASE RESPONSE
RIO ARRIBA COUNTY, NEW MEXICO

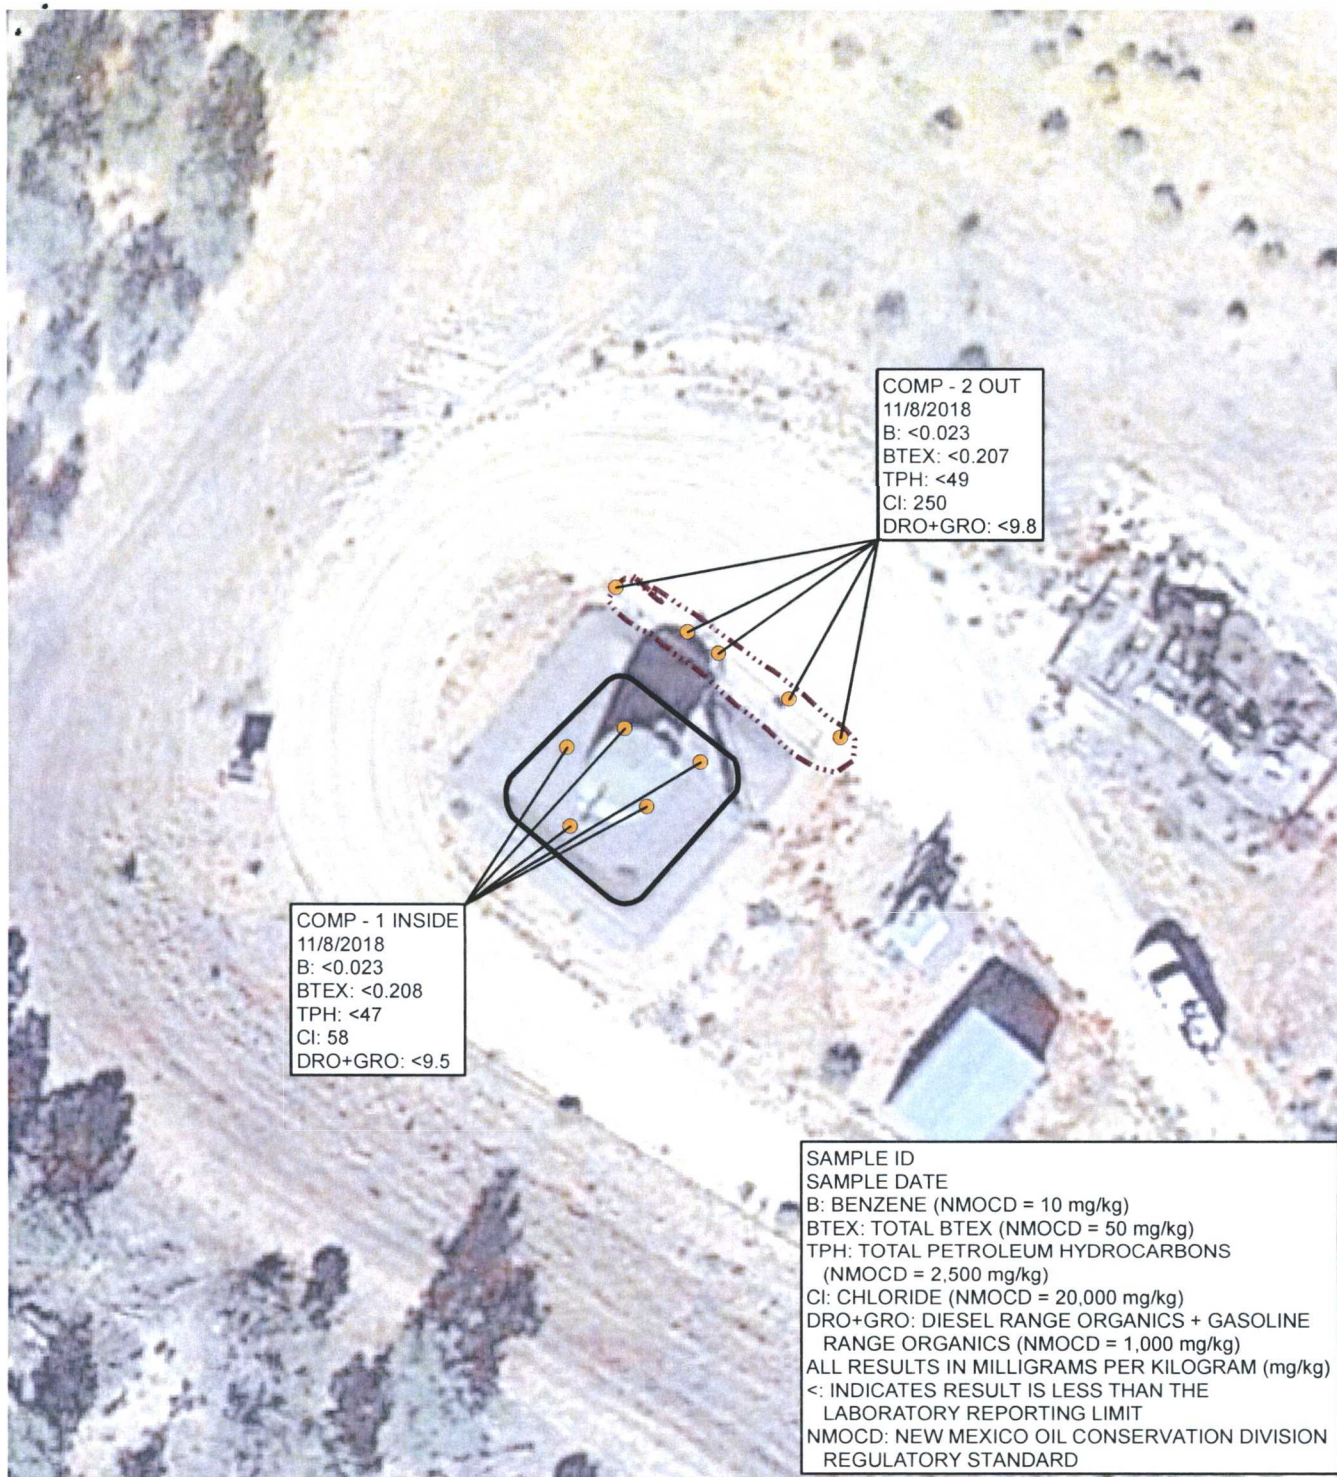
FIGURE 2
 SITE MAP
 ROSA UT 272A RELEASE RESPONSE
 RIO ARriba COUNTY, NEW MEXICO

On October 18, 2018, an LTE scientist collected two composite soil samples (COMP 1 - Inside and COMP 2 - Out) to confirm that impacted soil has been remediated and remaining soil is below NMOCD site-specific closure criteria. Each composite sample consisted of five discrete samples. Discrete samples collected outside the containment (COMP 2 – Out) were collected from a depth of 0 to 0.5 feet bgs. Discrete samples collected inside the containment (COMP 1 – Inside) were collected from a depth of 0.5 feet bgs to ensure soil was collected from beneath the newly applied gypsum and gravel. The soil sample locations, depicted on Figure 2, were based on information provided in the initial Form C-141 and field observations. No hydrocarbon odor was observed in the vicinity of the soil samples. Soil samples were screened for volatile aromatic hydrocarbons using a photo-ionization detector (PID) equipped with a 10.6 electron volt lamp. The soil samples were collected and placed directly into pre-cleaned glass jars, labeled with location, date, time, sampler, method of analysis, and immediately placed on ice. The soil samples were shipped at 4 degrees Celsius (°C) under strict chain-of-custody procedures to Hall Environmental Analysis Laboratory (Hall) in Albuquerque, New Mexico, for analysis of BTEX by United States Environmental Protection Agency (USEPA) Method 8021B, TPH-gasoline range organics (GRO), TPH-diesel range organics (DRO), and TPH-oil range organics (ORO) by USEPA Method 8015M/D, and chloride by USEPA Method 300.

- COMPOSITE SOIL SAMPLE
- BERM AREA
- SPILL EXTENT OUTSIDE BERM

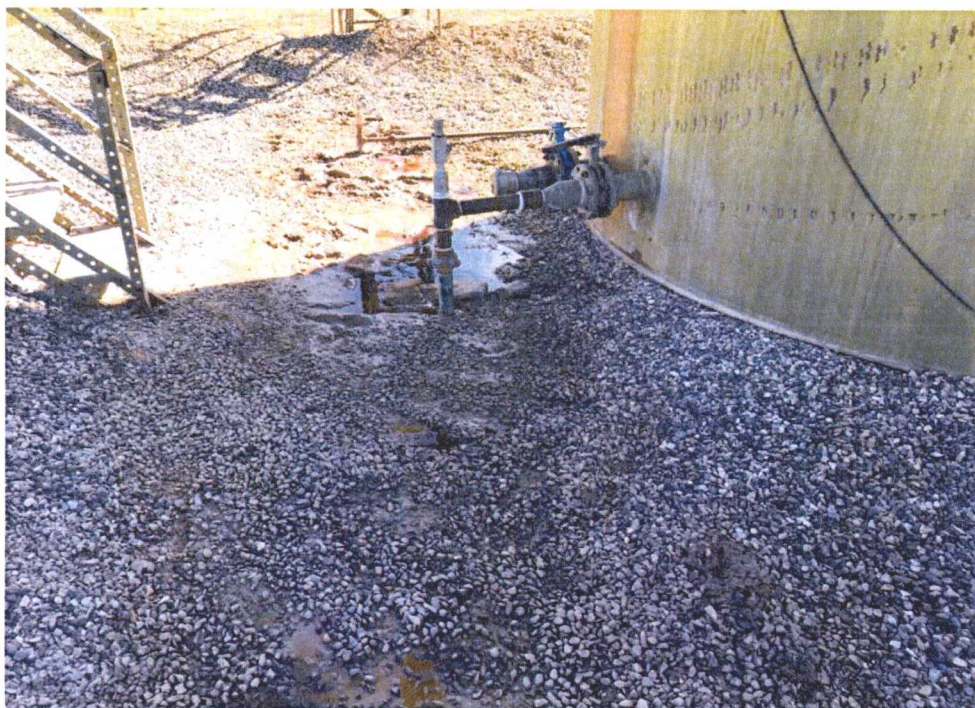
On October 1, 2018, the on-site produced water tank was overfilled, causing the release of approximately 14.4 barrels (bbls) of produced water into the unlined secondary containment. The fluid subsequently permeated through the containment and pooled outside the berm on the north side of the tank. A vacuum truck was dispatched to the Site and free-standing liquid was recovered; approximately 14 bbls of produced water were recovered. Logos reported the release to the NMOCD on a Release Notification and Corrective Action Form C-141 on October 16, 2018 and was assigned Incident Number #NCS1828940855 (Attachment 1). Logos scraped surficial soil and gravel within the secondary containment and applied gypsum and new gravel within the containment. It is estimated that a total of 5.7 cubic yards of gravel and soil were removed from the secondary containment.

Photograph 1: View of release area inside of berm.

Confirmation soil sampling activities indicate that BTEX, combined GRO and DRO, TPH, and chloride concentrations are compliant with NMOCD site-specific remediation action levels. Logos requests no further action for this release. An updated NMOCD Form C-141 is included as Attachment 1.

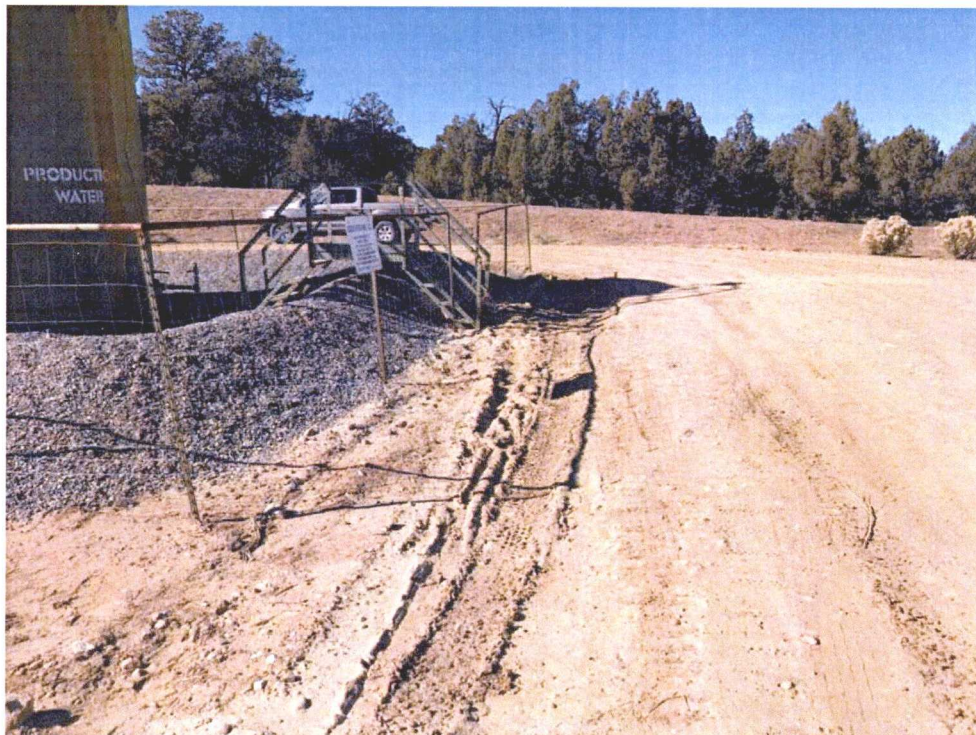
Photograph 2: View release area outside of berm.
