**Pit, Below-Grade Tank, or  
Proposed Alternative Method Permit or Closure Plan Application**

**RE: Below Grade Tank Release Final Excavation Report  
Jake Johnson #1  
API #3004527167  
San Juan County, New Mexico**

**Jake Johnson #1**  
**API #3004527167**  
**Below Grade Tank October 2018 Release**

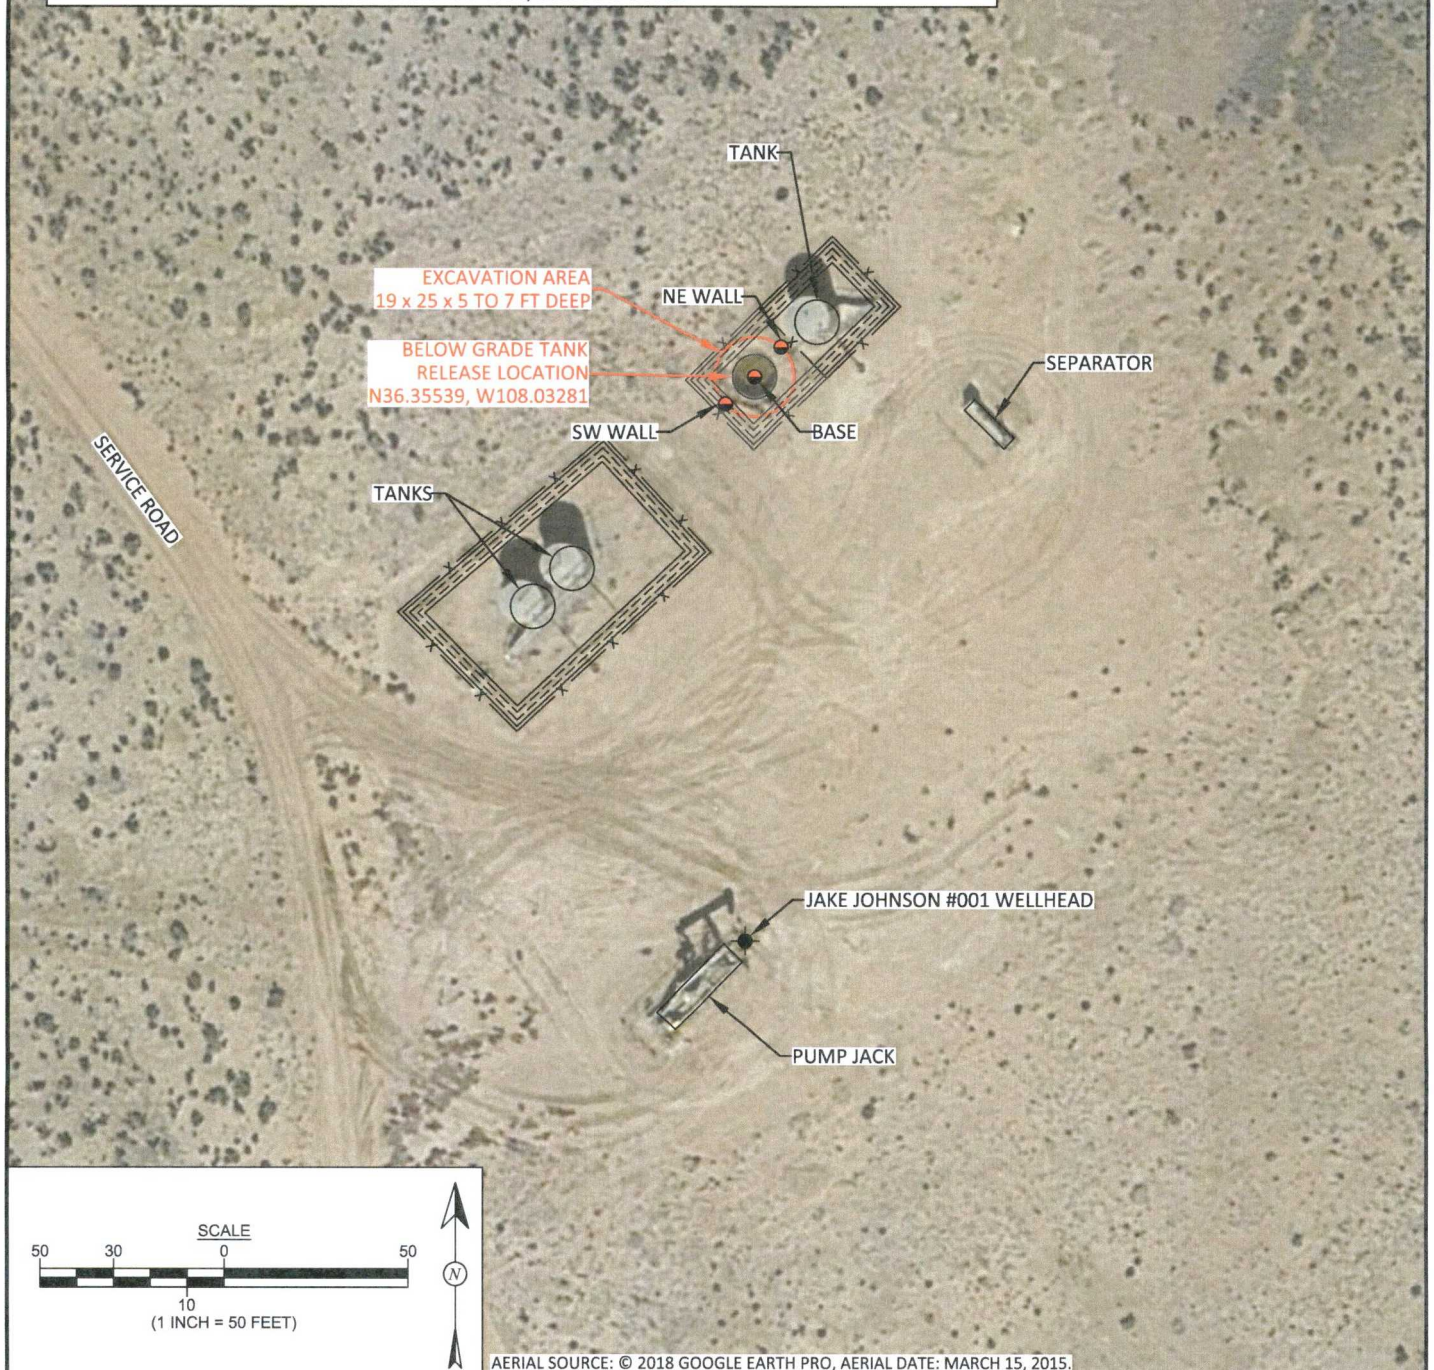
**FIGURE 2**

SAMPLES WERE ANALYZED PER USEPA METHOD 8021, 8015 AND 300.0.

**AERIAL SITE LOCATION MAP  
BELOW GRADE TANK RELEASE  
SOIL CONFIRMATION, OCTOBER 2018**

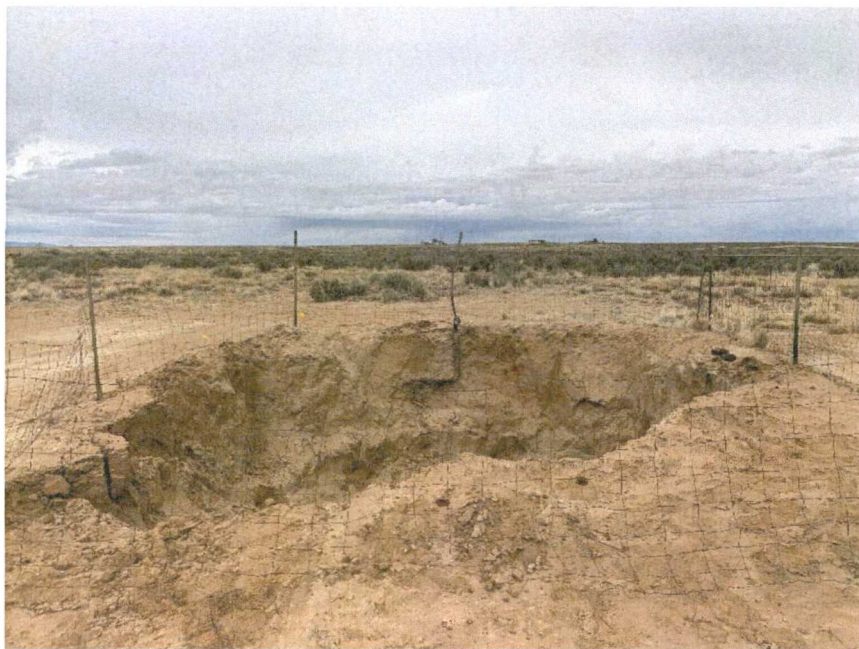
While cleaning out the soil around the below grade waste tank to provide visibility to the base, contaminated soil was observed. The cause of the release appears to be loss of integrity by corrosion.

Photo 2: BGT excavation extents.

The excavation was backfilled with approximately 80 cubic yards of clean soil on November 5, 2018; photographs of the completed excavation are provided in the attached photo log. Based on the final laboratory analytical results of the excavation no further work is recommended.

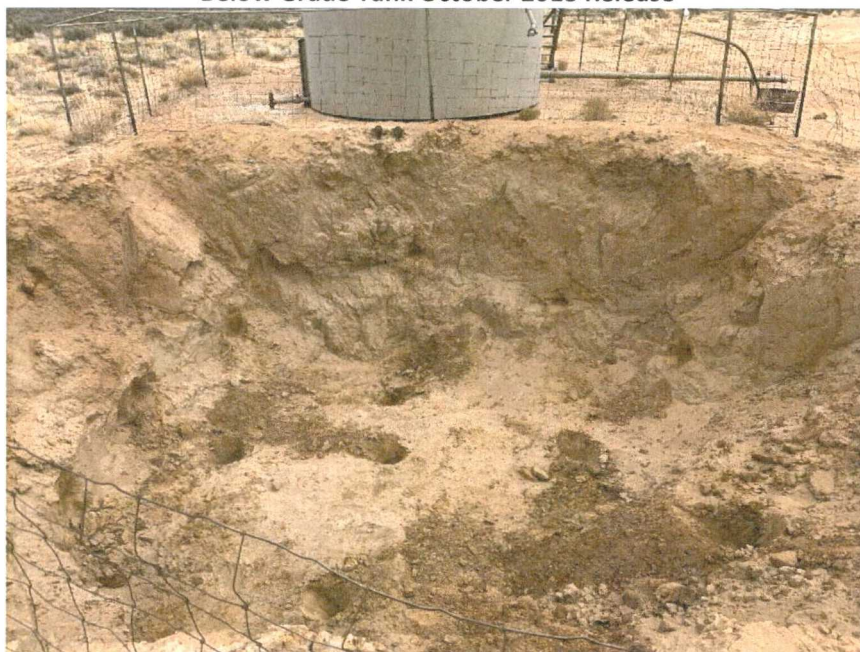
Photo 3: The BGT sample locations.

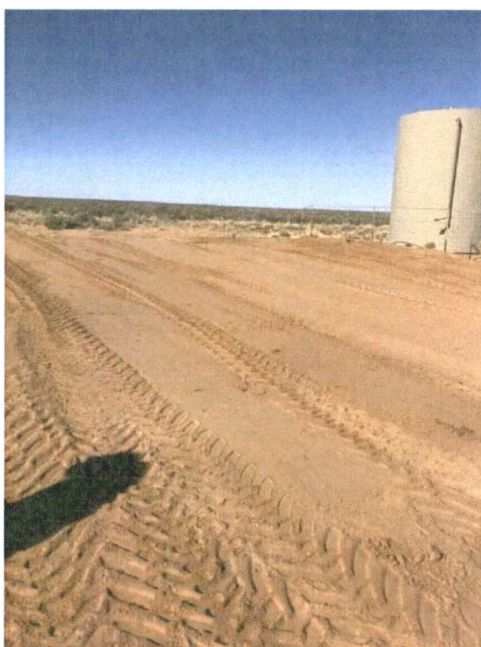
Photo 4: Reclamation completion.
