Release Notification

Site Name	Canyon Largo Unit #328	Site Type	Oil well
Date Release Discovered	9/17/18	API# (if applicable)	30-039-23266

Project Name/Location: CLU 328

Huntington Energy, L.L.C.
Canyon Largo Unit #328 As Built
API#: 30-039-23266 NMSF078874
NW/4, Sec 5-24N-6W, Rio Arriba Co., NM

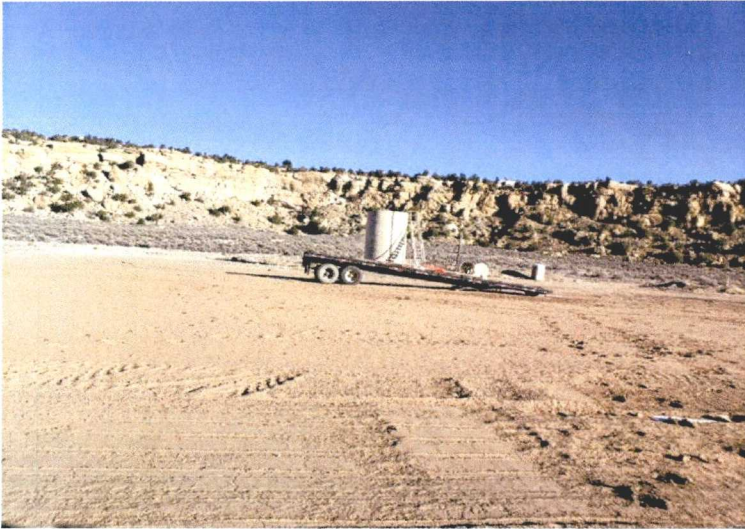
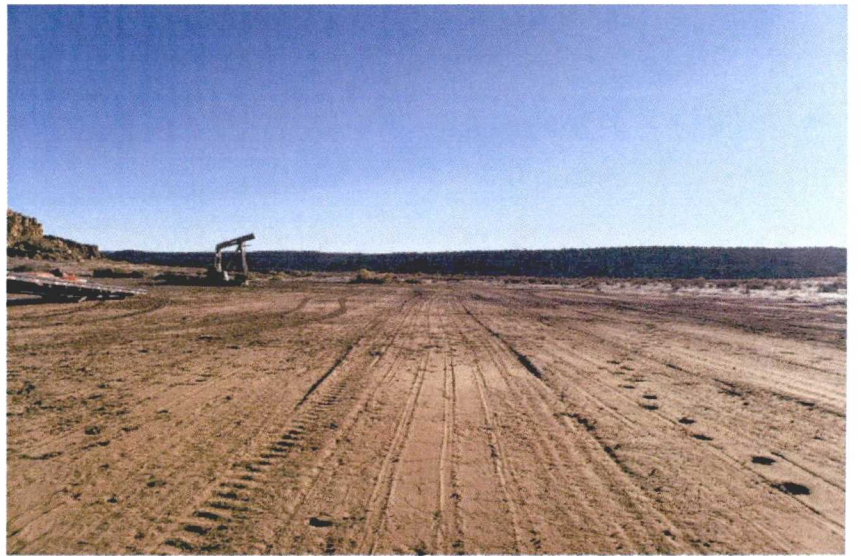
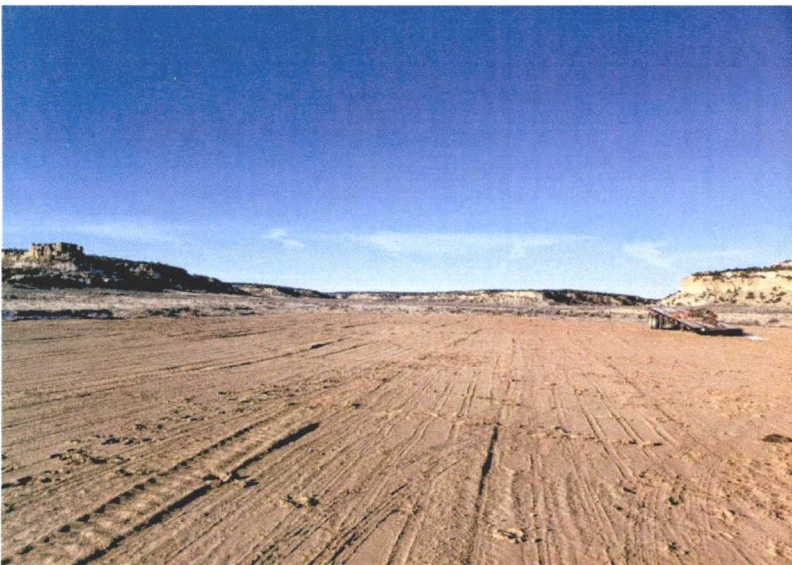
BGT CLOUSRE: 11/27/18

RIO ARRIBA CO., NM

On September 17, 2018, Ron Lackey, Huntington Energy's Field Supervisor, contacted Vanessa Fields with the NMOCD about finding contaminated soil around the BGT when crews began work on the location. On September 18th, work began to dig up and haul out the soil. A liner was also used to pile the contaminated soil. This work continued until October 9th, when soil samples were taken. This soil sample test failed, so work continued. Heavy equipment and many trucks were used to send contaminated soil to IEI or Envirotech. A log of cubic yards of dirt and dates is attached to the C-141 report. Clean soil was also brought in during the dig. On November 7, 2018, another soil sample was taken, and passed. Huntington Energy emailed a copy of the final results and were given approval from Vanessa Fields to fill in the hole. The hole was approximately 60' wide X 80' long X 40' deep. It was not dug as a rectangle, but a triangular prism. The total amount of contaminated soil taken out of the hole was 2,980 cu yds.
