Release Notification

Site Name Arviso #1	Site Type Well
Date Release Discovered 9/28/2018	API#30-045-33943

Arviso #1 Spill Map

Spill Remediation Plan

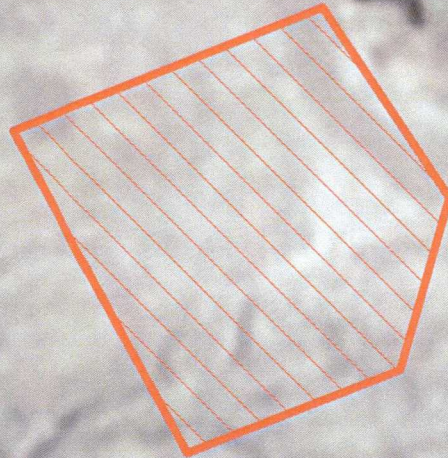
Arviso #1: Area To Be Ripped

1. Rip the pad in the affected area. The soil on the pad is a type of clay and raking in gypsum has not proven to be effective. By ripping the 50' x 50' square that was affected we will get better results when treating the spill with gypsum. Dugan will not be mixing the contaminated soil with clean soil. Please see map titled: Arviso #1: Area to be ripped.

2. Dugan will apply gypsum as needed to remove the chlorides from the soil.
3. The affected area will be sampled on a monthly basis, but no later than the 15th of every month, until samples prove to be acceptable.
