Release Notification

Site Name Keeling Federal #1	Site Type Oil Well
Date Release Discovered 1:05 PM 9/26/2018	API# (if applicable) 30-045-05299

Closure

Keeling #1 Sampling Events

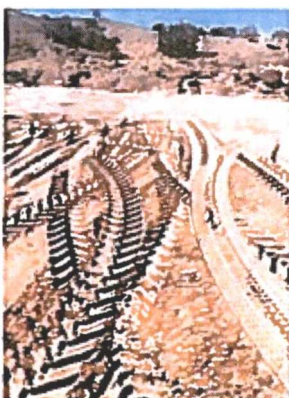
Photo of water spill area now back-filled

Work Detail: 3 D Services went to location on 11/7/18. Backfilled hole #1, which was water spill. Will backfill fill hole #2 in AM (which was small oil spill). Start digging hole #3, hauled 2 loads clean dirt and hauled out 2 loads contaminated to Envirotech Land Farm. (S. Calkins)
