Pit, Closed-Loop System, Below-Grade Tank, or
Proposed Alternative Method Permit or Closure Plan Application

BELOW-GRADE TANK CLOSURE PLAN

Tank Mountain B # 1S – Tank ID: A

API #: 3004531431

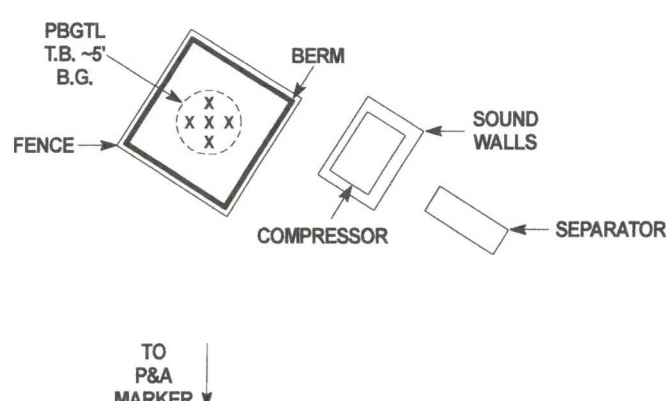
SOIL DESCRIPTION: SOIL TYPE: SAND / SILTY SAND / SILT SILTY CLAY / CLAY / GRAVEL / OTHER SOIL COLOR: MODERATE BROWN COHESION (ALL OTHERS): NON COHESIVE / SLIGHTLY COHESIVE / COHESIVE / HIGHLY COHESIVE CONSISTENCY (NON COHESIVE SOILS): LOOSE / FIRM / DENSE / VERY DENSE MOISTURE: DRY / SLIGHTLY MOIST / MOIST / WET / SATURATED / SUPER SATURATED SAMPLE TYPE: GRAB / COMPOSITE - # OF PTS. 5 DISCOLORATION/STAINING OBSERVED: YES NO EXPLANATION - PLASTICITY (CLAYS): NON PLASTIC / SLIGHTLY PLASTIC COHESIVE / MEDIUM PLASTIC / HIGHLY PLASTIC DENSITY (COHESIVE CLAYS & SILTS): SOFT FIRM / STIFF / VERY STIFF / HARD HC ODOR DETECTED: YES NO EXPLANATION - ANY AREAS DISPLAYING WETNESS: YES NO EXPLANATION -		
SITE OBSERVATIONS: LOST INTEGRITY OF EQUIPMENT: YES NO EXPLANATION - APPARENT EVIDENCE OF A RELEASE OBSERVED AND/OR OCCURRED: YES NO EXPLANATION: EQUIPMENT SET OVER RECLAIMED AREA: YES NO EXPLANATION - OTHER: NMOC D OR BLM REPS. NOT PRESENT TO WITNESS CONFIRMATION SAMPLING. GAS WELL IS PLUGGED & ABANDONED (P&A).

EXCAVATION DIMENSION ESTIMATION: NA ft. X NA ft. X NA ft. EXCAVATION ESTIMATION (Cubic Yards): NA DEPTH TO GROUNDWATER: > 100' NEAREST WATER SOURCE: > 1,000' NEAREST SURFACE WATER: 300' < x < 1,000' NMOC D TPH CLOSURE STD: 2,500 ppm		
SITE SKETCH BGT Located: off / on site PLOT PLAN circle: attached

MISCELL. NOTES PO #: 4301004787 REF #: VID: PJ #: Permit date(s): 06/02/10 OCD Appr. date(s): 05/02/16 Tank ID A OVM = Organic Vapor Meter ppm = parts per million BGT Sidewalls Visible: Y / (N) BGT Sidewalls Visible: Y / N BGT Sidewalls Visible: Y / N Magnetic declination: 10° E		
NOTES: BGT = BELOW-GRADE TANK; E.D. = EXCAVATION DEPRESSION; B.G. = BELOW GRADE; B = BELOW; T.H. = TEST HOLE; ~ = APPROX.; W.H. = WELL HEAD; T.B. = TANK BOTTOM; PBGTL = PREVIOUS BELOW-GRADE TANK LOCATION; SPD = SAMPLE POINT DESIGNATION; R.W. = RETAINING WALL; NA = NOT APPLICABLE OR NOT AVAILABLE; SW - SINGLE WALL; DW - DOUBLE WALL; SB - SINGLE BOTTOM; DB - DOUBLE BOTTOM. NOTES: GOOGLE EARTH IMAGERY DATE: 10/5/2016. ONSITE: 11/20/18
