Incident ID	NCS1903152646
District RP	
Facility ID	FCS143633K40
Application ID	32P-1021

Release Notification

Site Name San Juan 10-2 Water line (Near SJ 32-8 242A)	Site Type Pipeline
Date Release Discovered 1/14/2019 @ 2:30pm	API#

Pipeline leak near 32-8 242A

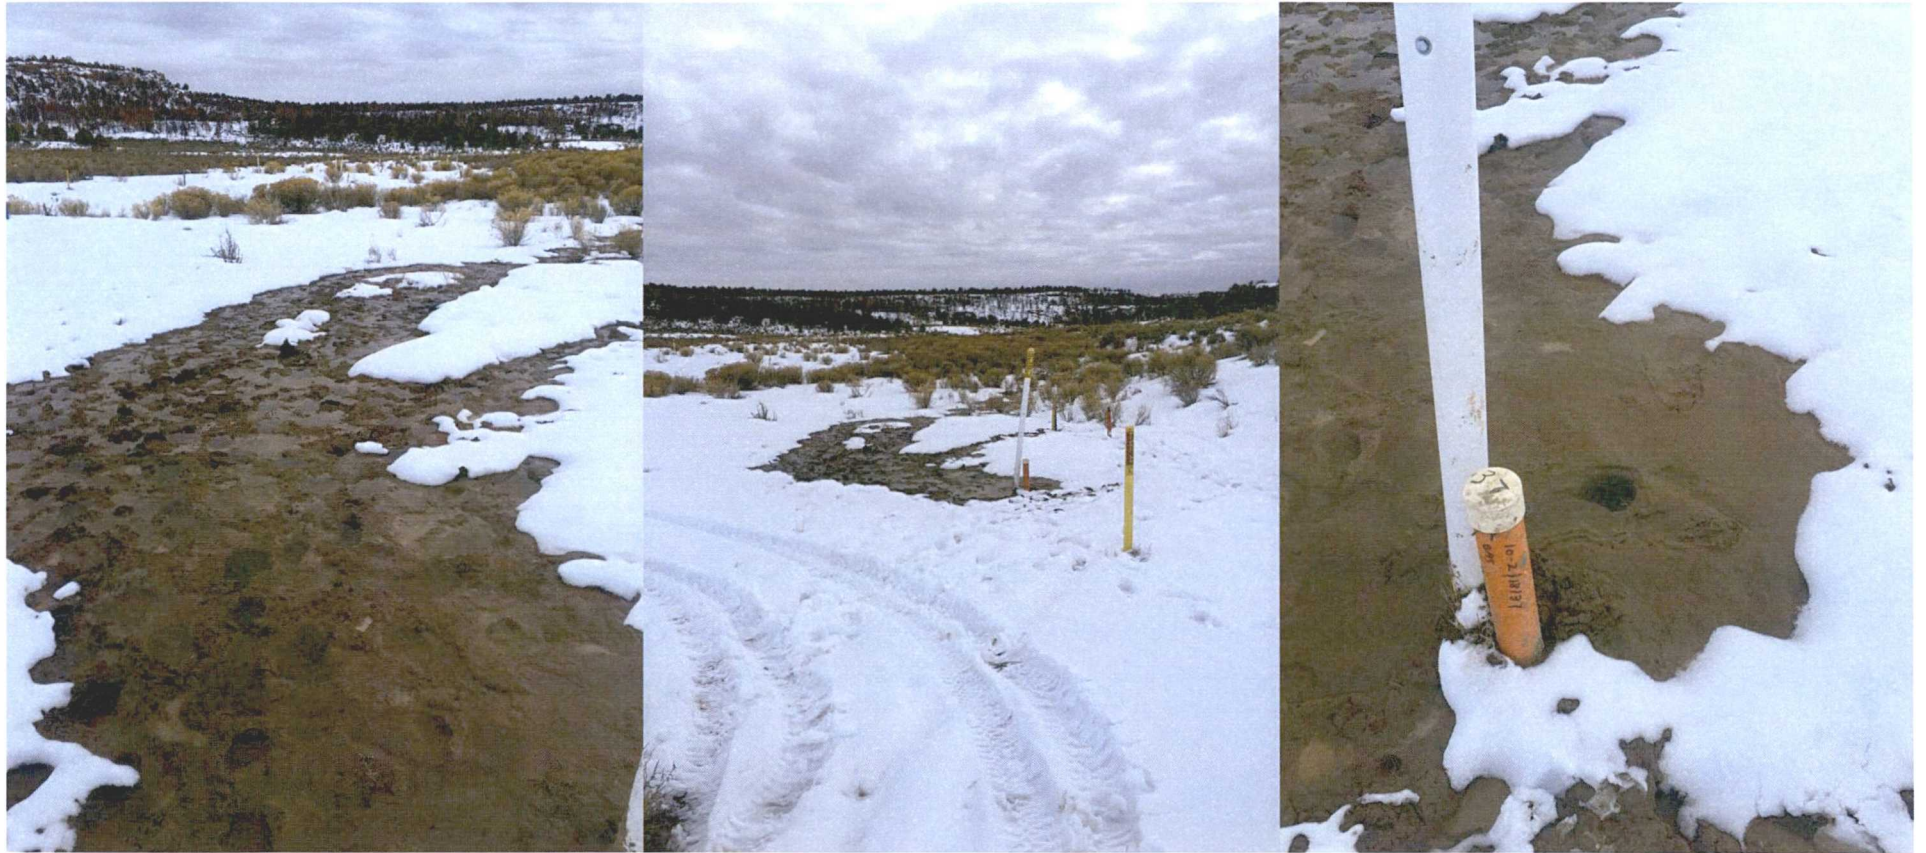
Photographs – Spill Event (1/14/19)

A release of ~12bbls of produced water was released due to internal corrosion on the pipeline. Pipeline CP tech arrived on location and found leak while performing cathodic protection survey. Shut in waterline and turned in one call. Excavated and repaired leak. Water was pooled approximately 20 x 30' but was very shallow. Release remained on pipeline right of way.

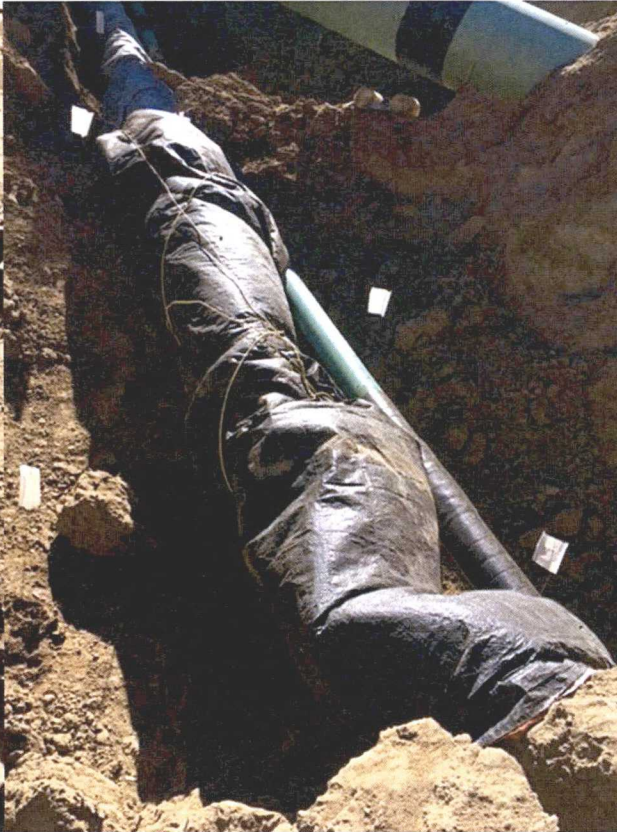
North Of Pipeline

Analyses	Result	PQL	Qual	Units	DF	Date Analyzed
EPA METHOD 8015M/D: DIESEL RANGE ORGANICS						Analyst: lrm
Diesel Range Organics (DRO)	ND	9.5		mg/Kg	1	1/24/2019 10:39:22 AM
Motor Oil Range Organics (MRO)	ND	48		mg/Kg	1	1/24/2019 10:39:22 AM
Surr: DNOP	95.3	50.6-138		%Rec	1	1/24/2019 10:39:22 AM
EPA METHOD 8015D: GASOLINE RANGE						Analyst: NSB
Gasoline Range Organics (GRO)	ND	3.7		mg/Kg	1	1/24/2019 9:56:25 AM
Surr: BFB	92.2	73.8-119		%Rec	1	1/24/2019 9:56:25 AM
EPA METHOD 8021B: VOLATILES						Analyst: NSB
Benzene	ND	0.019		mg/Kg	1	1/24/2019 9:56:25 AM
Toluene	ND	0.037		mg/Kg	1	1/24/2019 9:56:25 AM
Ethylbenzene	ND	0.037		mg/Kg	1	1/24/2019 9:56:25 AM
Xylenes, Total	ND	0.075		mg/Kg	1	1/24/2019 9:56:25 AM
Surr: 4-Bromofluorobenzene	92.8	80-120		%Rec	1	1/24/2019 9:56:25 AM
EPA METHOD 300.0: ANIONS						Analyst: smb
Chloride	ND	30		mg/Kg	20	1/24/2019 11:31:23 AM
