**Pit, Closed-Loop System, Below-Grade Tank, or
Proposed Alternative Method Permit or Closure Plan Application**

1.
Operator: BP AMERICA PRODUCTION COMPANY OGRID #: 778
Address: 380 North Airport Road, Durango, CO 81303
Facility or well name: BARNES LS 008A
API Number: 3004522460 OCD Permit Number: _____
U/L or Qtr/Qtr I Section 26.0 Township 32.0N Range 11W County: San Juan County
Center of Proposed Design: Latitude 36.953402 Longitude -107.954895 NAD: ☐ 1927 ☒ 1983
Surface Owner: ☒ Federal ☐ State ☐ Private ☐ Tribal Trust or Indian Allotment

4.
☒ **Below-grade tank:** Subsection I of 19.15.17.11 NMAC **Tank ID:** B
Volume: 21.0 bbl Type of fluid: Produced Water
Tank Construction material: Steel
☐ Secondary containment with leak detection ☐ Visible sidewalls, liner, 6-inch lift and automatic overflow shut-off
☐ Visible sidewalls and liner ☐ Visible sidewalls only ☐ Other SINGLE WALLED DOUBLE BOTTOMED SIDEWALLS NOT VISIBLE
Liner type: Thickness _____ mil ☐ HDPE ☐ PVC ☐ Other _____

Site Name BARNES LS 008A	Site Type Natural Gas Well
Date Release Discovered December 13, 2018	API# (if applicable) 30-045-22460

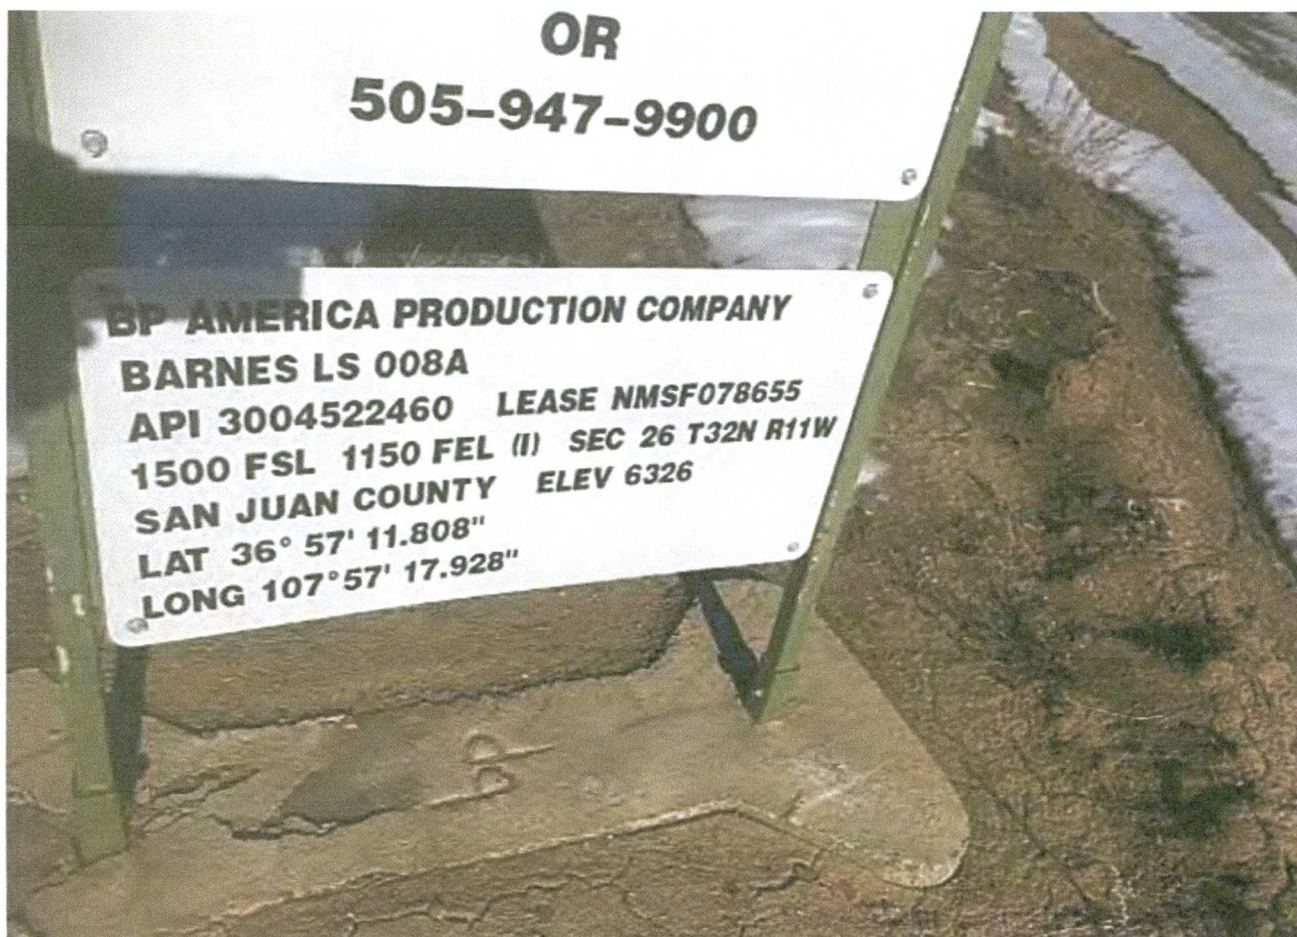
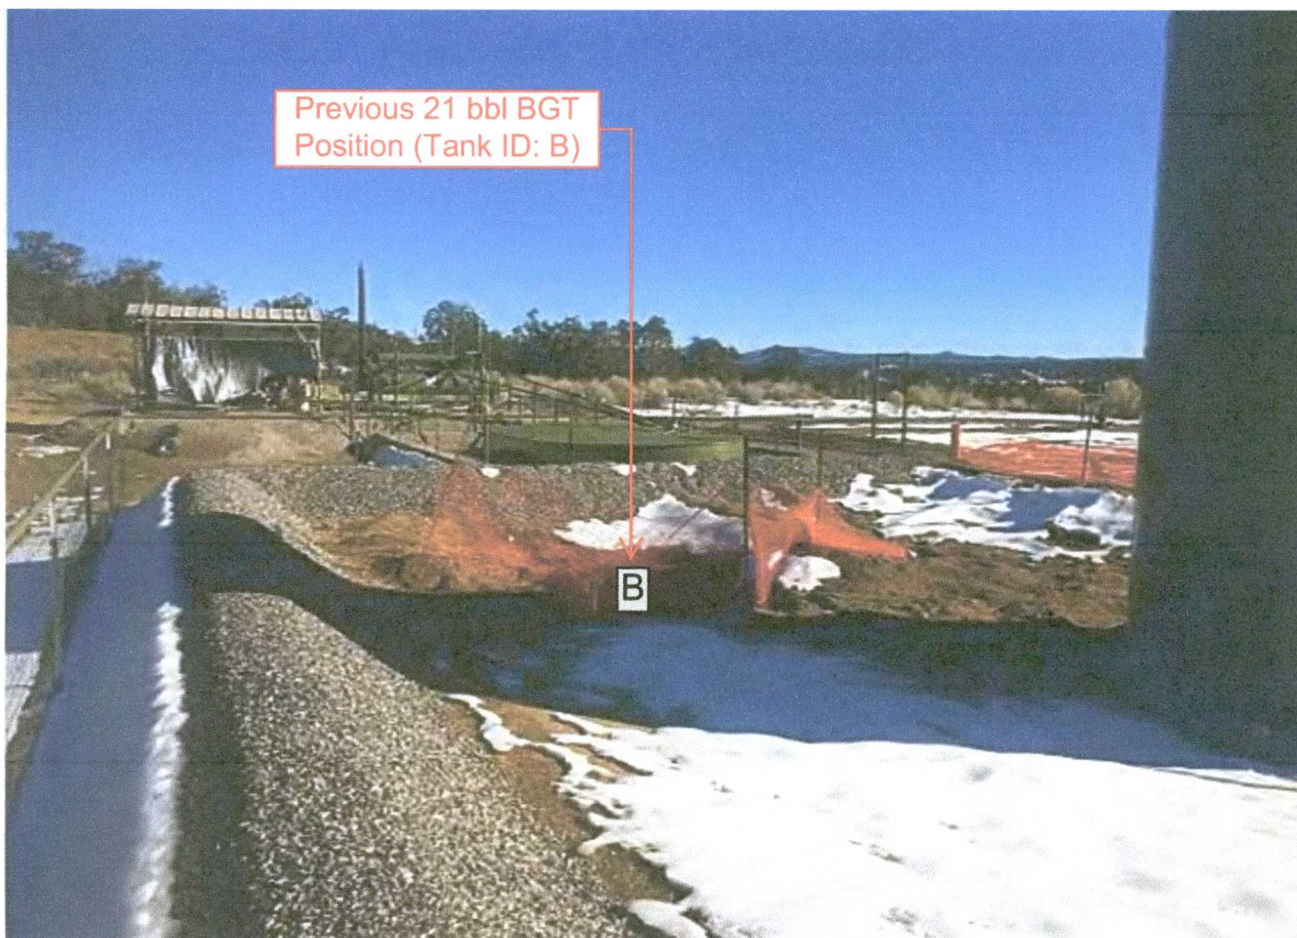
Closure report on C-144 form is included & contains a photo of the current condition.

10. BP shall reclaim the BGT location and all areas associated with the BGT including associated access roads to a safe and stable condition that blends with the surrounding undisturbed area. BP shall substantially restore the impacted surface area to the condition that existed prior to oil and gas operations by placement of the soil cover as provided in Subsection H of 19.15.17.13 NMAC, re-contour the location and associated areas to a contour that approximates the original contour and blends with the surrounding topography and re-vegetate according to Subsection I of 19.15.17.13 NMAC.
