#### NMOCD Release Notification MAR 2 5 2019 **Responsible Party** DISTRICT III OGRID: 372171 Responsible Party: Hilcorp Energy Contact Name: Lindsay Dumas Contact Telephone: 281-794-9159 Contact email: Ldumas@hilcorp.com Incident # (assigned by OCD) Contact mailing address: 1111 Travis St. Houston, TX 77002 **Location of Release Source** Latitude 36.43239 Longitude -107.44795 (NAD 83 in decimal degrees to 5 decimal places) Site Name: Canyon Largo Unit 252 Site Type: Gas Date Release Discovered: 2/24/19 API# (if applicable) 30-039-20805 Unit Letter Section Township Range County 3 A 25N 06W Rio Arriba Surface Owner: ☐ State ☒ Federal ☐ Tribal ☐ Private (Name: Nature and Volume of Release Material(s) Released (Select all that apply and attach calculations or specific justification for the volumes provided below) Crude Oil Volume Released (bbls) Volume Recovered (bbls) Produced Water Volume Released (bbls) 11 bbls Volume Recovered (bbls) 0 bbls Is the concentration of dissolved chloride in the Yes No produced water >10,000 mg/l? Condensate Volume Released (bbls) Volume Recovered (bbls) ☐ Natural Gas Volume Recovered (Mcf) Volume Released (Mcf) Other (describe) Volume/Weight Released (

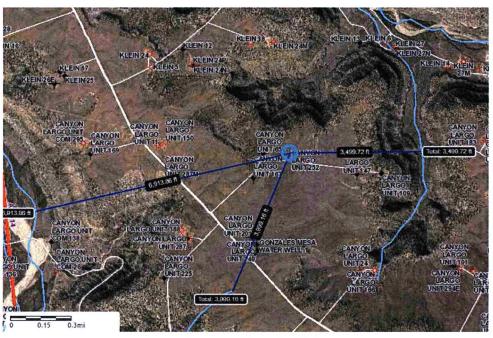
Determination of water sources and significant watercourses within ½ mile of the lateral extent of the release

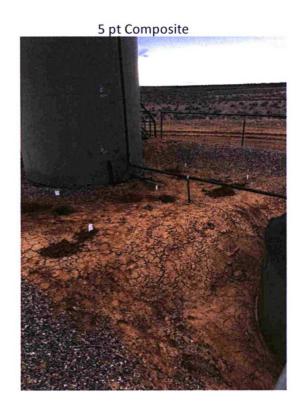
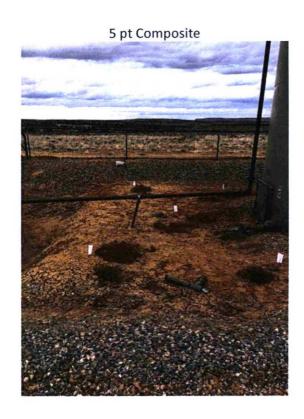
# Photographs – 3/7/19 Confirmation Sampling Event

Corrosion around the man way door of the tank.

On 2/24/2019 at 1pm, Hilcorp Energy discovered a release on the Canyon Largo 252, 30-039-20805, 36.43239, - 107.44795, A, 3, 25N, 06W. Field Operator discovered ice buildup around the man way door of the tank, upon further investigation and gauging the tank realized a loss of 11.04 bbl or produced water, remaining fluids were transferred. Tank is on schedule for inspection and repair. The release remained in the berm'd area. Zero fluid was recovered.
