Release Notification

| Site Name | Good Times D06 2309 #00111 | Site Type | Well |

Location: Good Times D06-2309 01H Unit D
Event: Enardo Valve Fire
Date: June 15, 2019

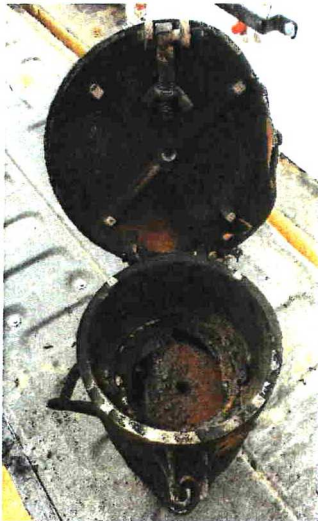
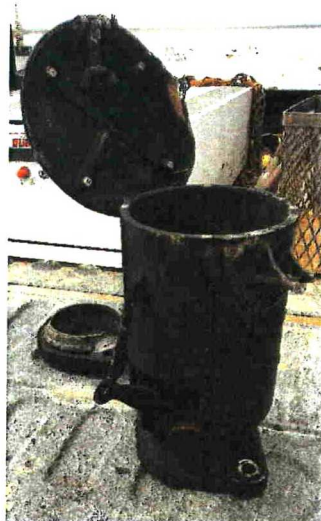
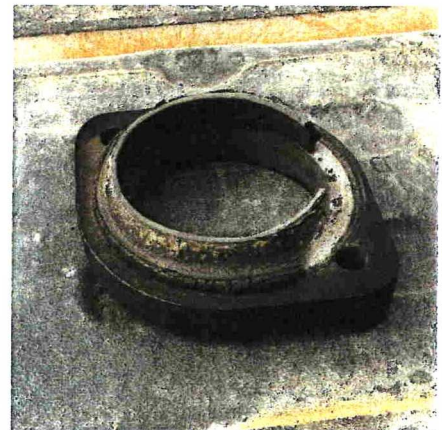
At approximately 7:20pm on June 15, 2019, Beau Dibble received a phone call from a Western driver informing him that one of the enardo valves on a tank at the Good Times D06 was on fire. He then drove to the site and saw that the enardo valve on the produced water tank was on fire. Beau called Richard Baldwin and was instructed to shut off the gas supply. After doing so, the flame extinguished in about 15 minutes.

At the time of the fire, there was a storm passing through the area and lightening or static electricity as a result of lightening is believed to have caused the fire. All tanks are properly grounded and there are no visible signs of a lightening strike.

On Monday morning, June 17, 2019, Wendell had Calder replace the valve and then put the well back into service.
