## FIELD PIT SITE ASSESSMENT FORM

EL PASO FIELD SERVICES

93-450 SK 8/10/94  
 Meter: ~~03-887~~ Location: Jelly Dog Jerry #1  
 Operator #: 5954 Operator Name: J.P. McHugh P/L District: Ojito  
 Coordinates: Letter: F Section 33 Township: 24 Range: 2  
 Or Latitude \_\_\_\_\_ Longitude \_\_\_\_\_  
 Pit Type: Dehydrator \_\_\_\_\_ Location Drip: X Line Drip: \_\_\_\_\_ Other: \_\_\_\_\_  
 Site Assessment Date: 8/18/94 Area: 08 Run: 52

# FIELD PIT REMEDIATION/CLOSURE FORM

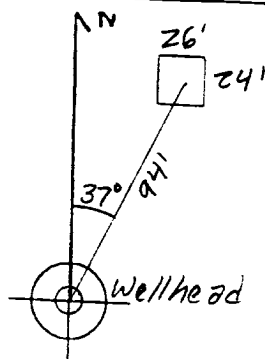
## ORIGINAL PIT LOCATION

Original Pit : a) Degrees from North 37° Footage from Wellhead 94'  
b) Length : 26' Width : 24' Depth : 3'
