JICARILLA L-12
SEC-34 T85N R-5W
WFS

Project: Jicarilla Pit Remediation

ON-SITE SOIL REMEDIATION REPORT

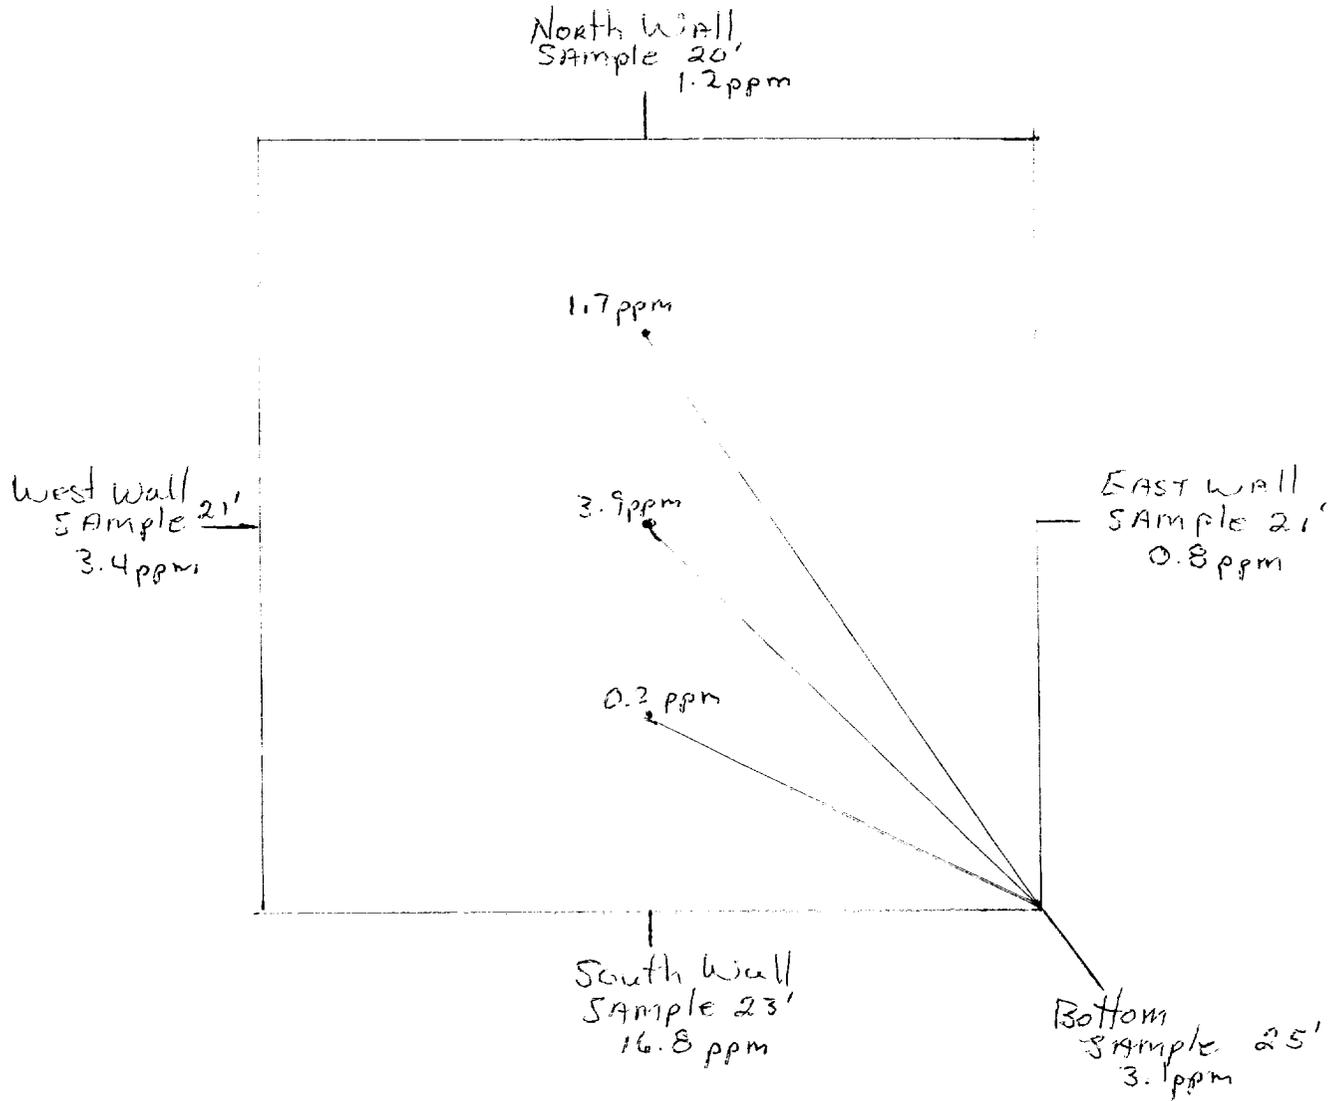
EXCAVATION DRAWING

General Description of Remedial Action: Removed Contaminated Soil from all four side walls and Pit bottom as to get a below 100ppm headspace reading
Final excavation: 26' X 25' X 25'.

Final Pit Closure Sampling: Sample Location North, East, South, West side walls and Pit bottom

(if multiple samples, attach sample result and diagram of sample locations and depths.) Sample depth 2.5'

Jicarilla L-12
Sec-34 T-25N R-5W UNIT J

26' X 25' X 25'

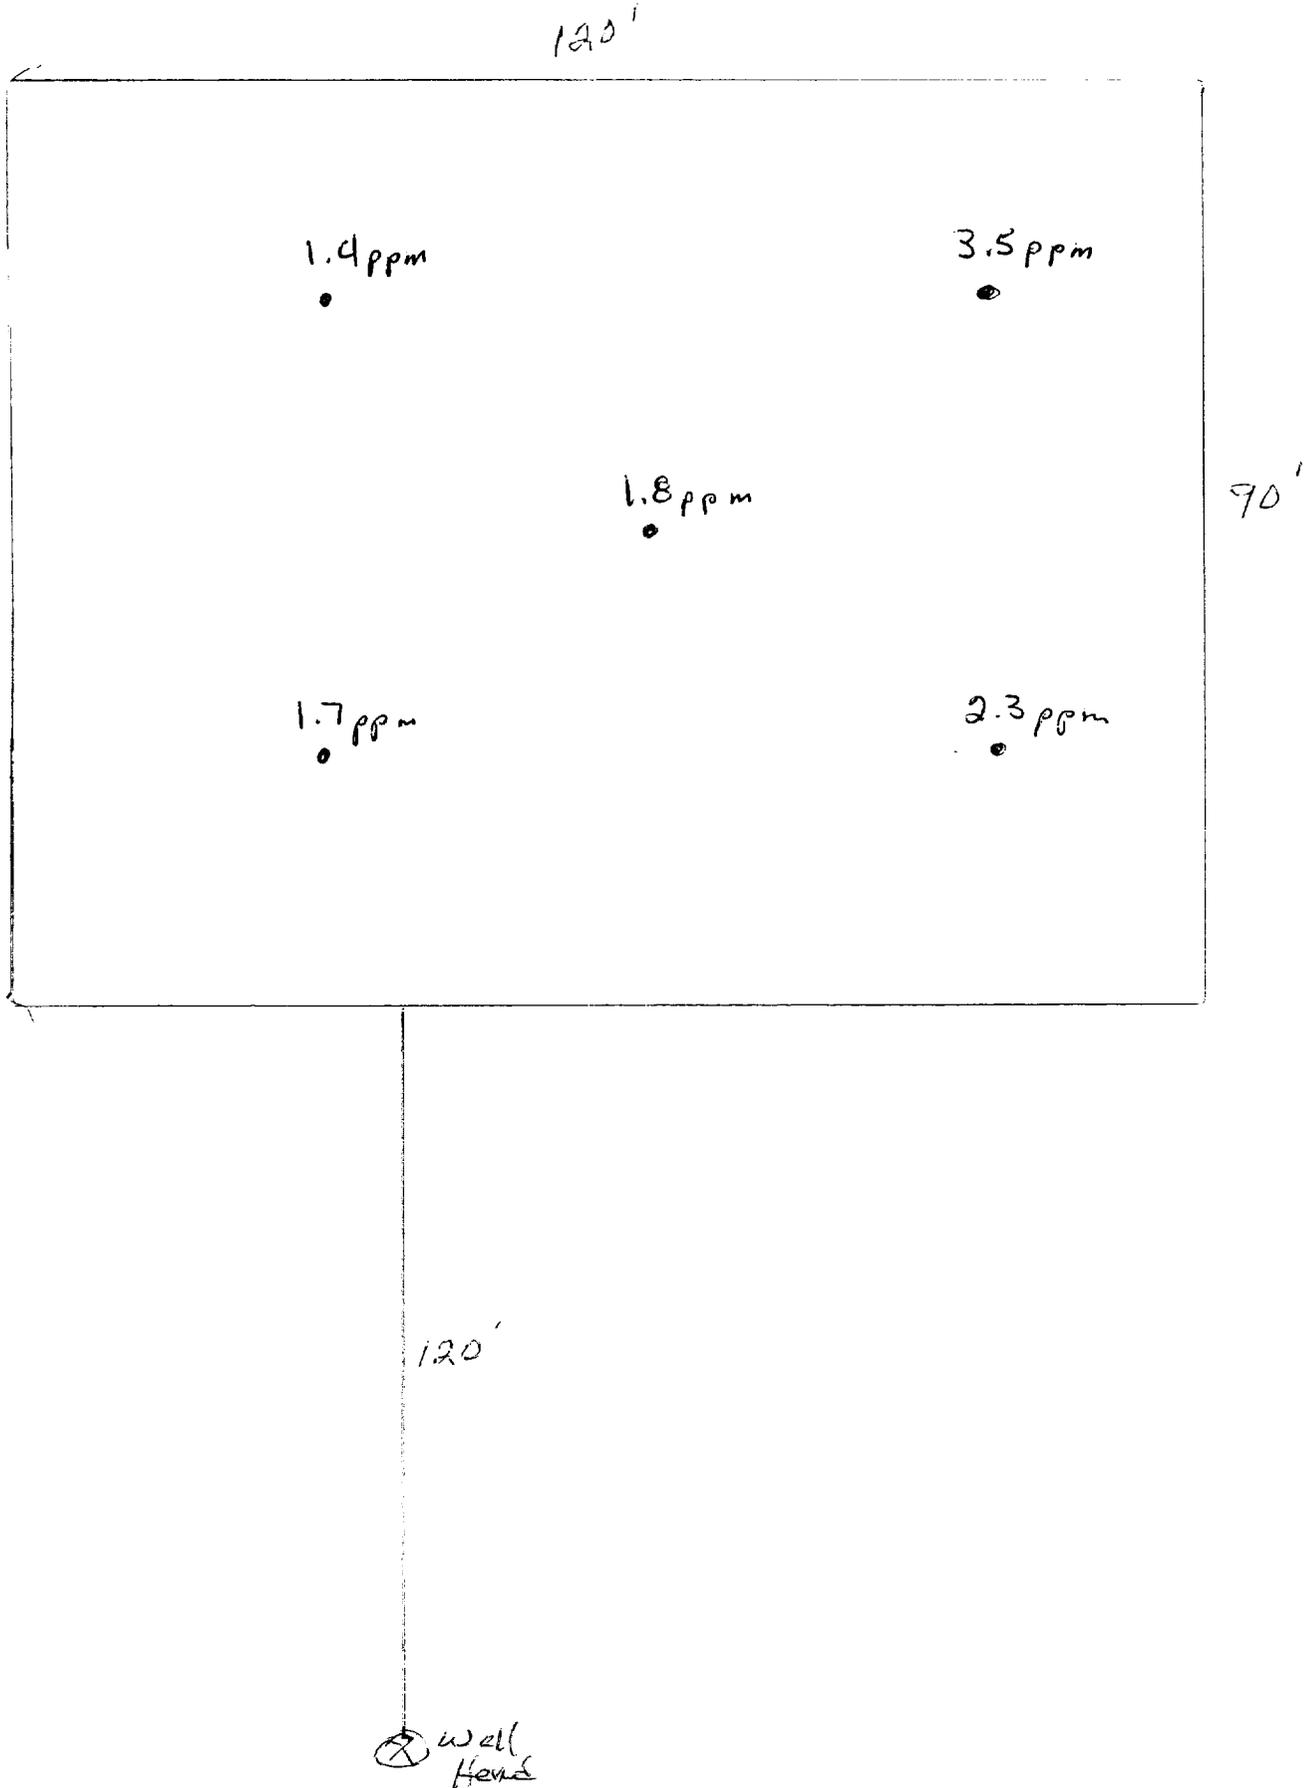
Land farm

MEADWELL L-12
R. 34 T. 25N R. 5W Unit J
AUGUS
