PIT REMEDIATION AND CLOSURE REPORT

Operator: PNM Gas Services (Caulkins) Telephone: 324-3764

Facility or Well Name: Breach A #136E

Location: Unit O Sec 10 T 26 N R 6 W County Rio Arriba

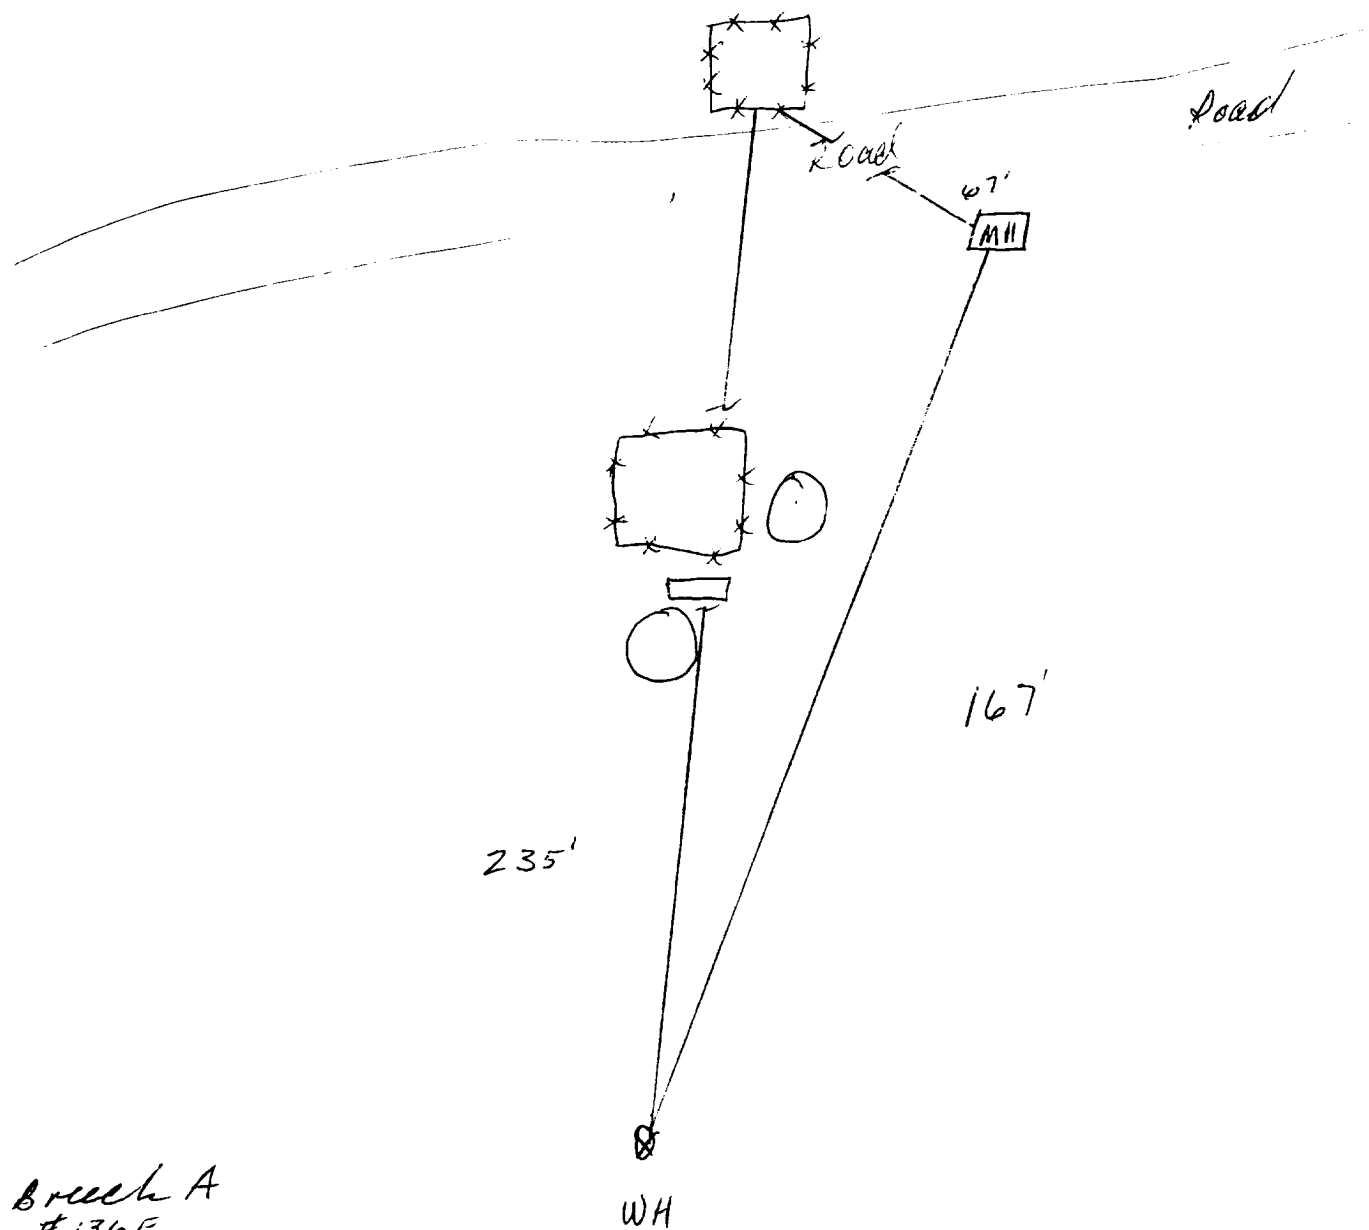
Breach A
#136 E.
Caulkins
(O) 10-26N-6W

Excavated contaminated soil to a pit size of 15' X 13' X 11' and landfarmed soil onsite within a bermed area at a depth of 6" to 12". Soil was aerated by disking/plowing until soil met regulatory levels.

Sample Location 5 pt. composite - 4 side walls and center of pit bottom.

7° E of N
235' from W.H.

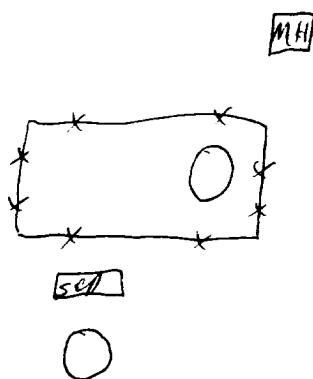
Breach A #13GE

Sample # 9708281050

Land from field headspace - 1.8 ppm

See lab analysis for BTEX.

2' 10"
