## EL PASO FIELD SERVICES

### FIELD PIT SITE ASSESSMENT FORM

| <b>GENERAL</b> | <p>Meter: <u>70510</u> Location: <u>BURNS #4</u></p> <p>Operator #: _____ Operator Name: <u>CENTRAL RESOURCE</u> / <u>L</u> District: <u>BALLARD</u></p> <p>Coordinates: Letter: <u>D</u> Section <u>9</u> Township: <u>26</u> Range: <u>7</u></p> <p>Or Latitude _____ Longitude _____</p> <p>Pit Type: Dehydrator _____ Location Drip: <u>X</u> Line Drip: _____ Other: _____</p> <p>Site Assessment Date: <u>6.16.94</u> Area: <u>07</u> Run: <u>51</u></p> |

# FILL PIT REMEDIATION/CLOSURE FORM

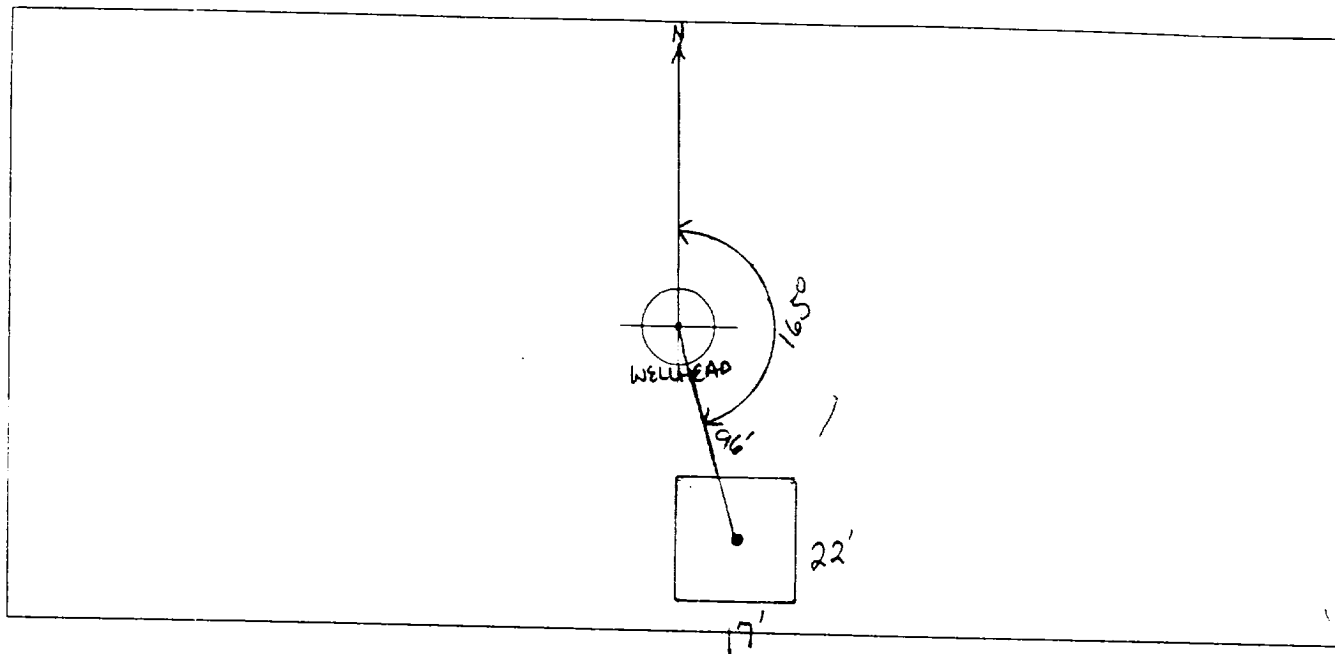
# ORIGINAL PIT LOCATION

| <b>REMARKS</b> | <p>Remarks : <u>ONLY PIT ON LOCATION. PIT IS DRY. LOCATION IS IN LARGO CANYON SOUTH OF LARGO WASH. REDLINE AND TPO CONFIRMED LOCATION IS INSIDE V.2.</u></p> |

Original Pit : a) Degrees from North 165° Footage from Wellhead 96'  
 b) Length : 22' Width : 17' Depth : 3'
