### FIELD PIT SITE ASSESSMENT FORM

| <b>GENERAL</b> | <p>Meter: <u>70647</u> Location: <u>Rincon Unit #16</u></p> <p>Operator #: _____ Operator Name: <u>Unocal</u> P/L District: <u>Blanco</u></p> <p>Coordinates: Letter: <u>C</u> Section <u>25</u> Township: <u>27</u> Range: <u>7</u></p> <p>Or Latitude _____ Longitude _____</p> <p>Pit Type: Dehydrator _____ Location Drip: <input checked="" type="checkbox"/> Line Drip: _____ Other: _____</p> <p>Site Assessment Date: <u>11/15/94</u> Area: <u>03</u> Run: <u>22</u></p> |

# FIELD PIT REMEDIATION/CLOSURE FORM

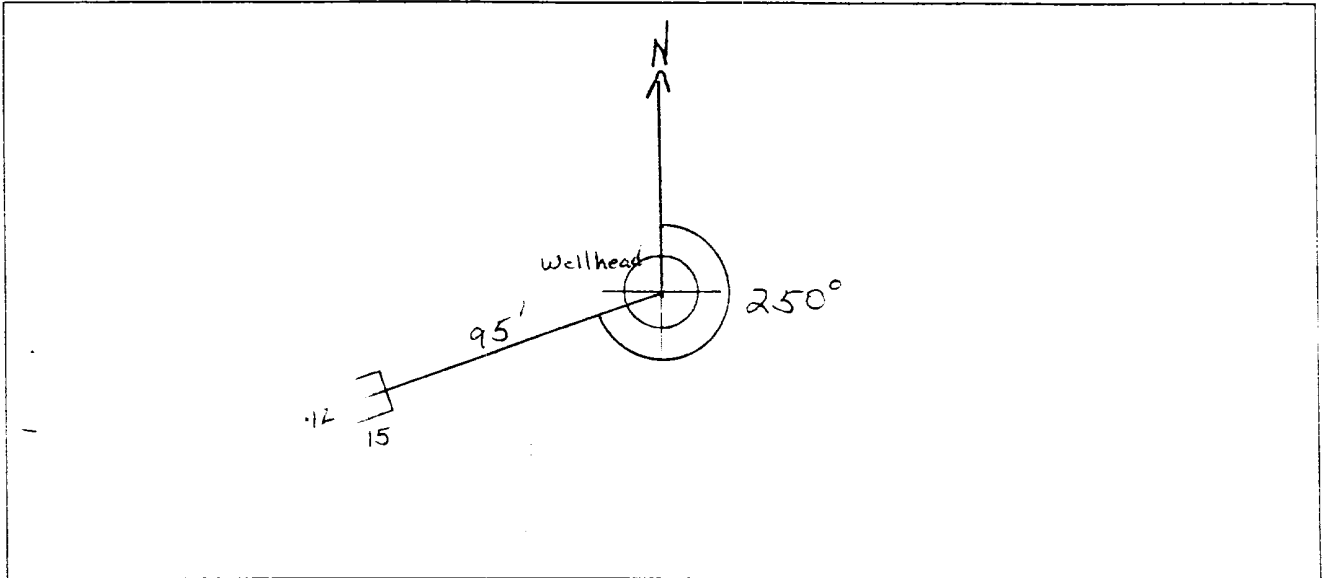
### ORIGINAL PIT LOCATION

Original Pit : a) Degrees from North 250° Footage from Wellhead 95'  
b) Length : 15' Width : 12 Depth : 0

Pit covered and capped. All measurements taken from  
approximate center of old pit. Marked w/ Survey lath. Old  
pit appeared to be in sandstone.
