EL PASO FIELD SERVICES

# FIELD PIT SITE ASSESSMENT FORM

| GENERAL | | |
|---|---|---|
| | Meter: <u>70-415</u> Location: <u>Hughes Federal No. 3</u><br>Operator #: <u>0286</u> Operator Name: <u>CONOCO P/L</u> District: <u>Ballard</u><br>Coordinates: Letter: <u>M</u> Section <u>34</u> Township: <u>26</u> Range: <u>7</u><br>Or Latitude _____ Longitude _____<br>Pit Type: Dehydrator _____ Location Drip: <u>X</u> Line Drip: _____ Other: _____<br>Site Assessment Date: <u>06/29/94</u> Area: <u>07</u> Run: <u>41</u> | |

# FIELD PIT REMEDIATION/CLOSURE FORM

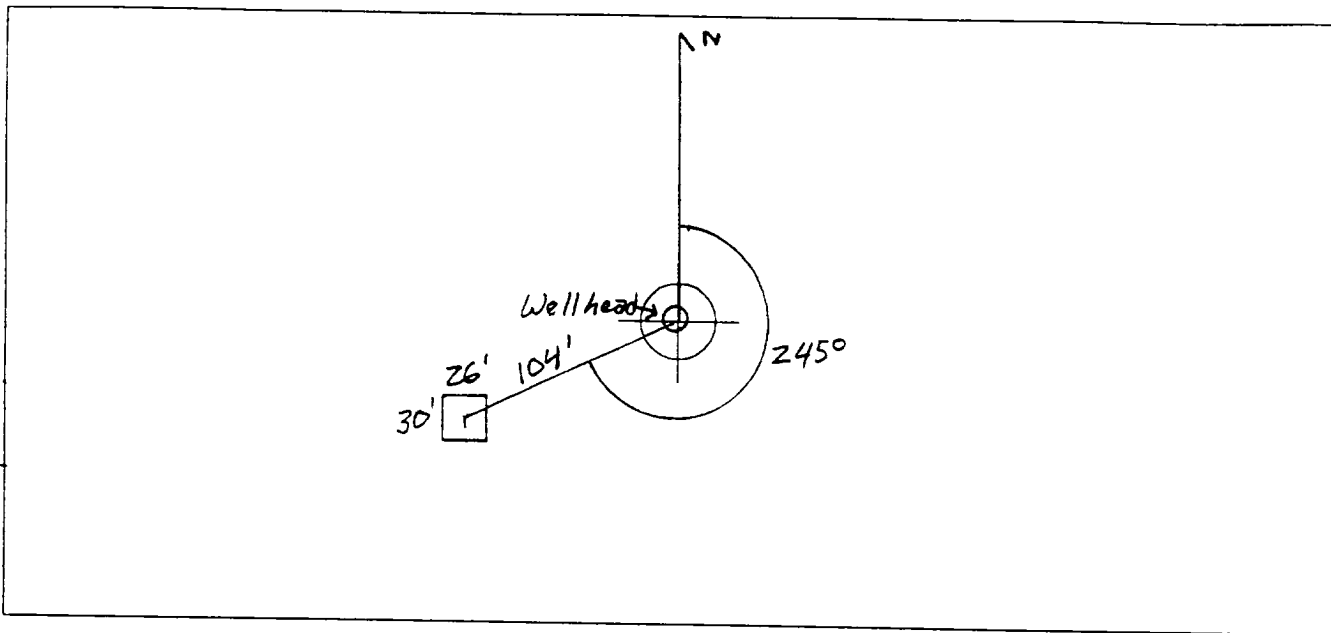
# ORIGINAL PIT LOCATION

Original Pit : a) Degrees from North 245° Footage from Wellhead 104'  
 b) Length : 26' Width : 30' Depth : 3'
