## FIELD PIT SITE ASSESSMENT FORM

# FIELD PIT REMEDIATION/CLOSURE FORM

#### PIT CLOSURE PROJECT - Soil Samples Inside the GWV Zone

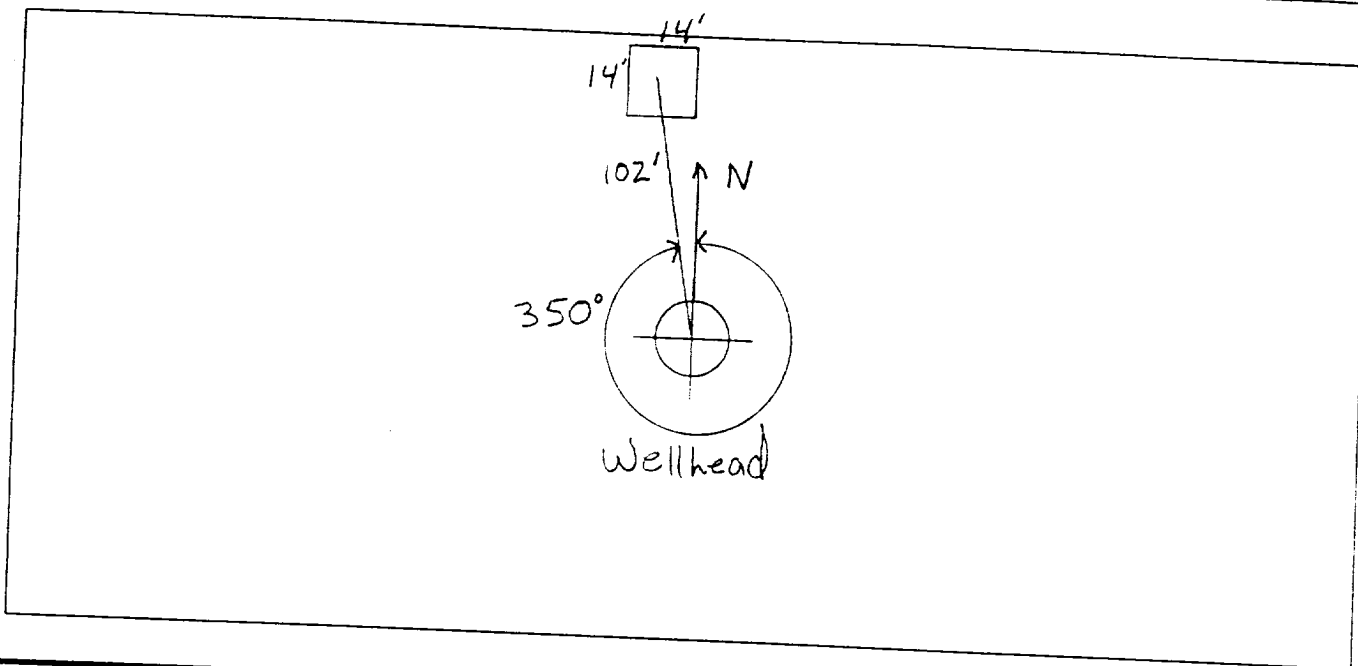
# ORIGINAL PIT LOCATION

Original Pit : a) Degrees from North 350° Footage from Wellhead 102  
 b) Length : 14 Width : 14 Depth : 3
